Report on

FLOODING IN EASTERN MARICOPA COUNTY

JULY 17-18, 1984

November 15, 1984

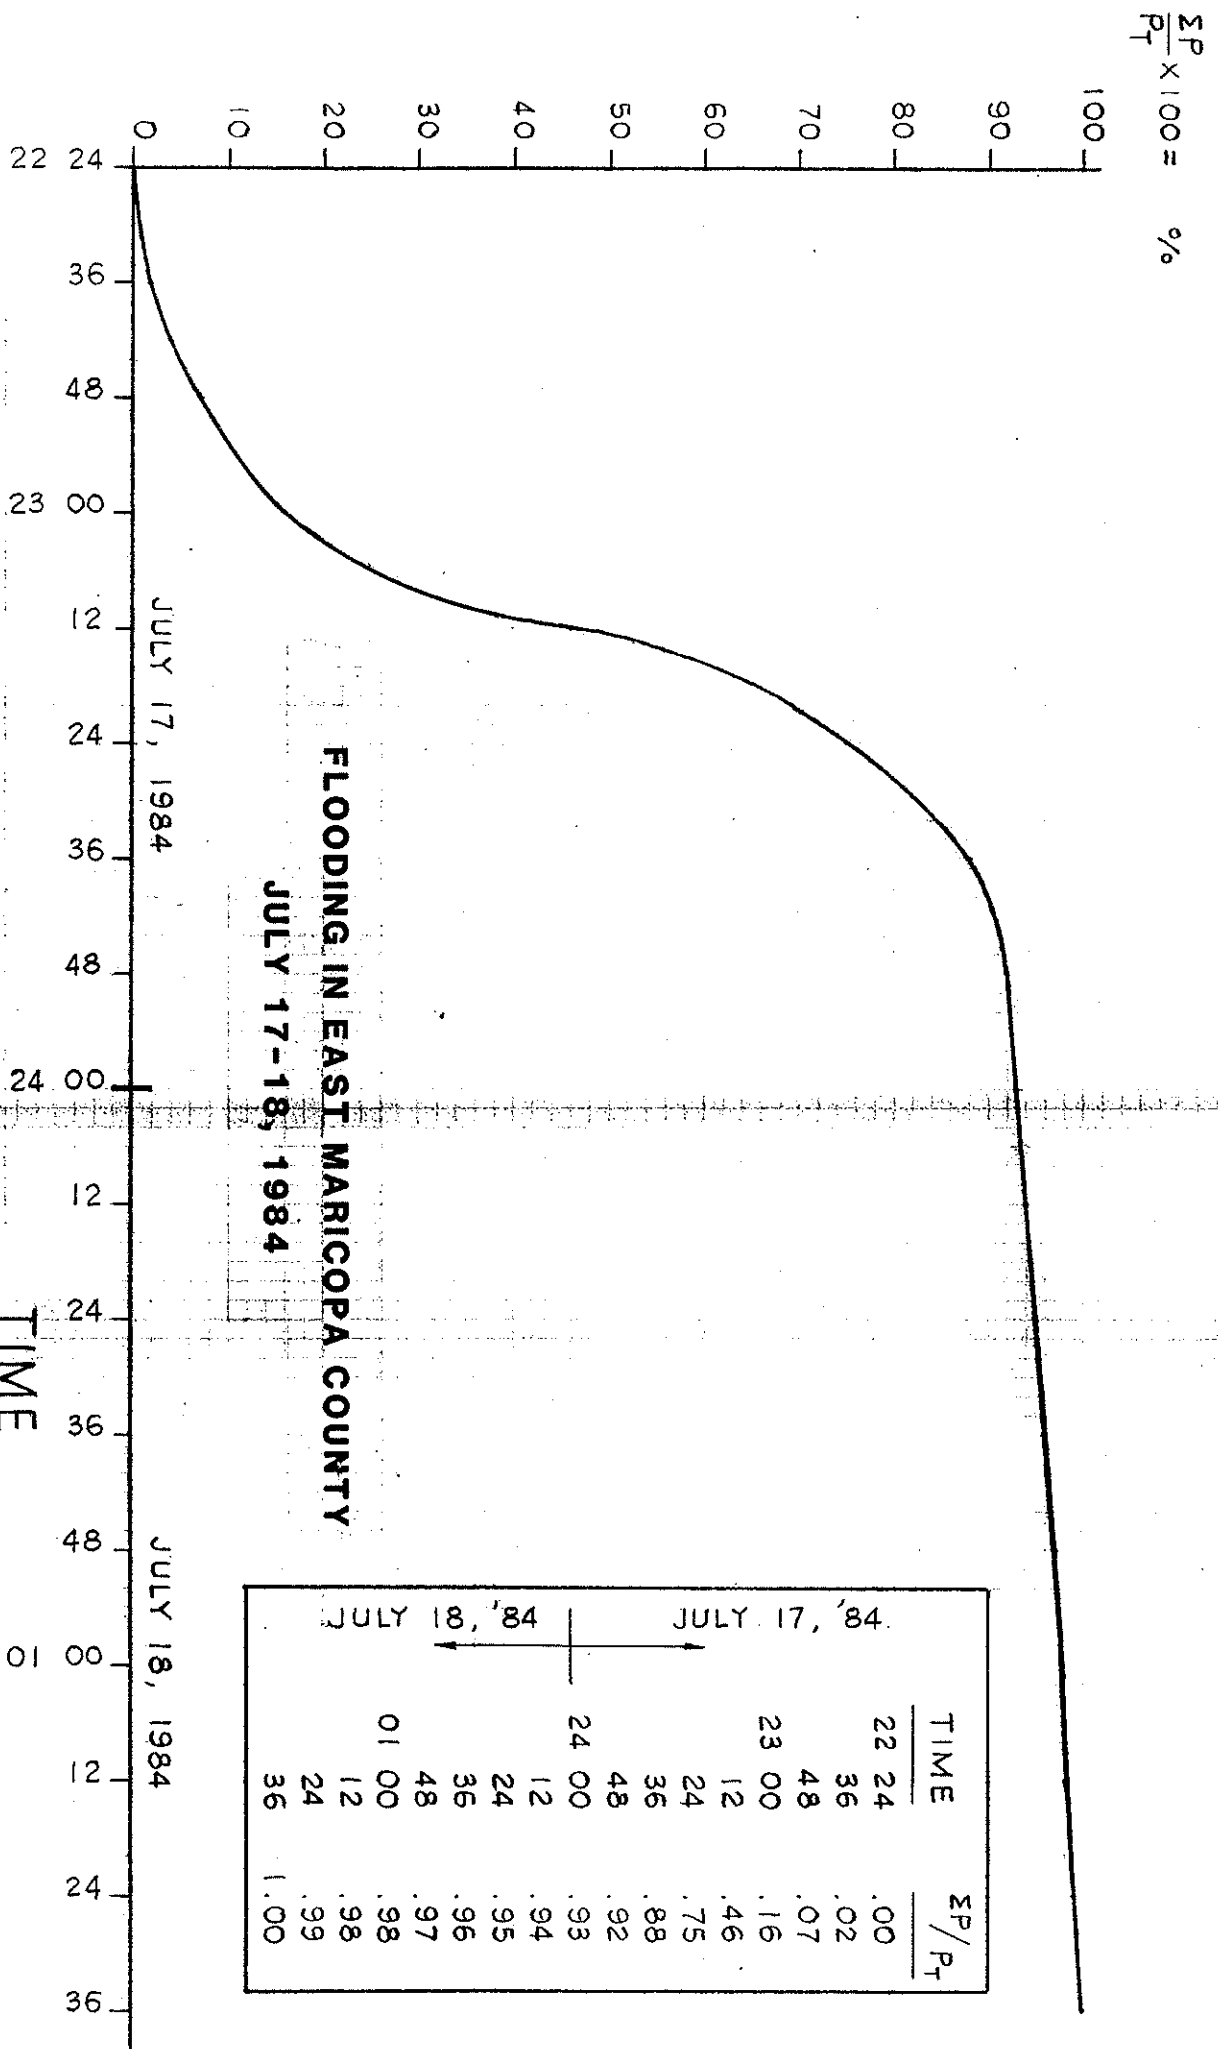
FIGURE 2: MASS CURVE FOR PRECIPITATION V.S. TIME (12 MIN. INTERVAL)

Data provided by the recording rain gauges indicated the storm began at approximately 10:30 p.m. with highly intense rainfall until 11:30 p.m. and rainfall ceasing at approximately 1:00 a.m. A mass curve (Figure 2) was drawn from the data to provide a temporal distribution of the rainfall for model input.

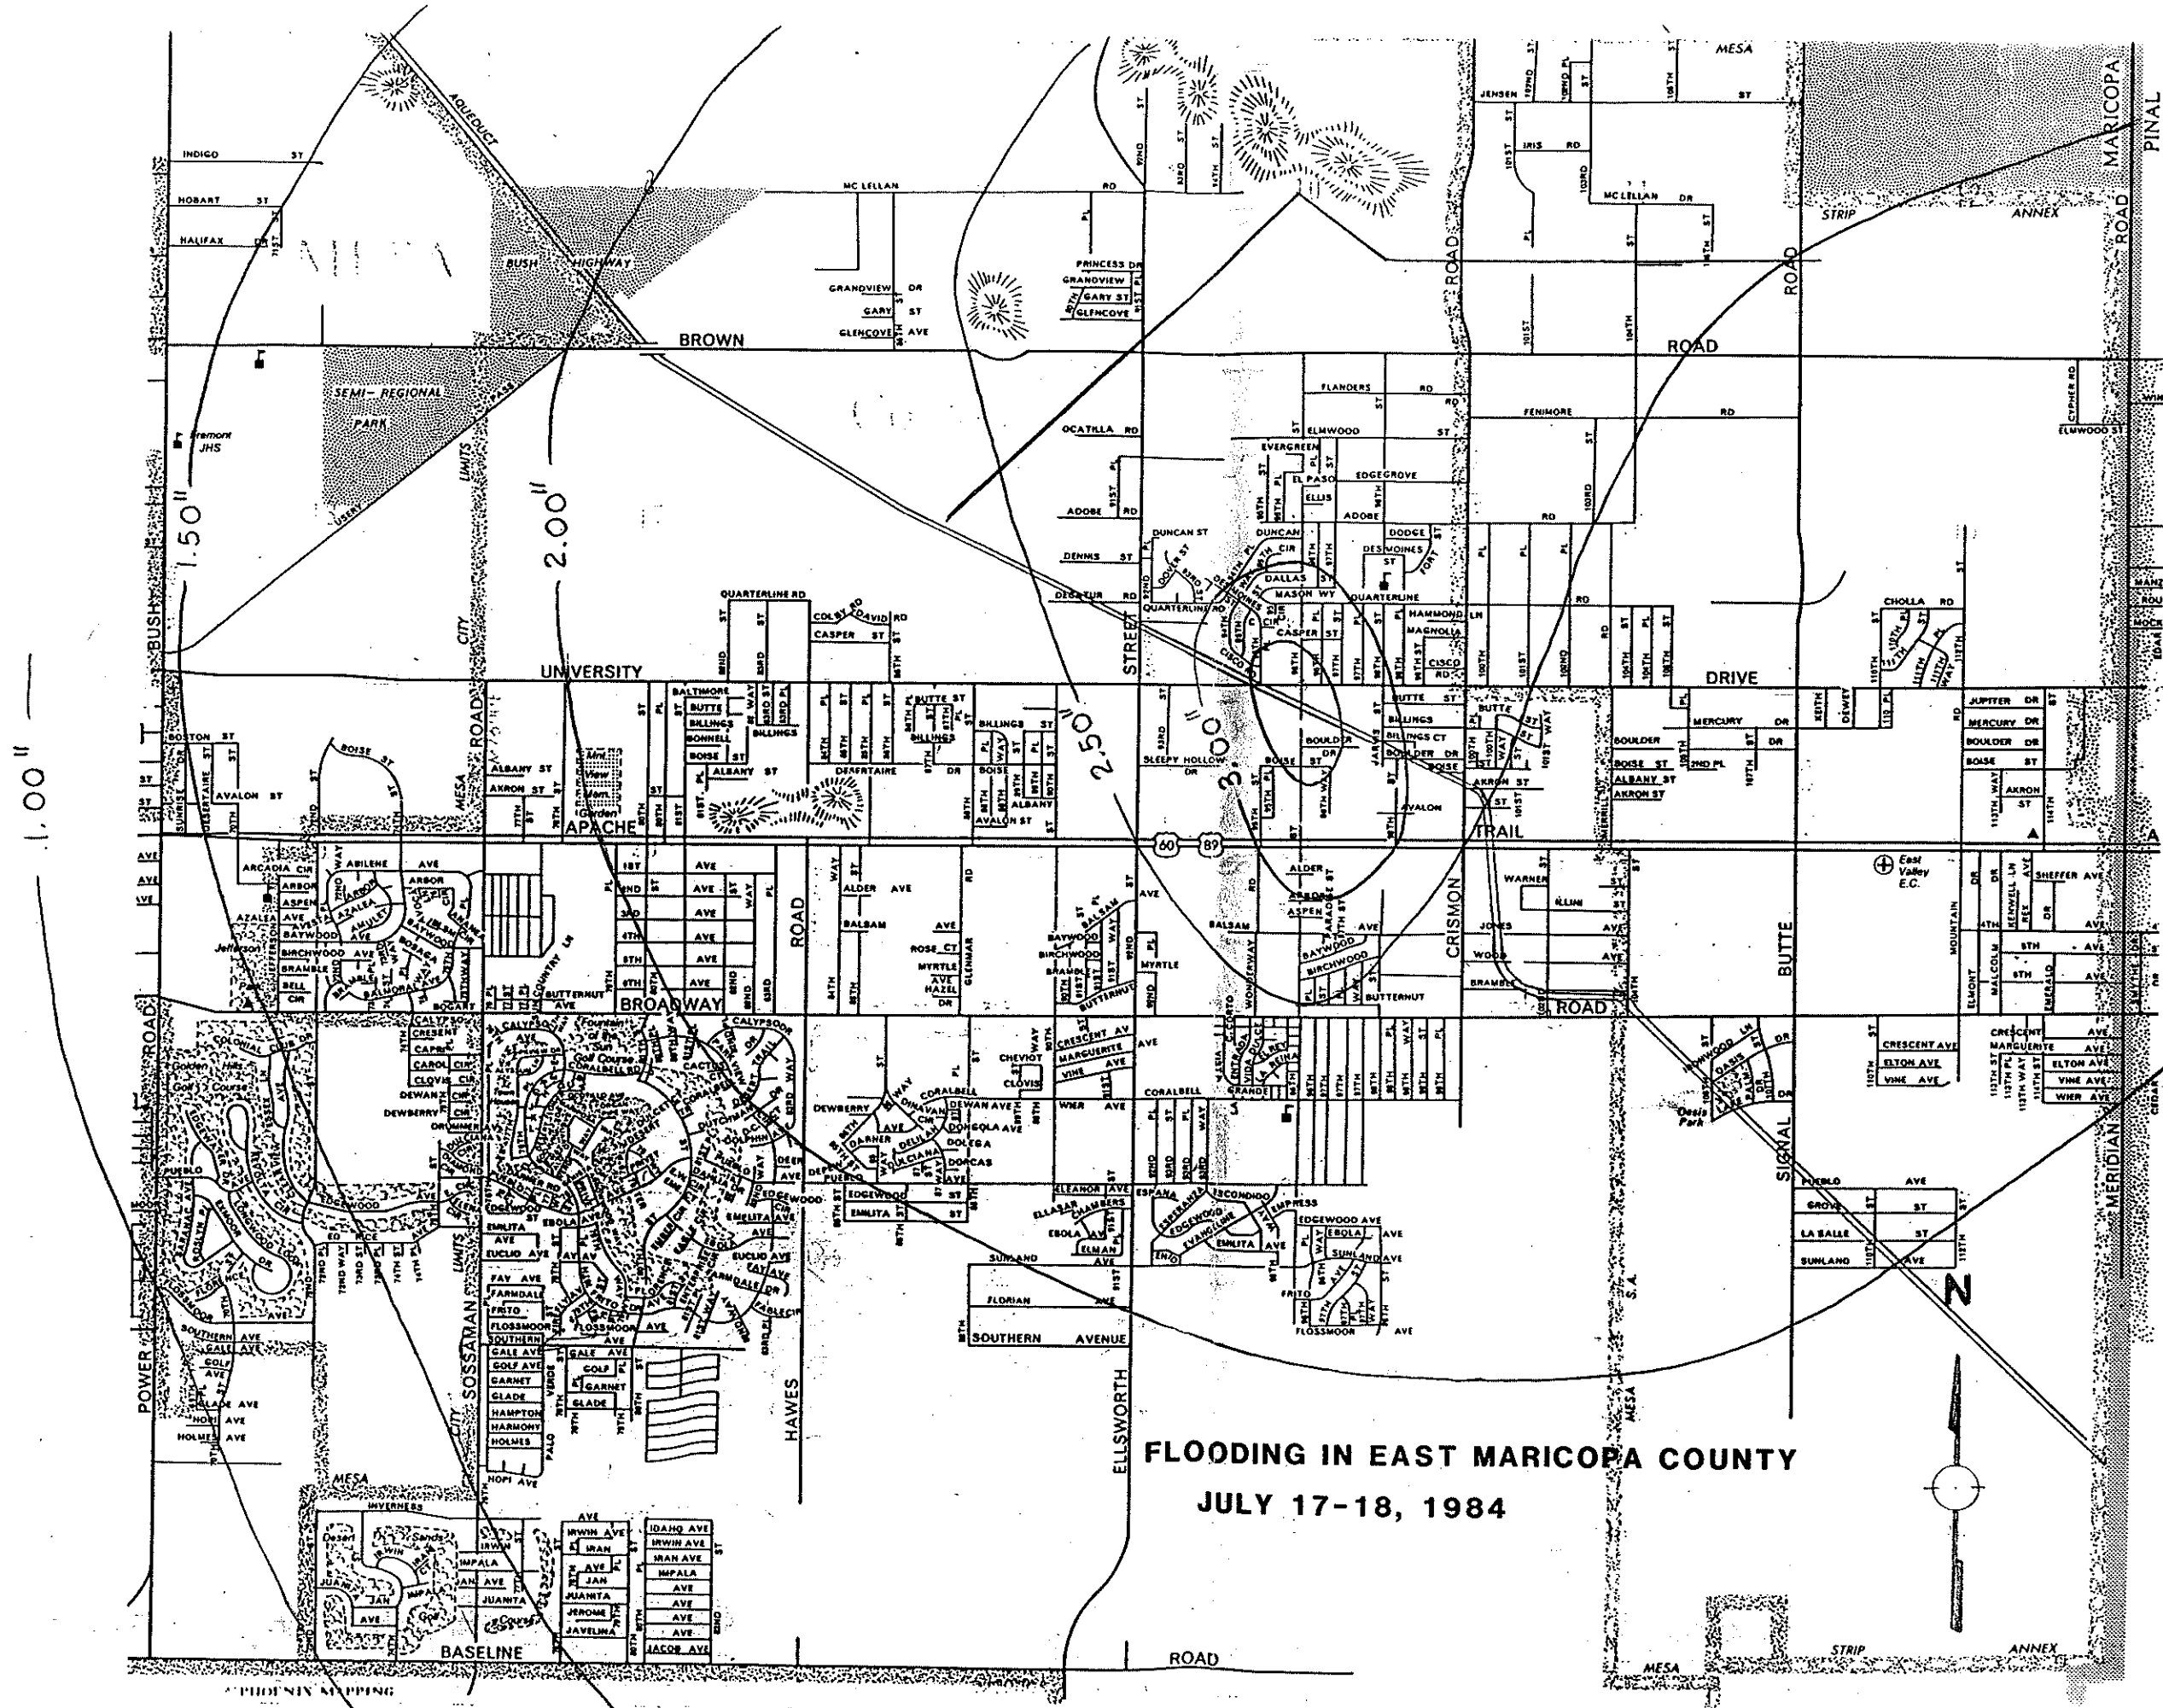
FIGURE 1: ISOHYETS FOR STORM OF JULY 17-18, 1984

Three of the rain gauges located in the study area recorded total rainfall depths in excess of 2.60 inches; two of these were greater than or equal to 3.75 inches. This indicates that in parts of the study area this storm had a return period greater than the 100-year point precipitation values used for subdivision and development drainage review.

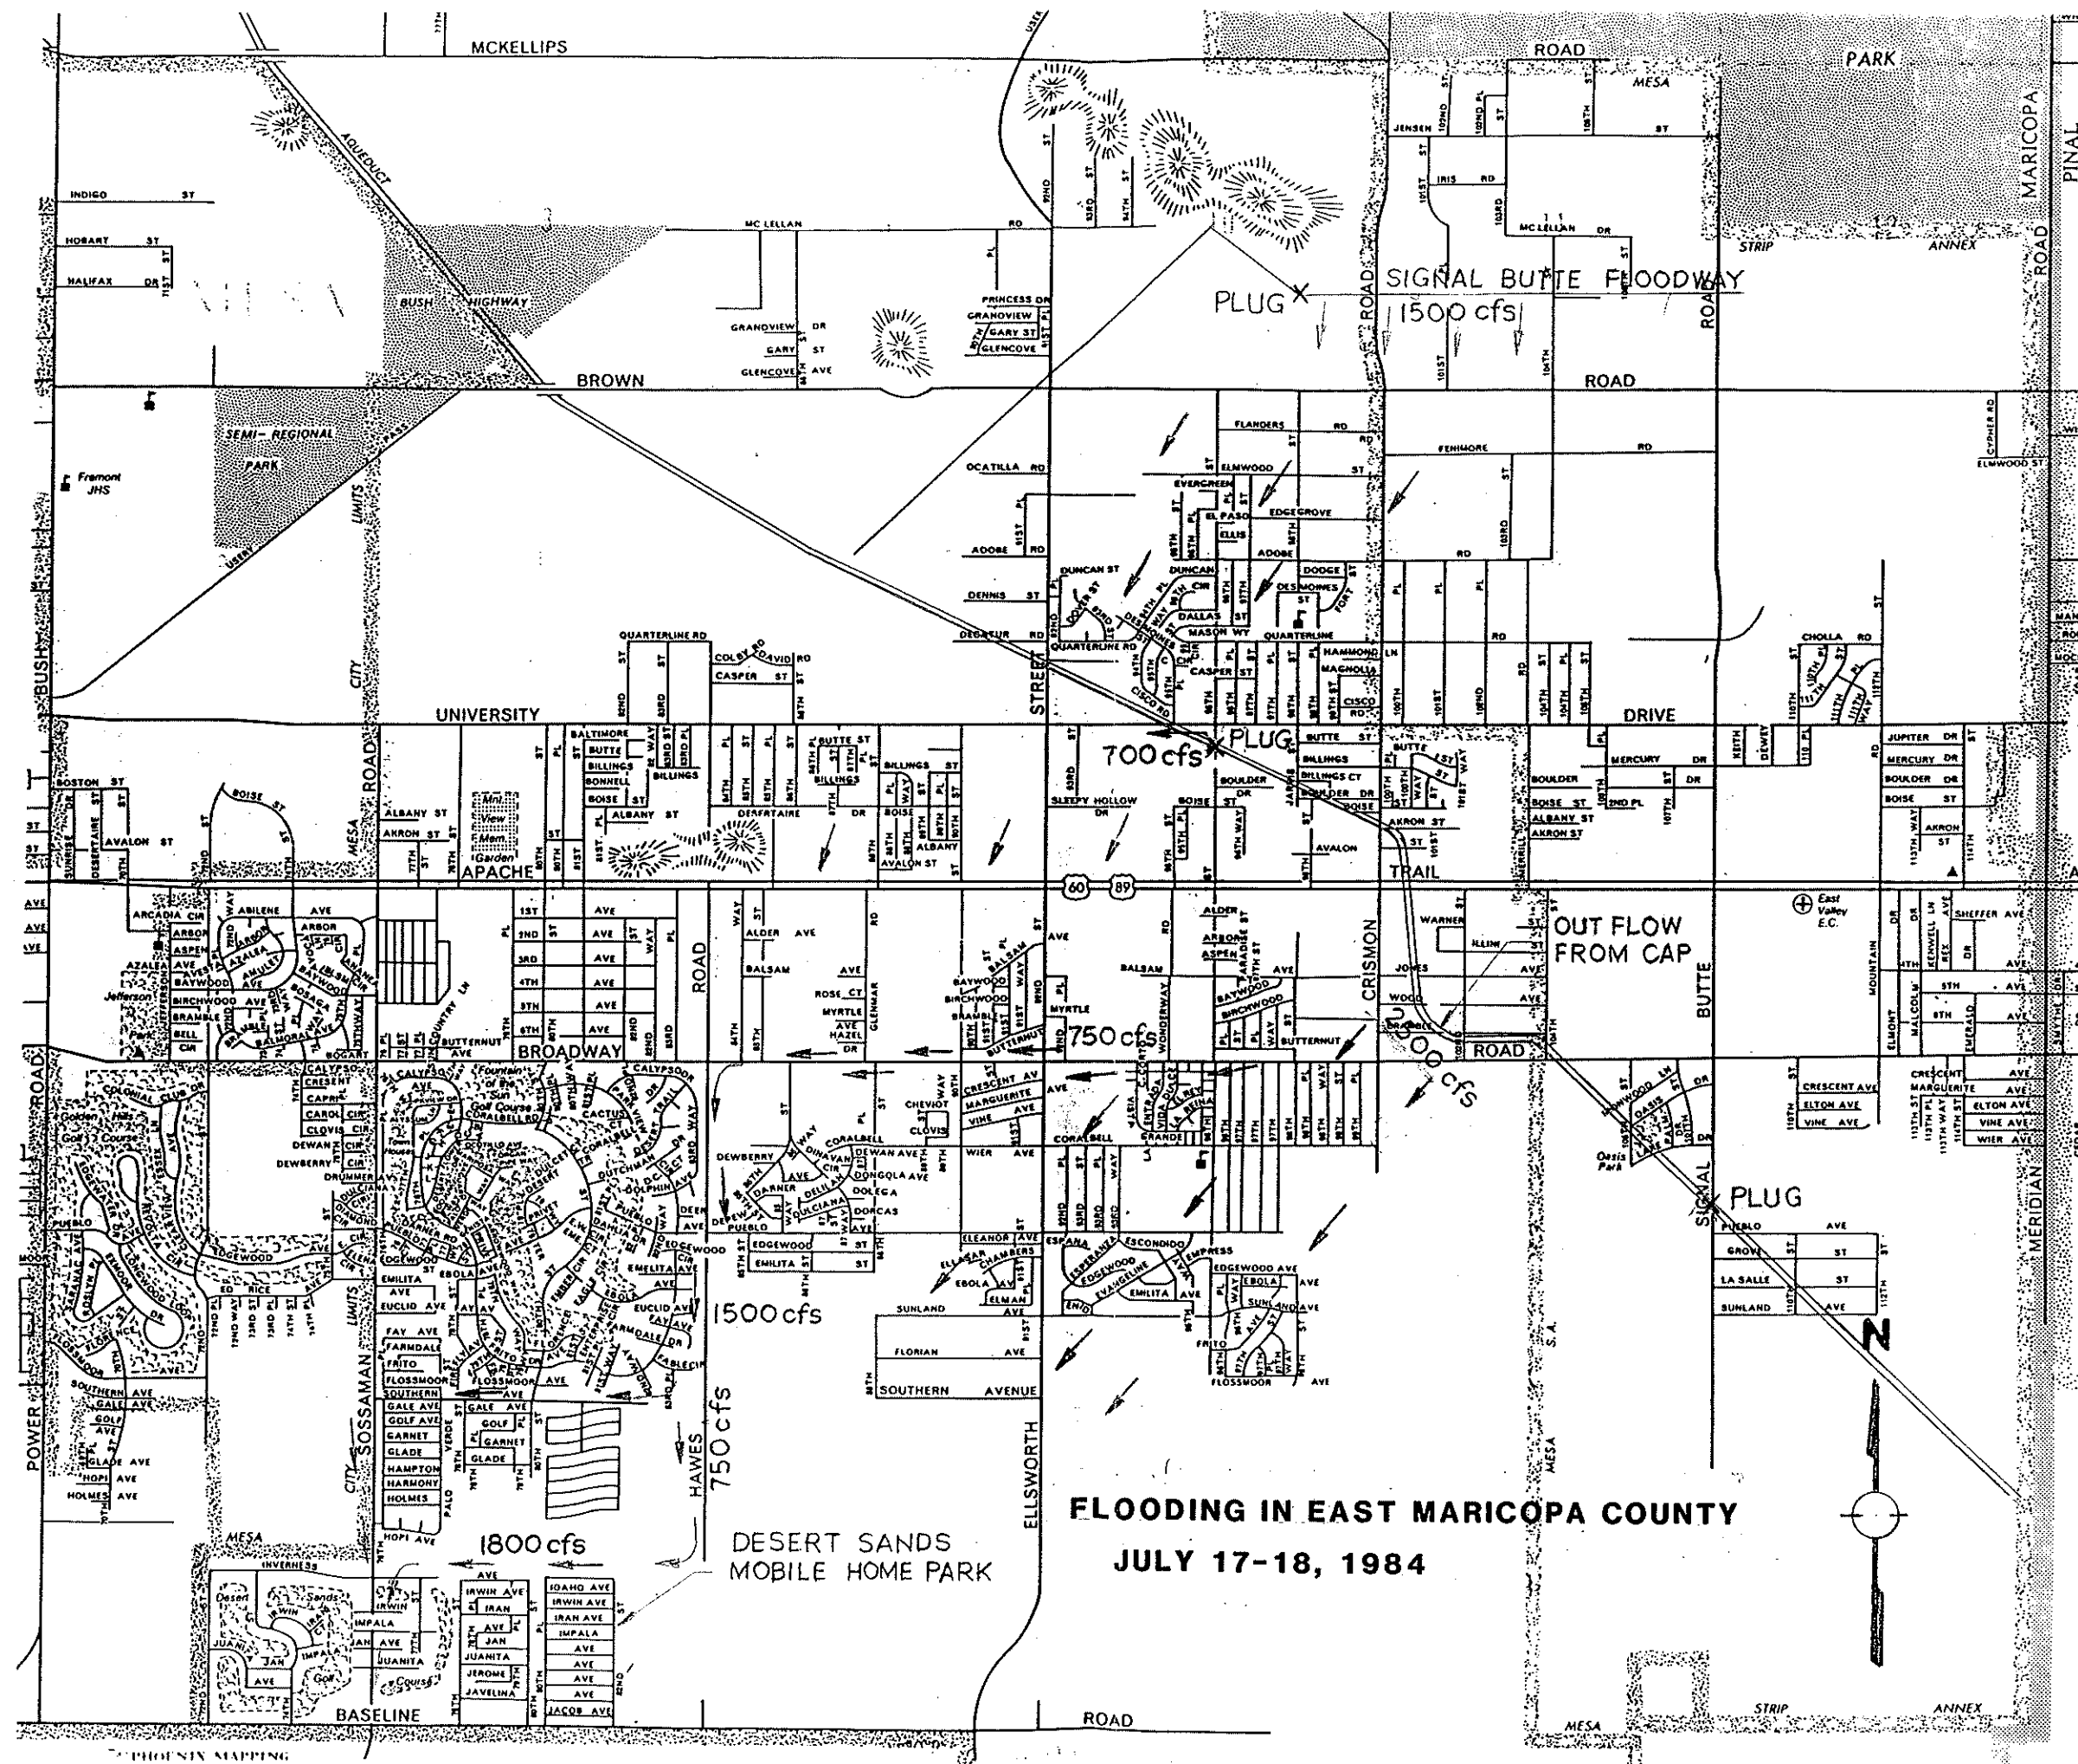
FIGURE 3: OVERVIEW OF RUNOFF RESULTING FROM STORM OF JULY 17-18, 1984

A pictorial summary of the runoff resulting from the storm of July 17-18 is provided in Figure 3.

The lined section of Signal Butte Floodway was separated from the unlined section by an earthen plug at their juncture. The apparent purpose of this plug was to aid in "tie-in" work at the juncture of the lined and unlined sections. As a result, runoff from the drainage above the unlined section first filled and then overtopped that section of the floodway. Approximately 75 acre-feet of runoff were stored in the unlined section of the Signal Butte Floodway.

At some time the inflow to this area greatly exceeded the outflow into the collection channel and severe ponding, as deep as 3-4 feet, occurred in the area of University Drive and 96th Street. Highwater marks on the University Drive bridge indicate that in excess of 700 cfs flowed over the bridge in a westerly direction. This flow then continued as sheetflow and as channel flow in the existing drainage patterns in a southwesterly direction.

Runoff exiting the aqueduct at this point caused erosion of the aqueduct embankment which in turn allowed the previously stored water to exit. Failure of the embankment at this section was gradual.

The peak discharge of these combined flows was approximately 1800 cfs. This exceeded the capacity of that drainage channel and caused some flooding in the Desert Sands Mobile Home Park. This flow was ultimately captured by the Sossaman Road drainage channel.

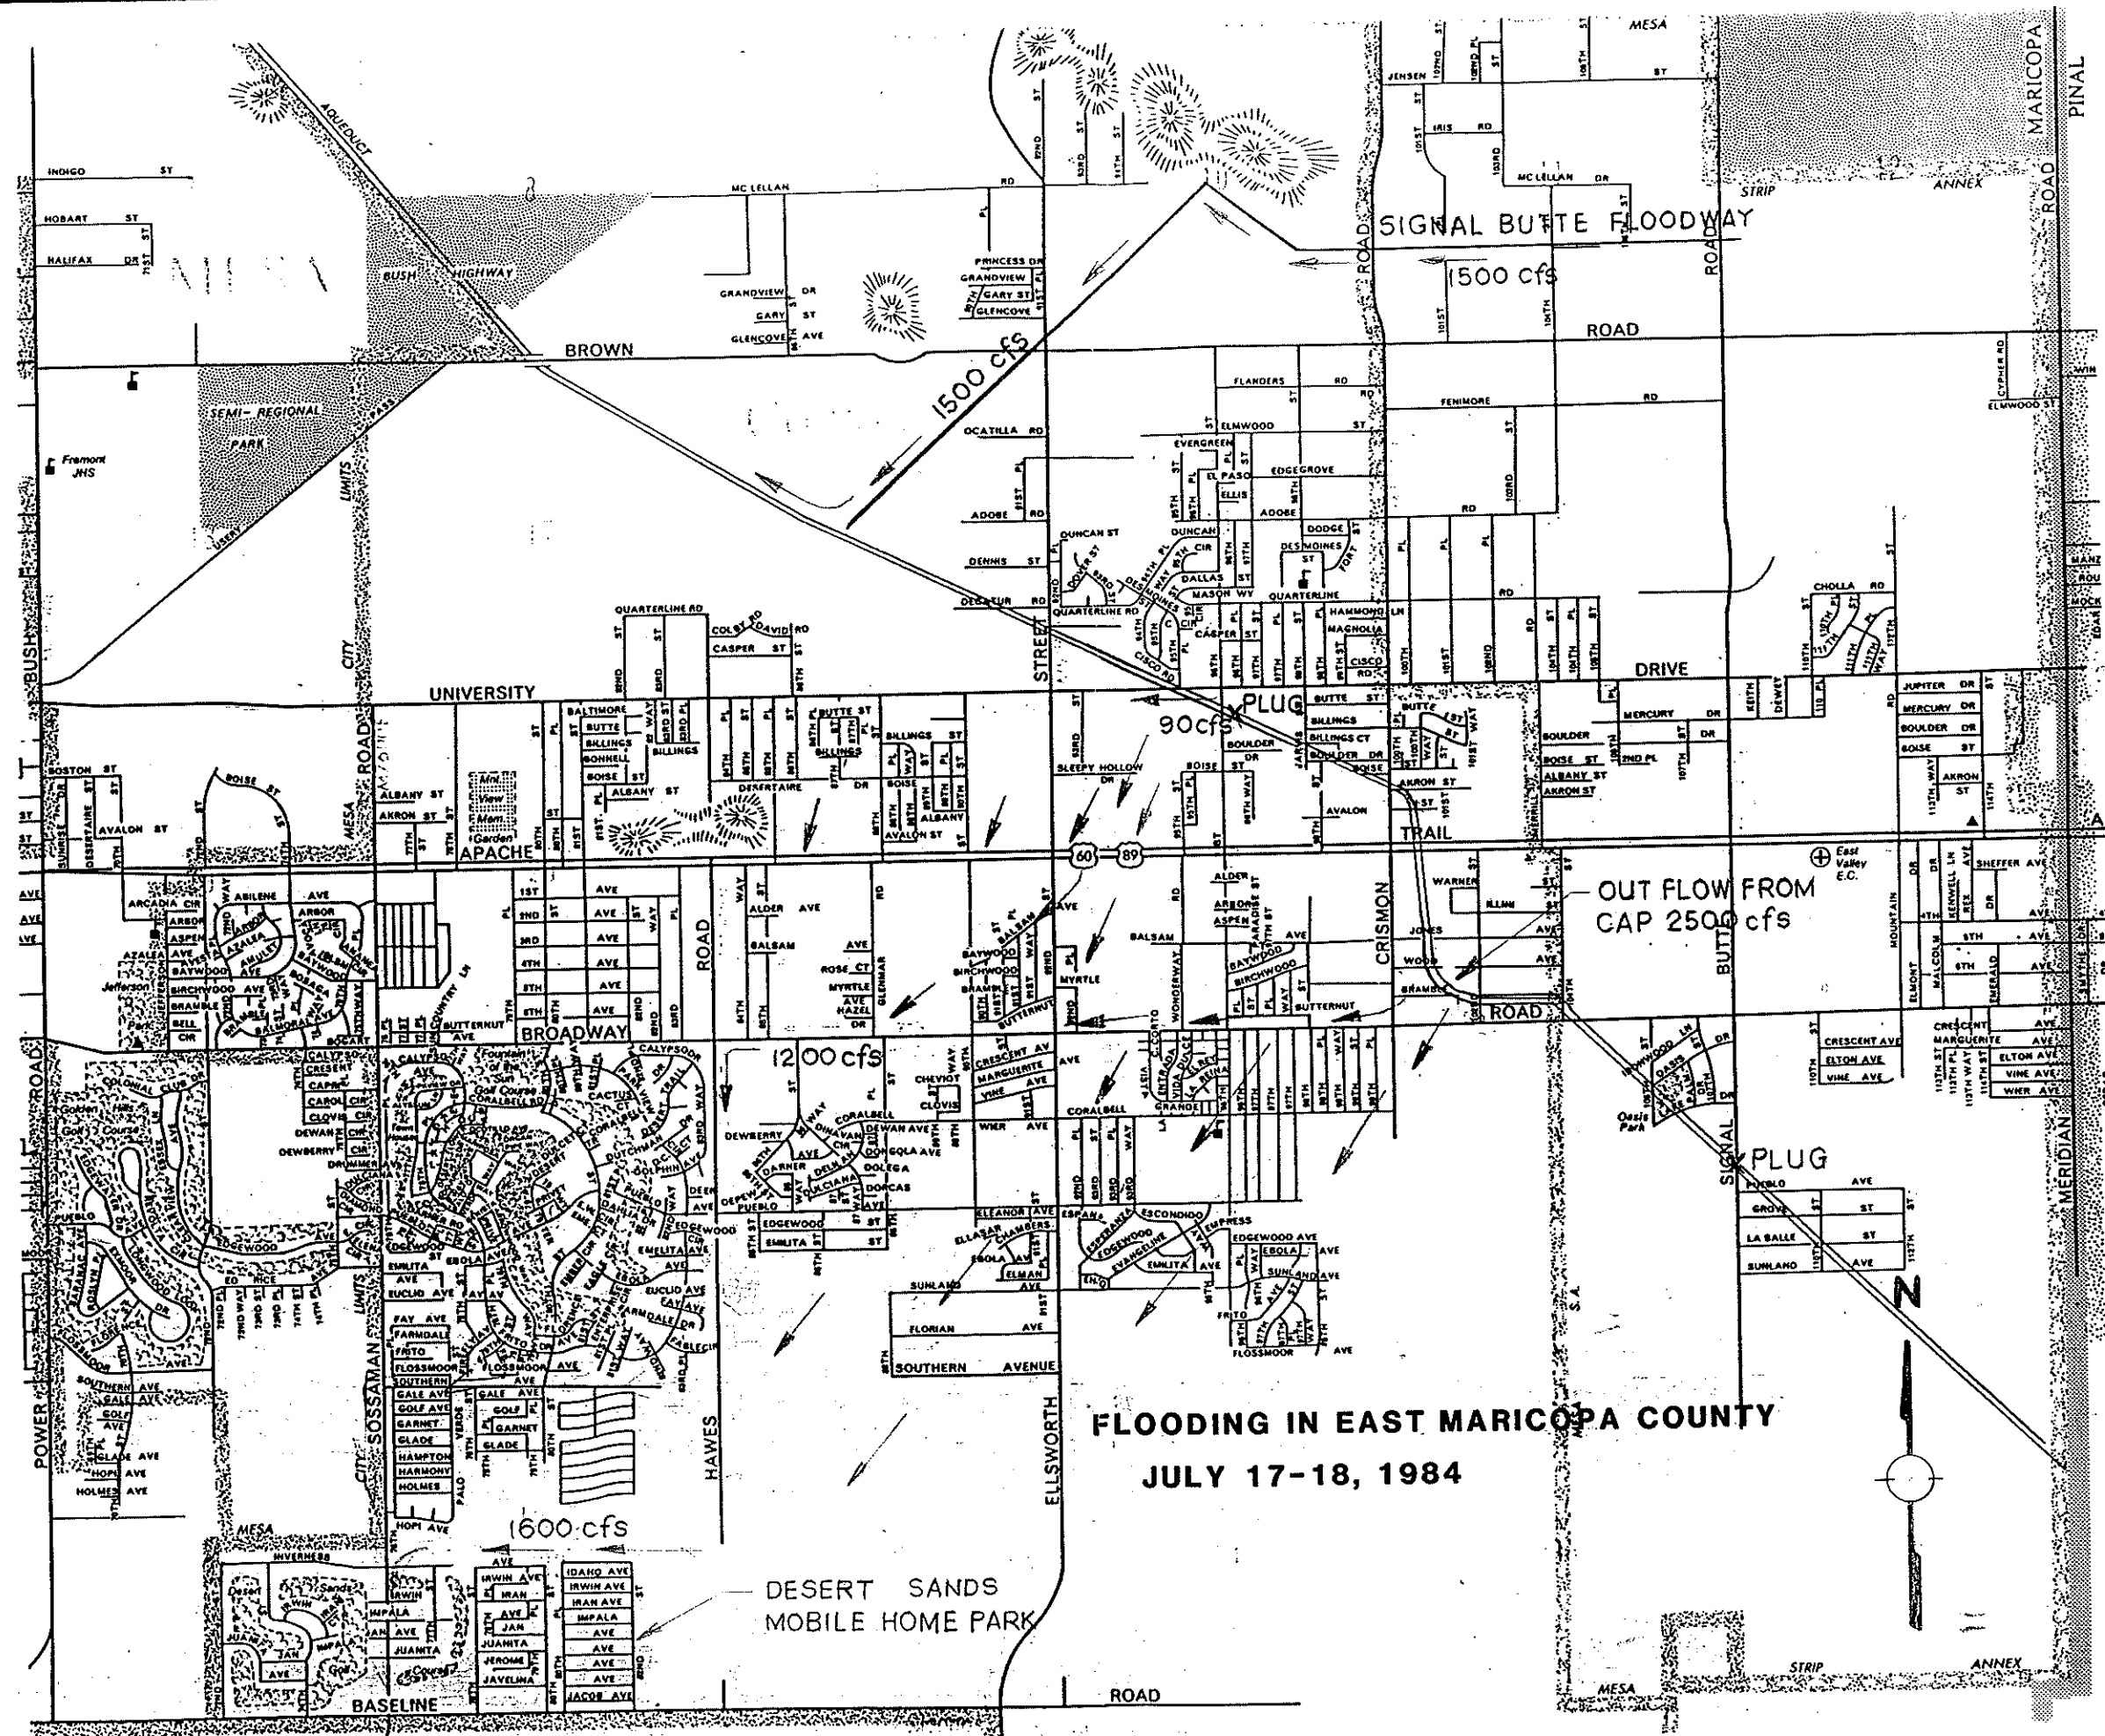
FIGURE 4: OVERVIEW OF RUNOFF RESULTING FROM SITUATION 2 (SIGNAL BUTTE FLOODWAY OPERATIONAL)

A pictorial summary of the runoff described in the following discussion is provided in Figure 4.

On the other hand, had this floodway been fully operational at the time of the storm, the peak flow into this area would have been less than 550 cfs or a reduction in peak flow of nearly 30%. Additionally, the flow over the University Drive bridge would have been reduced from 700 cfs to only 90 cfs, thereby alleviating, if not eliminating, the flooding on the west side of that bridge and further south.
