# FLOOD CONTROL DISTRICT OF MARICOPA COUNTY

## FLOOD REPORT

OCTOBER 14, 1988 STORM

PRELIMINARY FLOOD REPORT FROM THE STORM OF OCTOBER 14, 1988

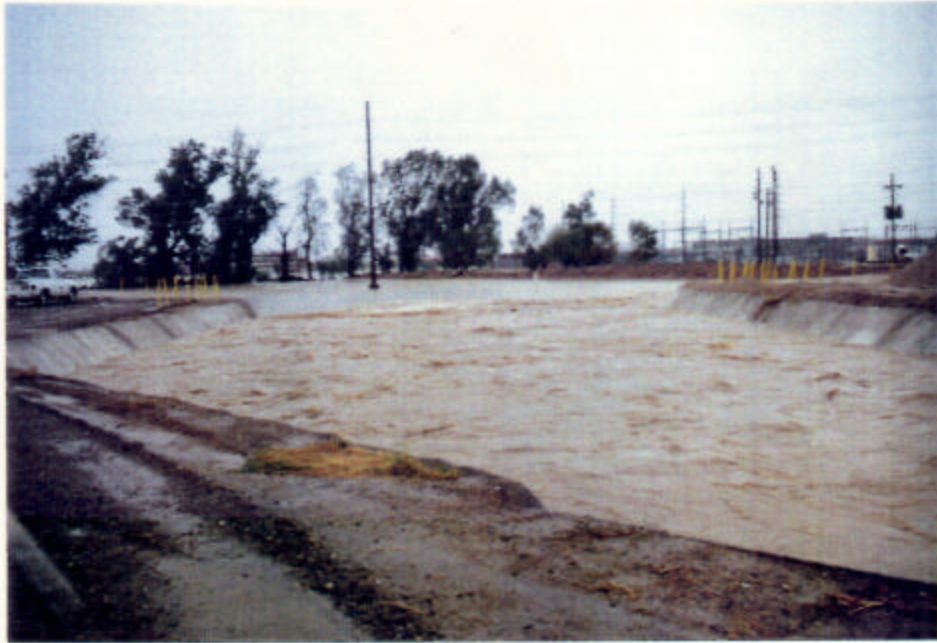
Figure 6: Cave Creek at the confluence of the Arizona Canal looking south.  
( $Q=900$  cfs)

Flows from Cave Creek into the Arizona Canal reached a maximum discharge of 900 cfs according to SRP. Figure 6 shows a view of Cave Creek at its confluence with the Arizona Canal. Of this discharge, SRP measured, using a propeller meter, 690 cfs spilling over Spillway #8 of the Arizona Canal directly south of the Cave Creek confluence during peak flows. Figure 7 shows flows passing over Spillway #8, heading south. The flows from Cave Creek, along with other local inflows into the Arizona Canal, caused the Arizona Canal to start overtopping. Upon consultation with the Maricopa County Flood Control District and receiving permission to breach the Arizona Canal into the ACDC, SRP breached the Arizona Canal between 51st and 59th Avenues allowing water in the canal to flow directly into the ACDC. Maximum flows into the ACDC from this breach was estimated to be 200 cfs by SRP officials. Water levels in the Arizona Canal were lowered about 4 inches about an hour after breaching. Figures 8 and 9 show the breaching of the Arizona Canal. Figures 10 and 11 show the water running down the embankment of the ACDC and the erosion caused by the breach. The maximum flow in the

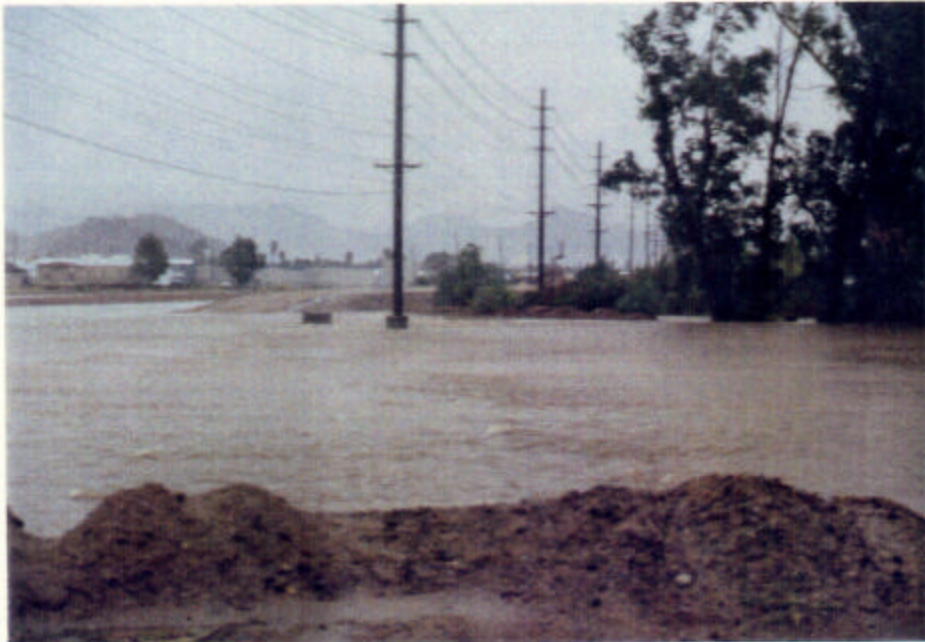
Figure 7: Flood waters from Cave Creek passing over Spillway #8 of the  
Arizona Canal. ( $Q=690$  cfs)

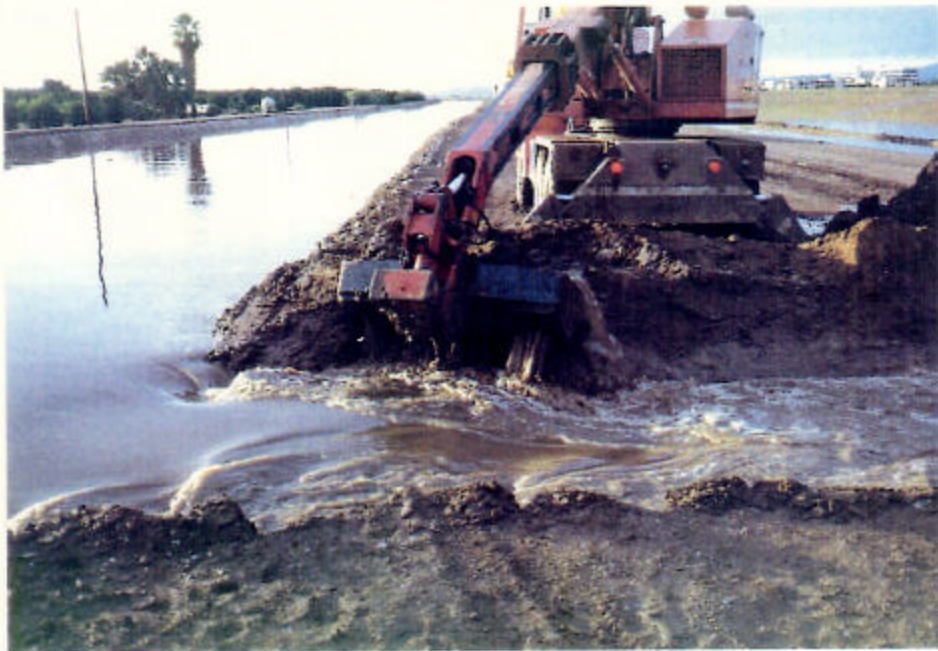
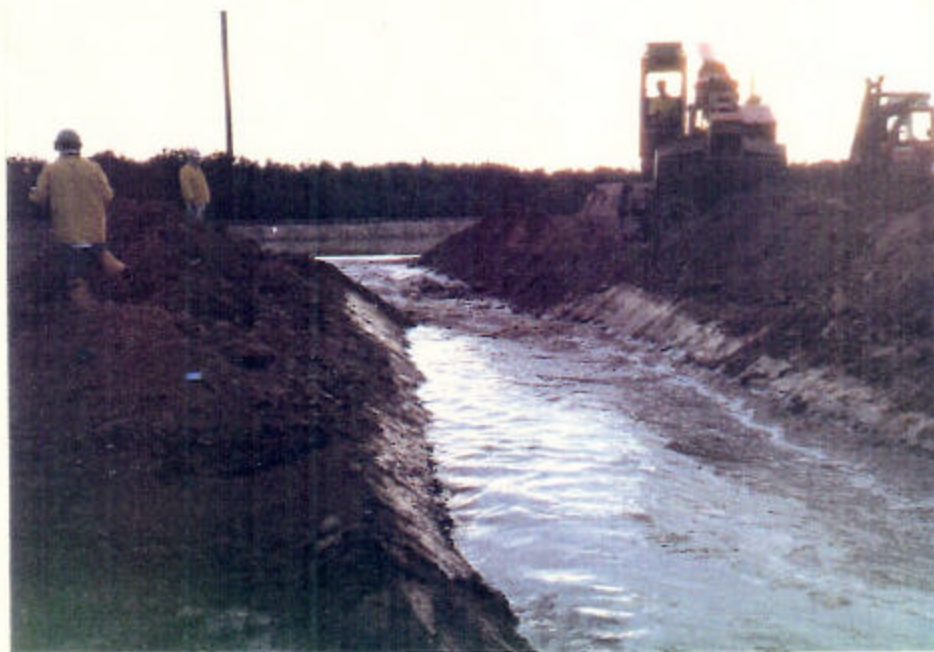
Figure 8 & 9: Breaching of the Arizona Canal between 51st and 59th Avenues.  
Maximum flow was estimated at 200 cfs.

The Arizona Canal overtopped its south bank several hundred yards east of 43rd Avenue giving cause for the mechanical breaching of the canal mentioned previously. Figure 14 shows the main area of overtopping and the flooding caused as a result. The subdivision west of 39th Avenue was flooded, with water halfway up the lawns of the houses, but there was no flood damage to the houses. Grading within the subdivision directed the flood water west toward 43rd Avenue.

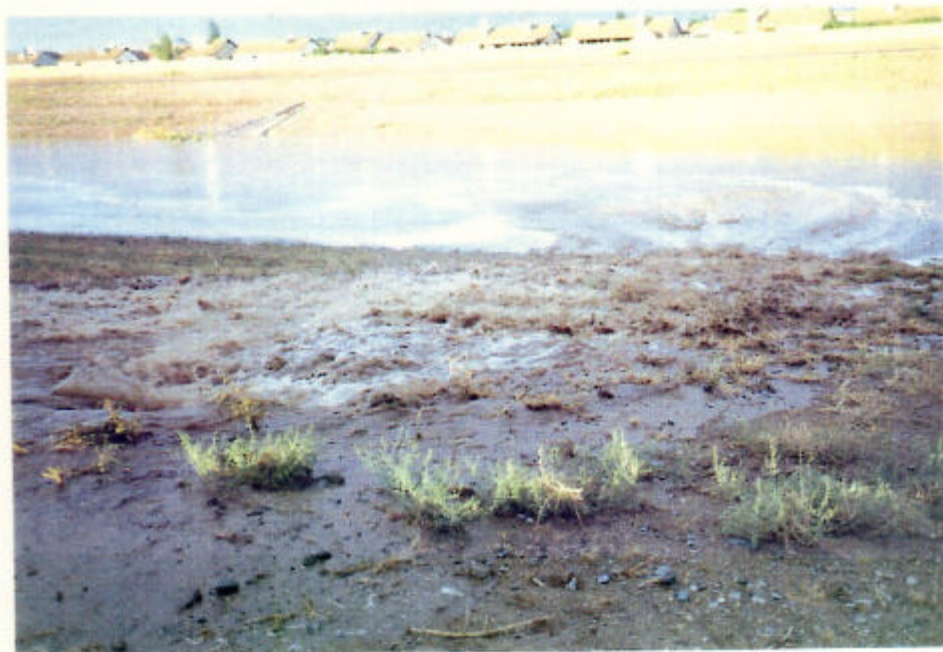
Figure 10: Breach water of Arizona Canal flowing down south embankment of ACDC (Arizona Canal Diversion Channel).

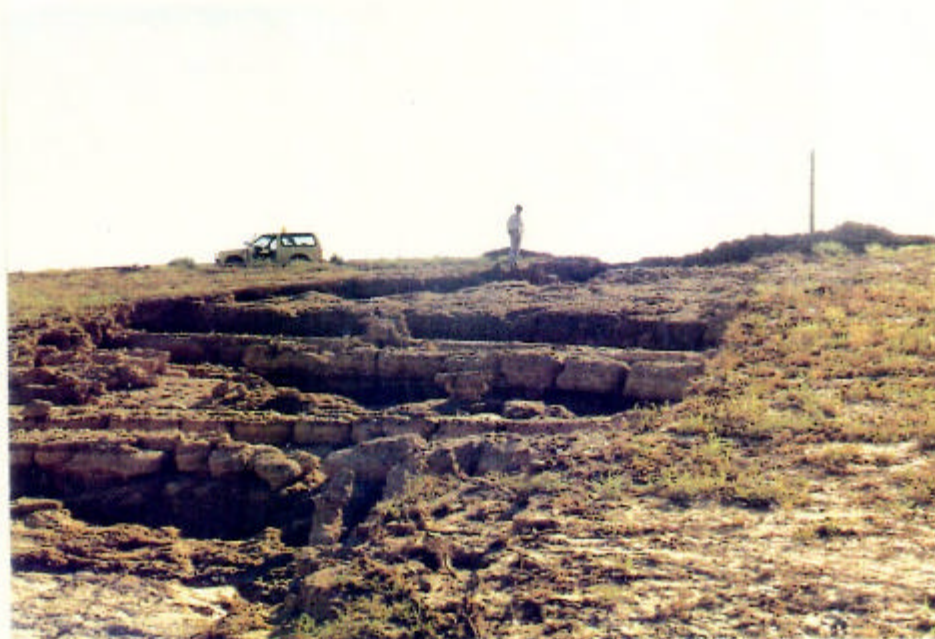
Figure 11: Erosion of ACDC caused by breach waters from Arizona Canal.

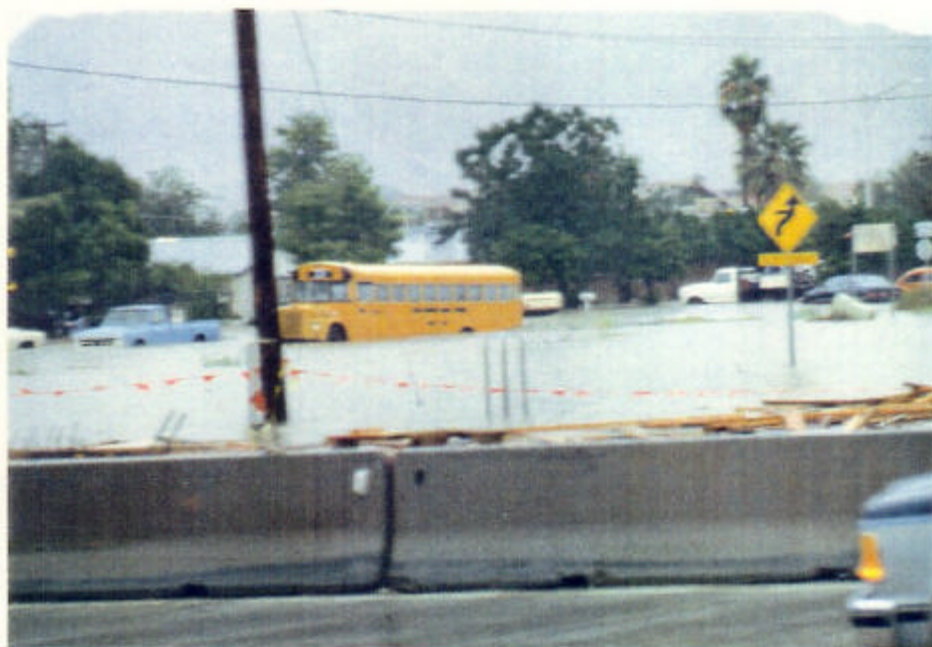
Figure 12: Flooding at 19th Avenue and Hatcher, Phoenix.

Avenue. From here, flows gradually shifted east, heading south between 19th and 21st Avenues. Most of the flow had dissipated by the time it reached Bethany Home Road. It should be noted that some flooding had occurred earlier due to storm sewer surcharges. Flood flows from Cave Creek only augmented these flood waters. Estimated depth of flood waters were 3-4 feet at 23rd Ave. and Alice, 4 feet at 23rd Av. north of Northern Ave. and 4 feet at 19th Ave. and Orangewood. There was particular heavy flooding in the vicinity of 19th Ave. and Hatcher. This flooding was attributed to the ponding of local runoff waters in area, not as a result of the Arizona Canal overtopping. Figures 12 and 13 show the magnitude of flooding at a couple of intersections in north Phoenix.

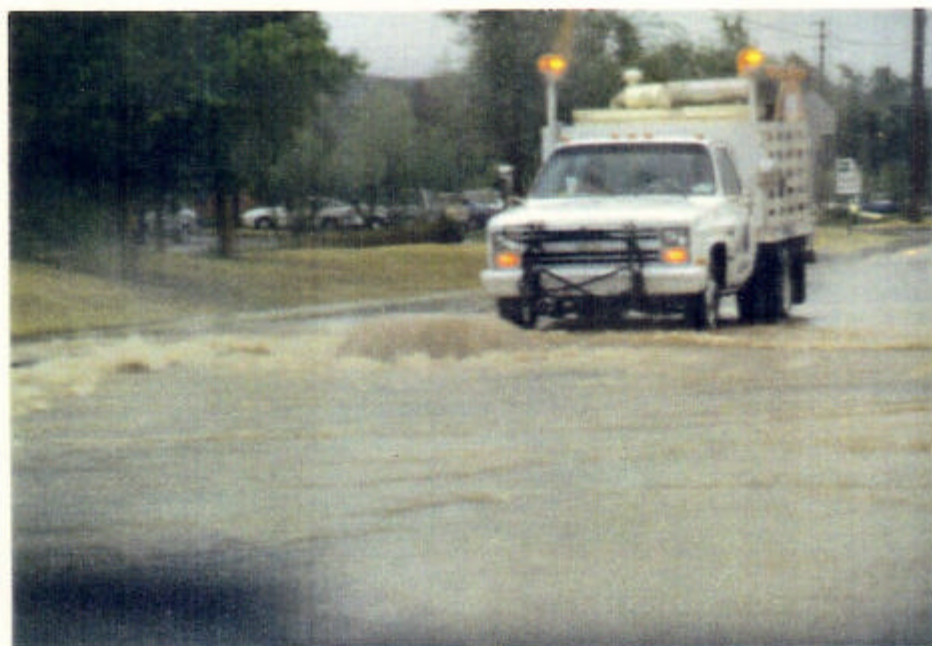
Figure 13: Storm sewer surcharge causing flooding at 23rd Avenue and Alice.

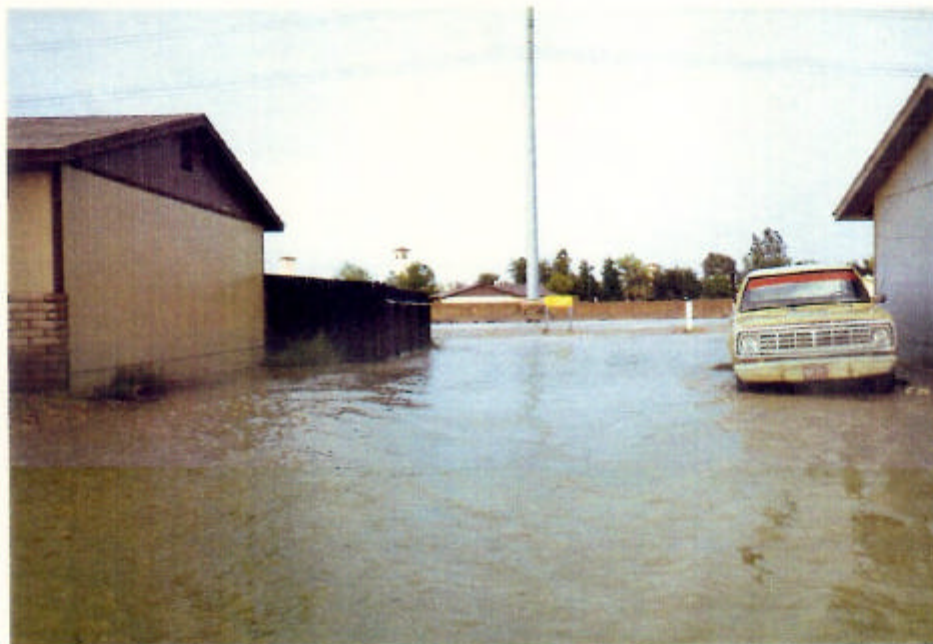
Figure 14: Arizona Canal overtopping it's south banks several hundred yards east of 43rd Avenue
