Flood Control District of Maricopa County

Engineering Division, Flood Warning Branch

Storm Report : July 22-25, 2021

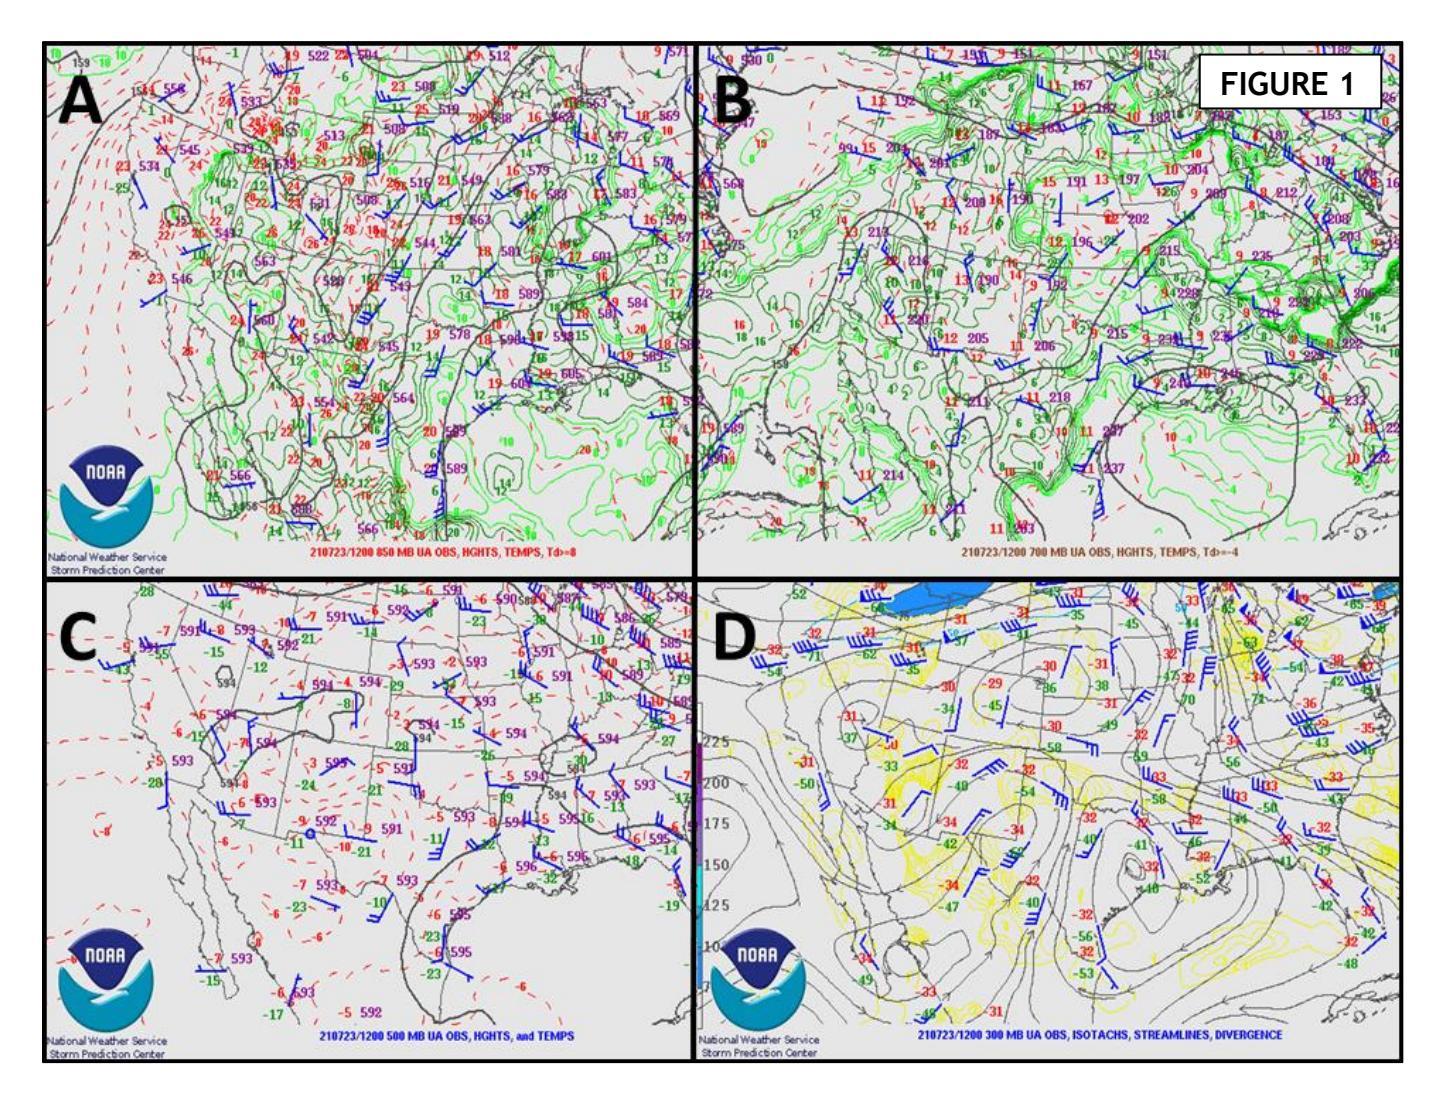
4-Panel 12Z (5:00am MST) Synoptic Setup 07/23/2021

Figure 1: depicts the synoptic setup at 12Z (5:00 AM MST) on July 23rd, 2021. The images are from the Storm Prediction Center upper air maps archive. **A)** is the 850mb map: the black lines are heights, the red dashed lines are isotherms, the green lines are isodrosotherms, blue barbs are wind speed, and station observations are plotted at each available location. **B)** is the 700mb map: variables colored the same as A. **C)** is the 500mb map: variables colored the same as in A. **D)** is the 300mb map: the black lines are stream lines, the yellow lines are divergence, and station observations are plotted at each available location.

The IT took shape across central Texas during July 20th and 21st before strengthening as it moved into West TX. The synoptic setup on the morning of July 23rd is shown in Figure 1 (below). The upper-level images (C and D) depict the aforementioned ridge draped across the Four Corners region of the western US and the IT along the TX/NM border. Images A and B depict the moisture rich environment in place across AZ. It's worth noting that the positioning of the ridge and trough during this period created a large area of upper-level divergence (rising motion), which proved to be a strong catalyst for t-storm activity across southcentral AZ (more on this in the next section). Ultimately, the IT slowly traversed west across NM on the 24th and then across Arizona on the 25th. In fact, the circulation center passed through Maricopa County during the late morning hours on Sunday July 25th. This system helped spawn multiple waves of organized thunderstorms that lead to periods of severe weather, heavy rainfall, and flash flooding across six states encompassing the Desert Southwest. A GOES-16 Water Vapor loop showing much of the IT's path can be viewed <u>here</u>.

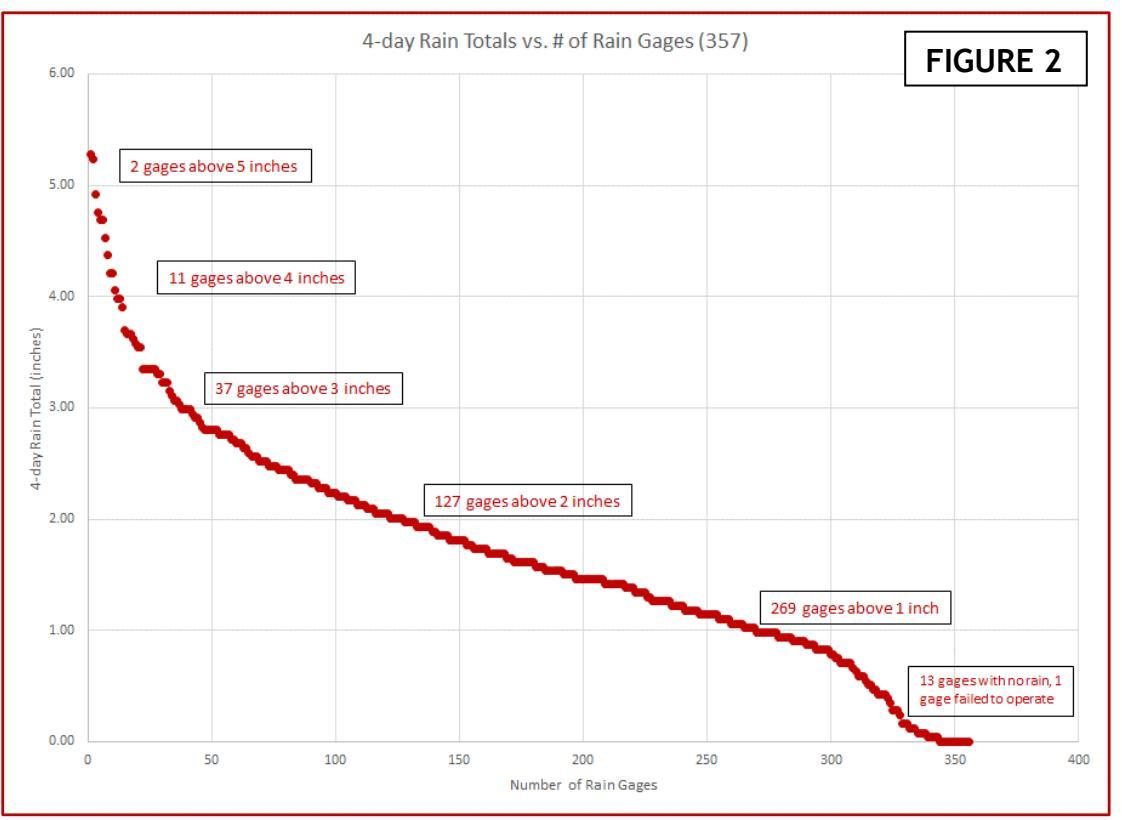
Figure 2 above presents a plot of rainfall amounts for all FCDMC ALERT rain gages for the period 7/22/2021 0:00 through 7/25/2021 24:00. Thirteen gages, mostly in the west and southwest County, recorded no rain, and one gage failed to operate. Tabular hourly data for all gages for the 4-day period is available <u>here</u>.

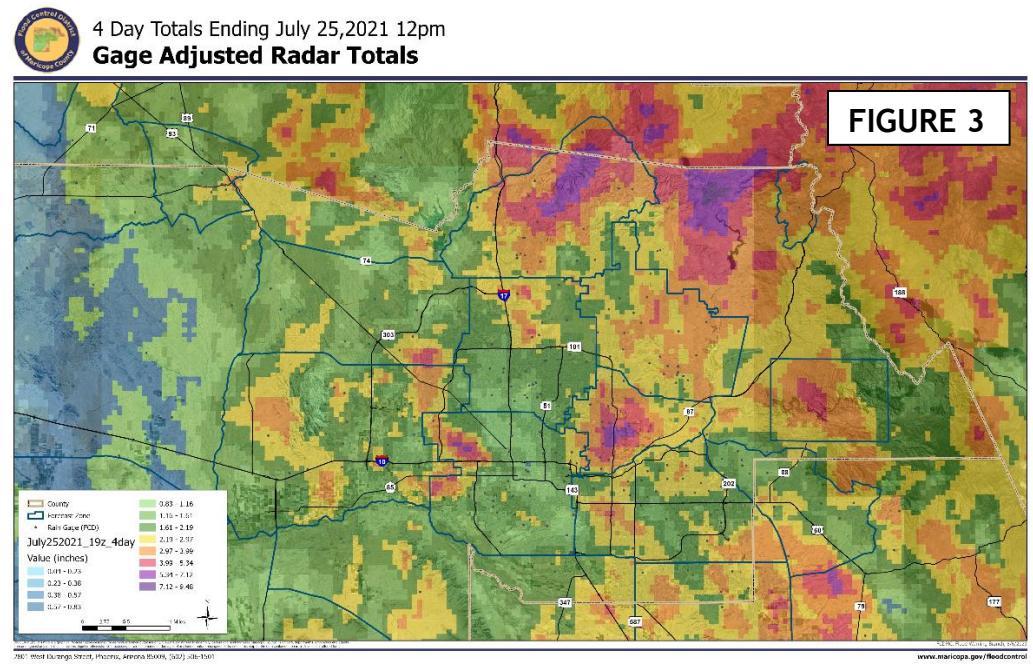
Figure 3 above presents an image of rainfall amounts for all FCDMC ALERT rain gages for the period 7/21/2021 12:00 through 7/25/2021 12:00. Click the image for a full-size view in your browser. Use CTRL +/- to zoom in/out.

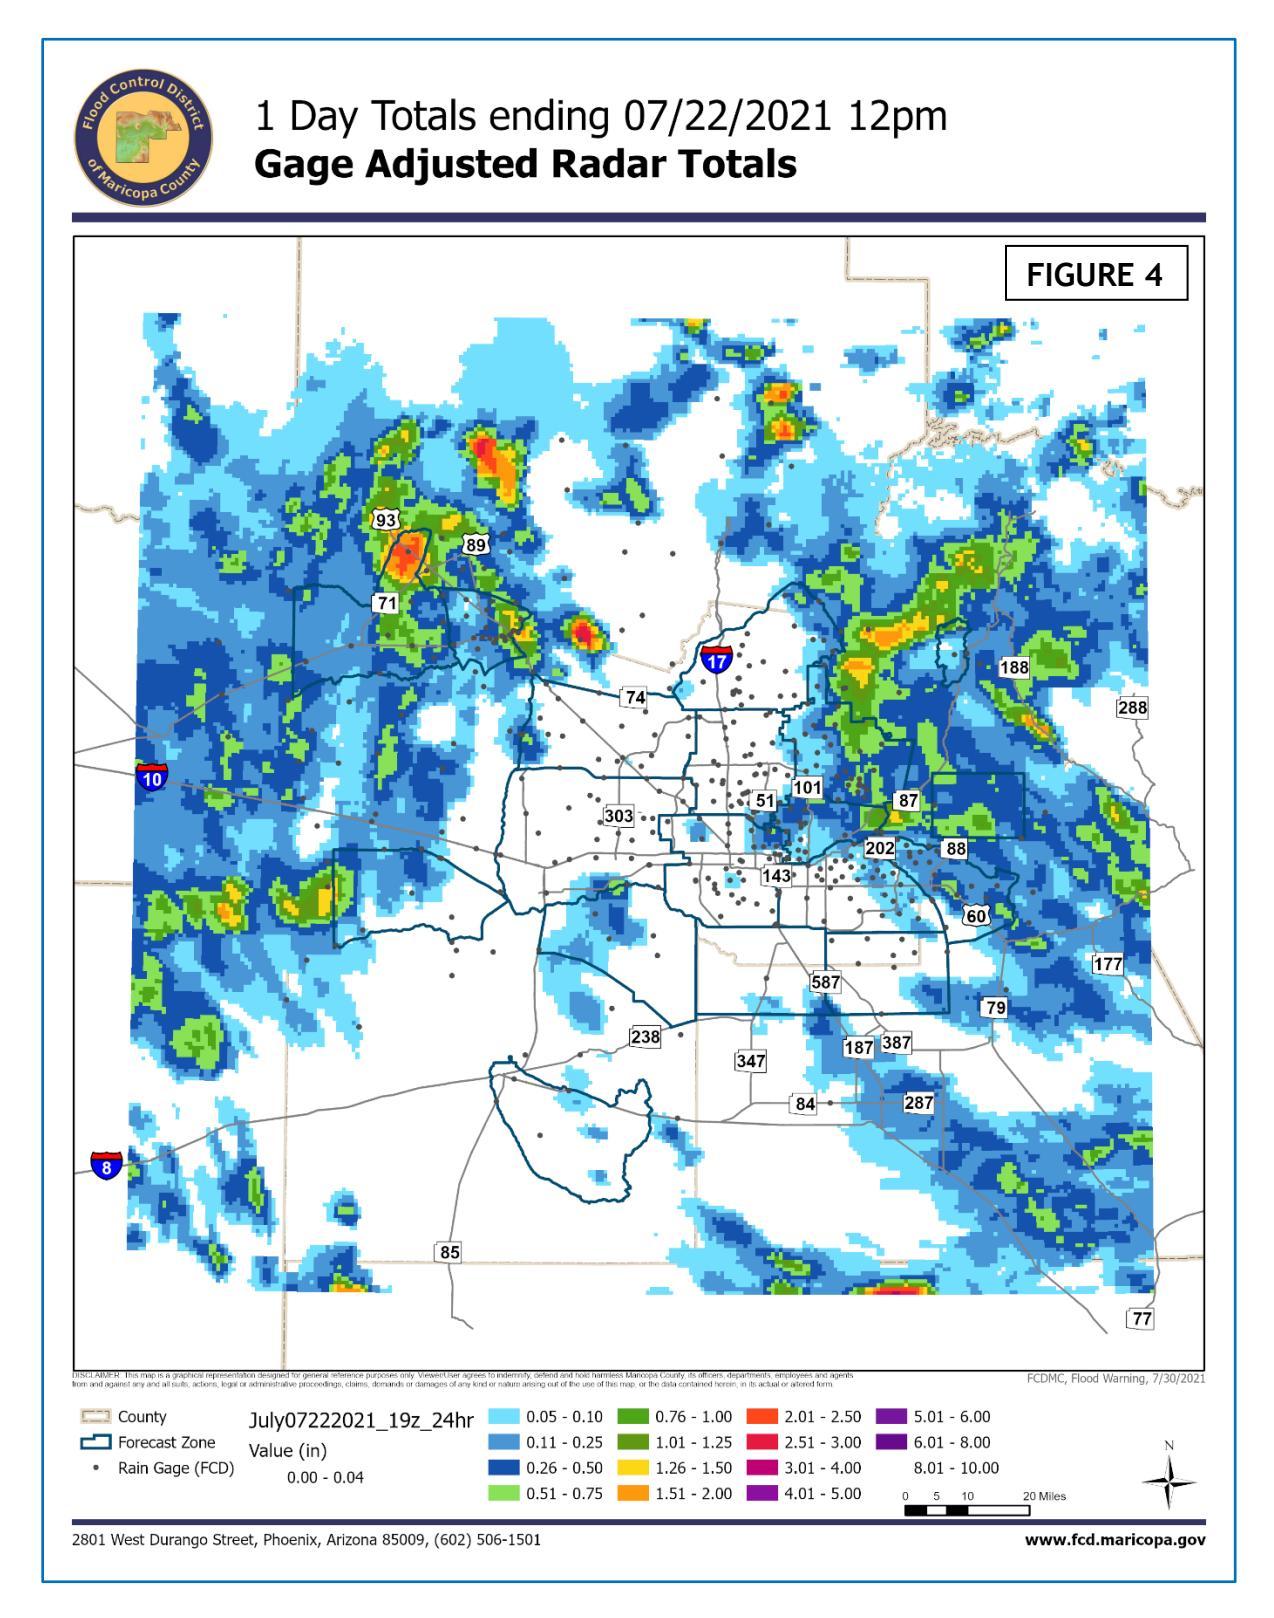
Pre-Storm: Rainfall from 7/21/2021 at Noon through 7/22/2021 at Noon

Figure 4 above presents an image of rainfall amounts from gage-adjusted radar rainfall estimates for the period 7/21/2021 12:00 through 7/22/2021 12:00. To see a map of the recorded gage amounts for this period click <u>here</u>.

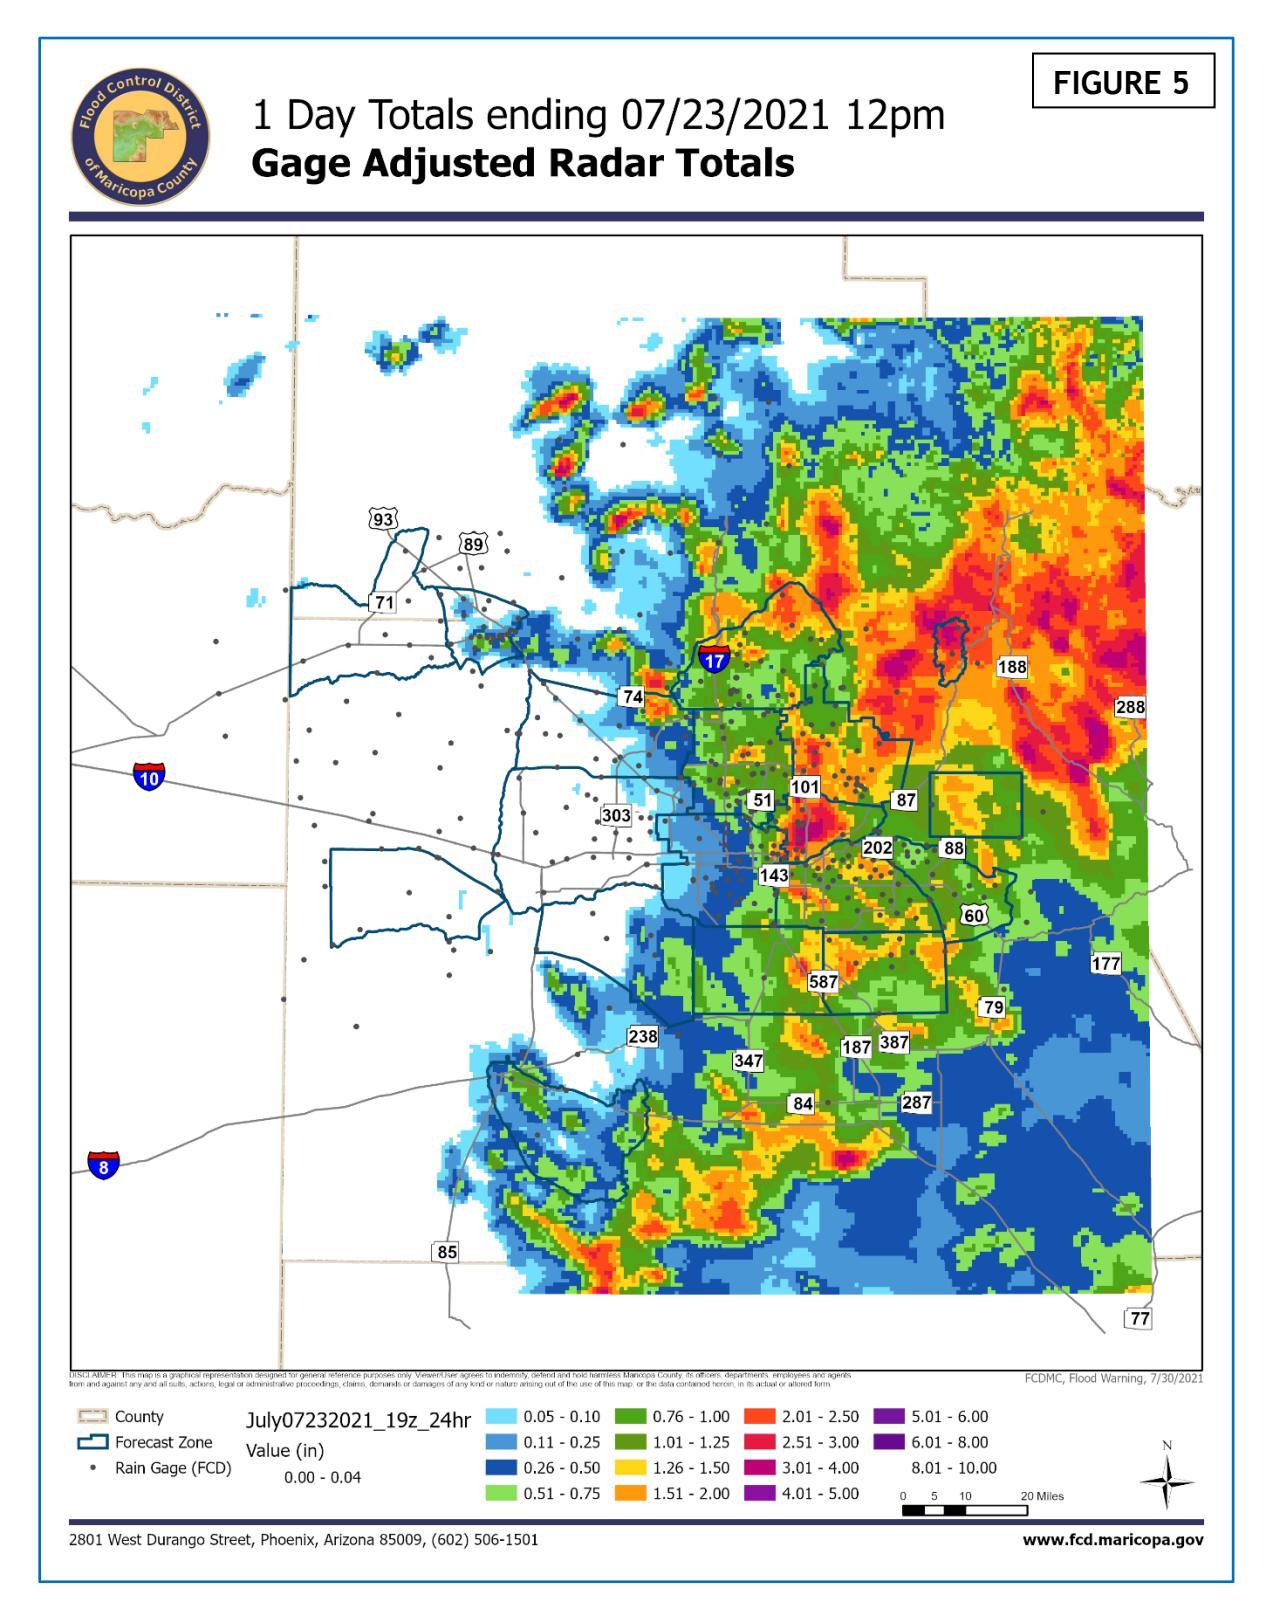
Rainfall from 7/22/2021 at Noon through 7/23/2021 at Noon

Figure 5 above presents an image of rainfall amounts from gage-adjusted radar rainfall estimates for the period 7/22/2021 12:00 through 7/23/2021 12:00. To see a map of the recorded gage amounts for this period click <u>here</u>.

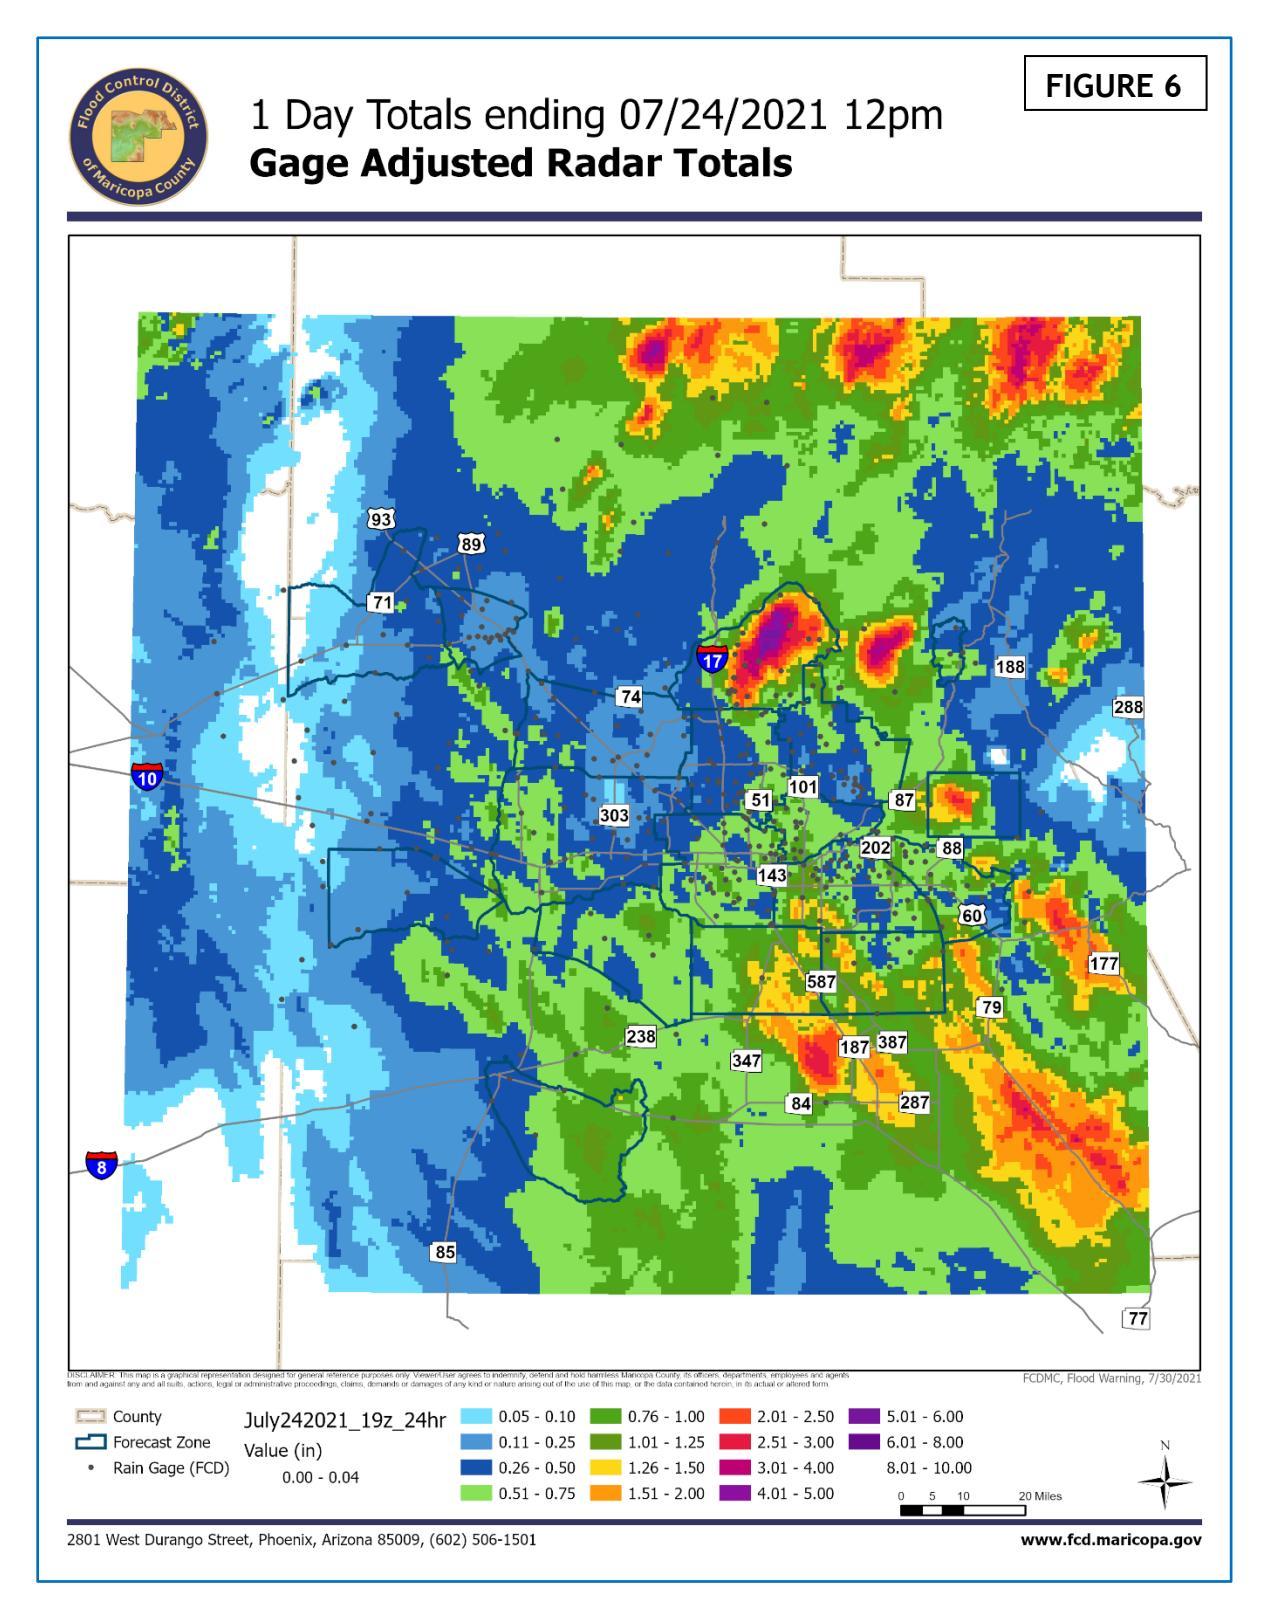
Rainfall from 7/23/2021 at Noon through 7/24/2021 at Noon

Figure 6 above presents an image of rainfall amounts from gage-adjusted radar rainfall estimates for the period 7/23/2021 12:00 through 7/24/2021 12:00. To see a map of the recorded gage amounts for this period click <u>here</u>.

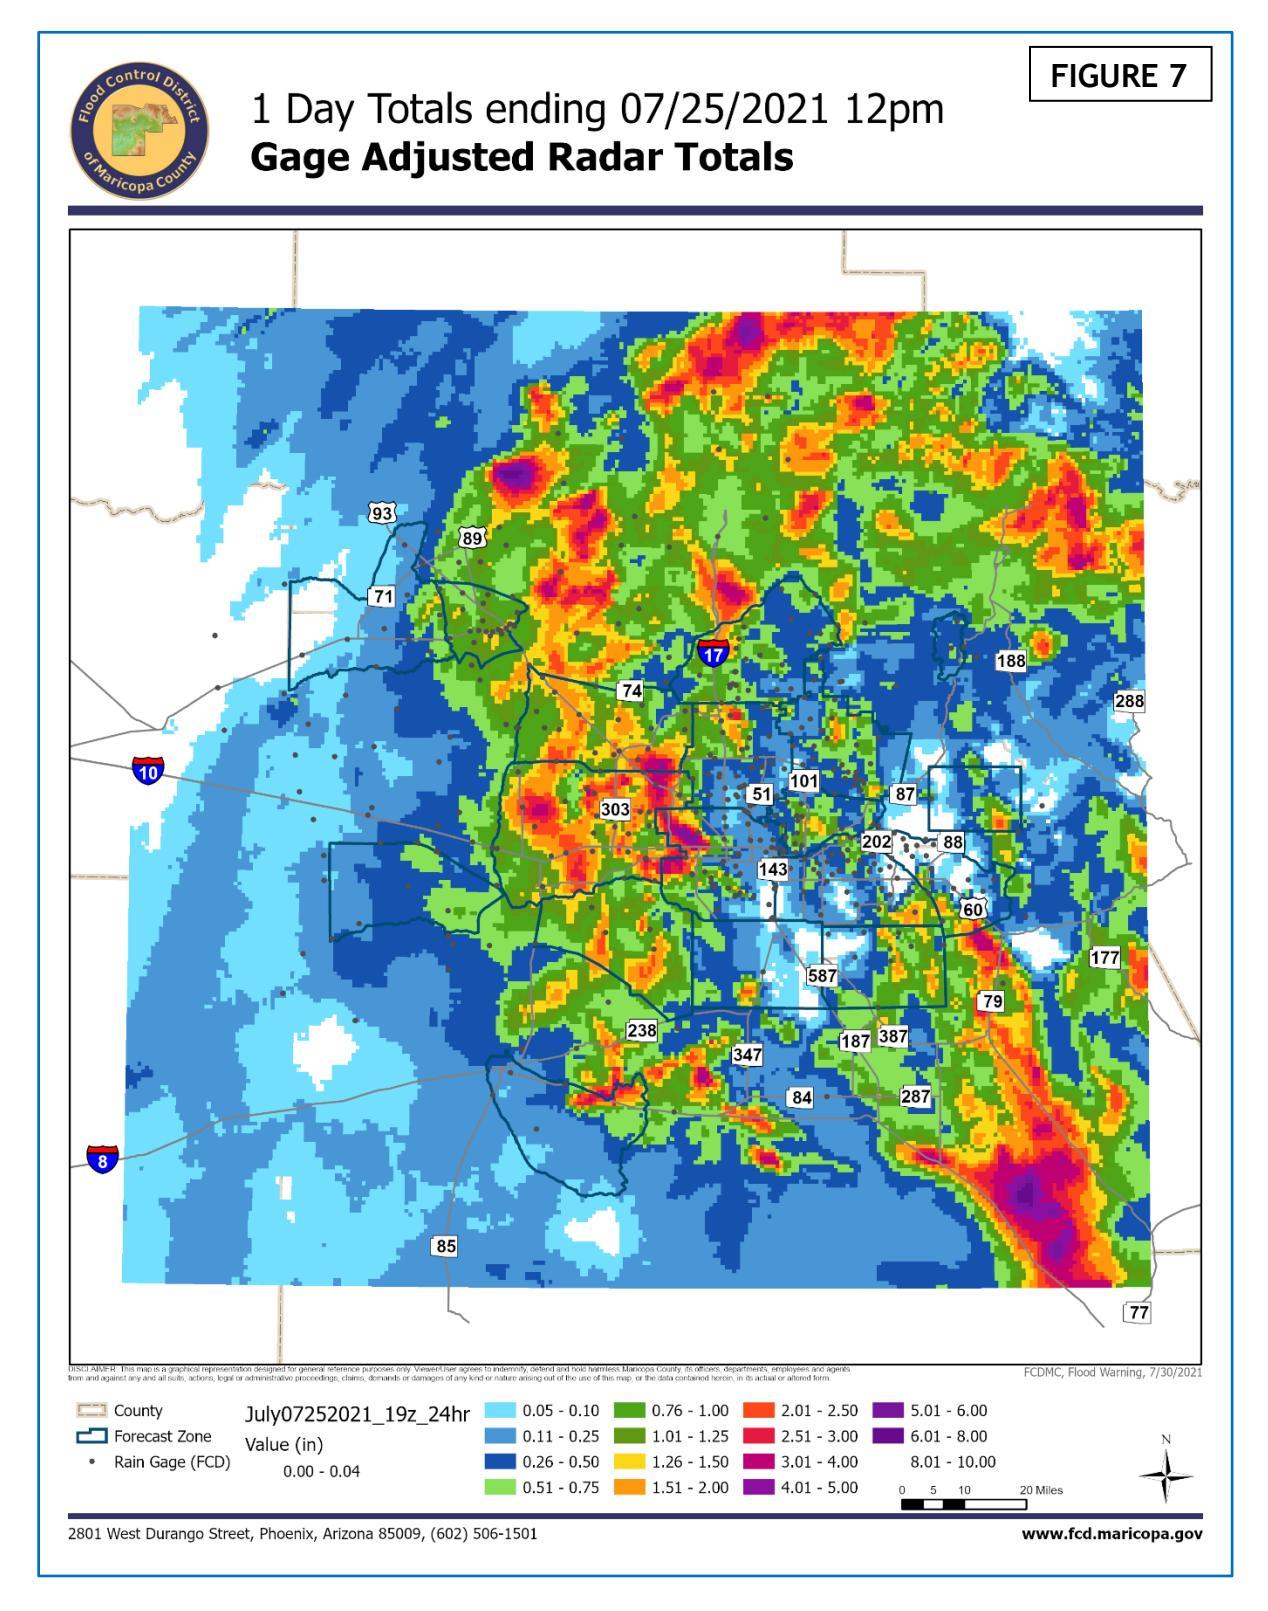
Rainfall from 7/24/2021 at Noon through 7/25/2021 at Noon

Figure 7 above presents an image of rainfall amounts from gage-adjusted radar rainfall estimates for the period 7/24/2021 12:00 through 7/25/2021 12:00. To see a map of the recorded gage amounts for this period click <u>here</u>.

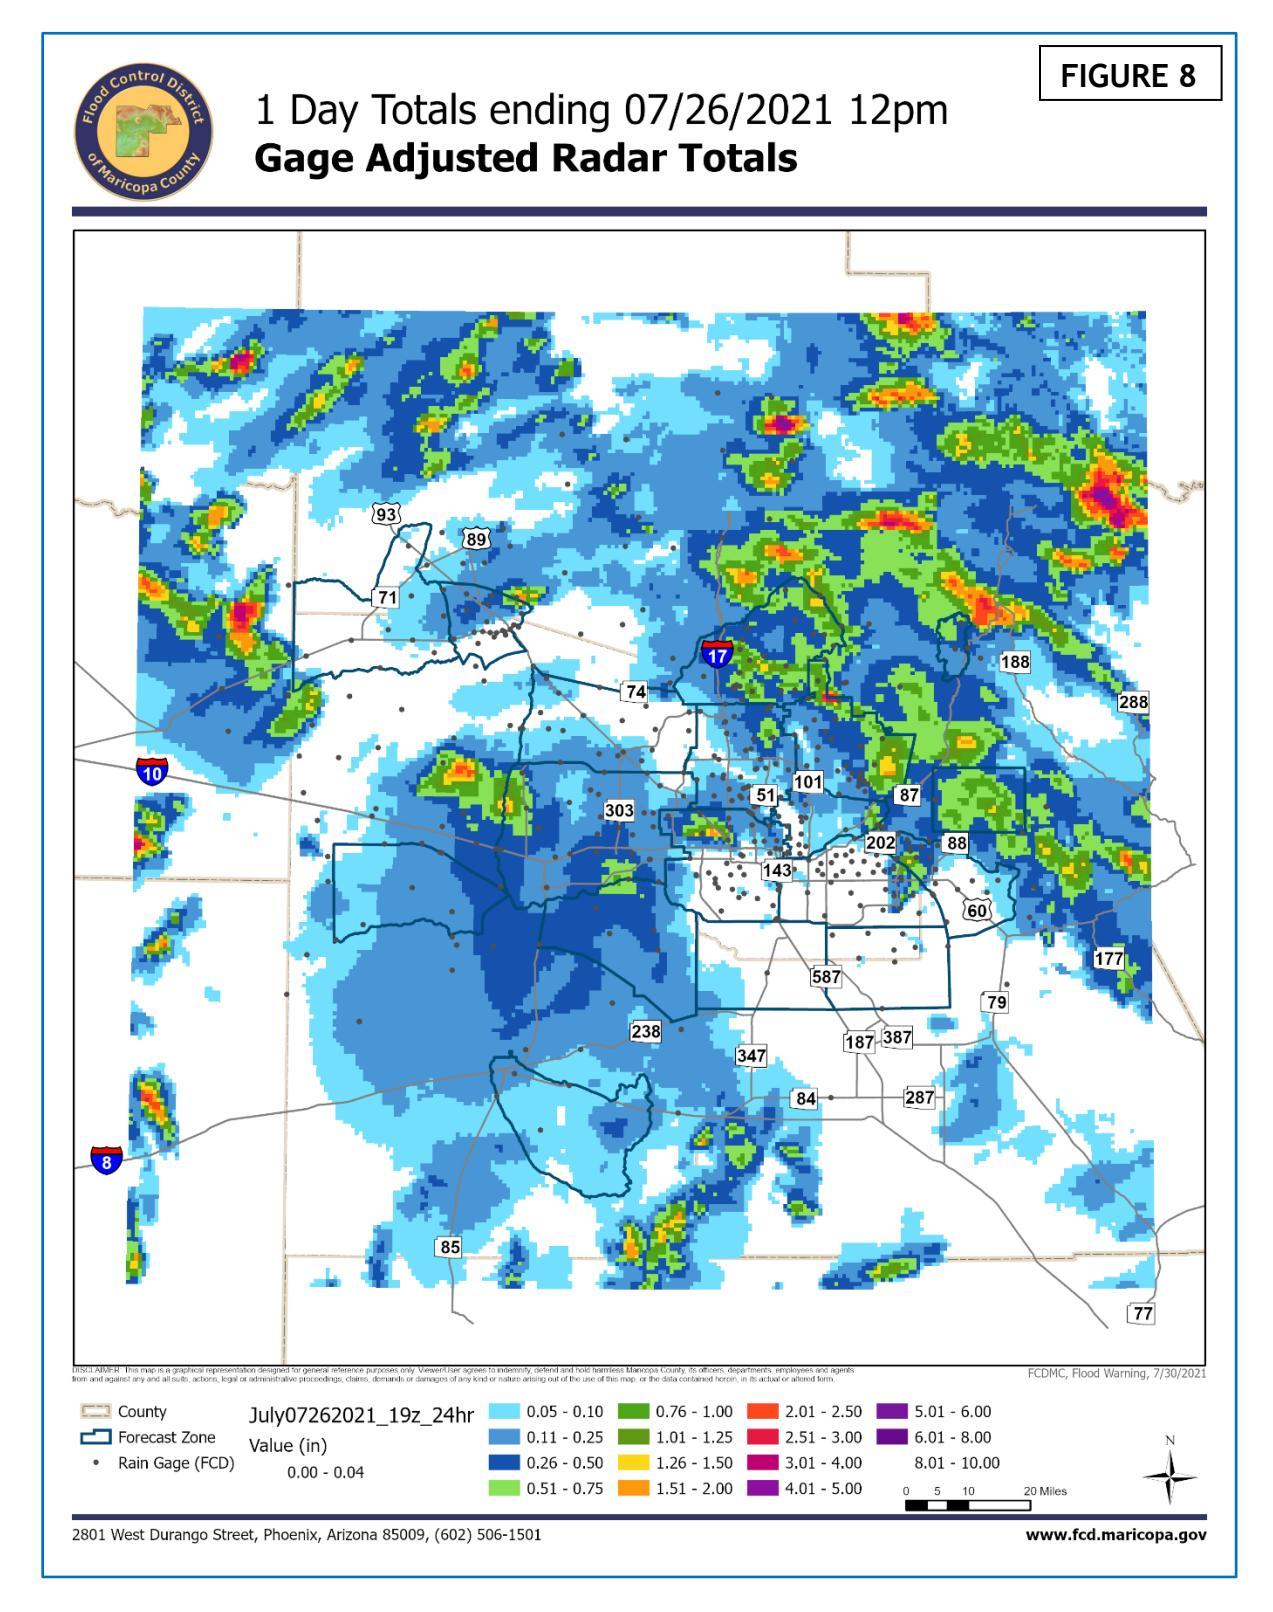
Post Storm: Rainfall from 7/25/2021 at Noon through 7/26/2021 at Noon

Figure 8 above presents an image of rainfall amounts from gage-adjusted radar rainfall estimates for the period 7/25/2021 12:00 through 7/26/2021 12:00. To see a map of the recorded gage amounts for this period click <u>here</u>.

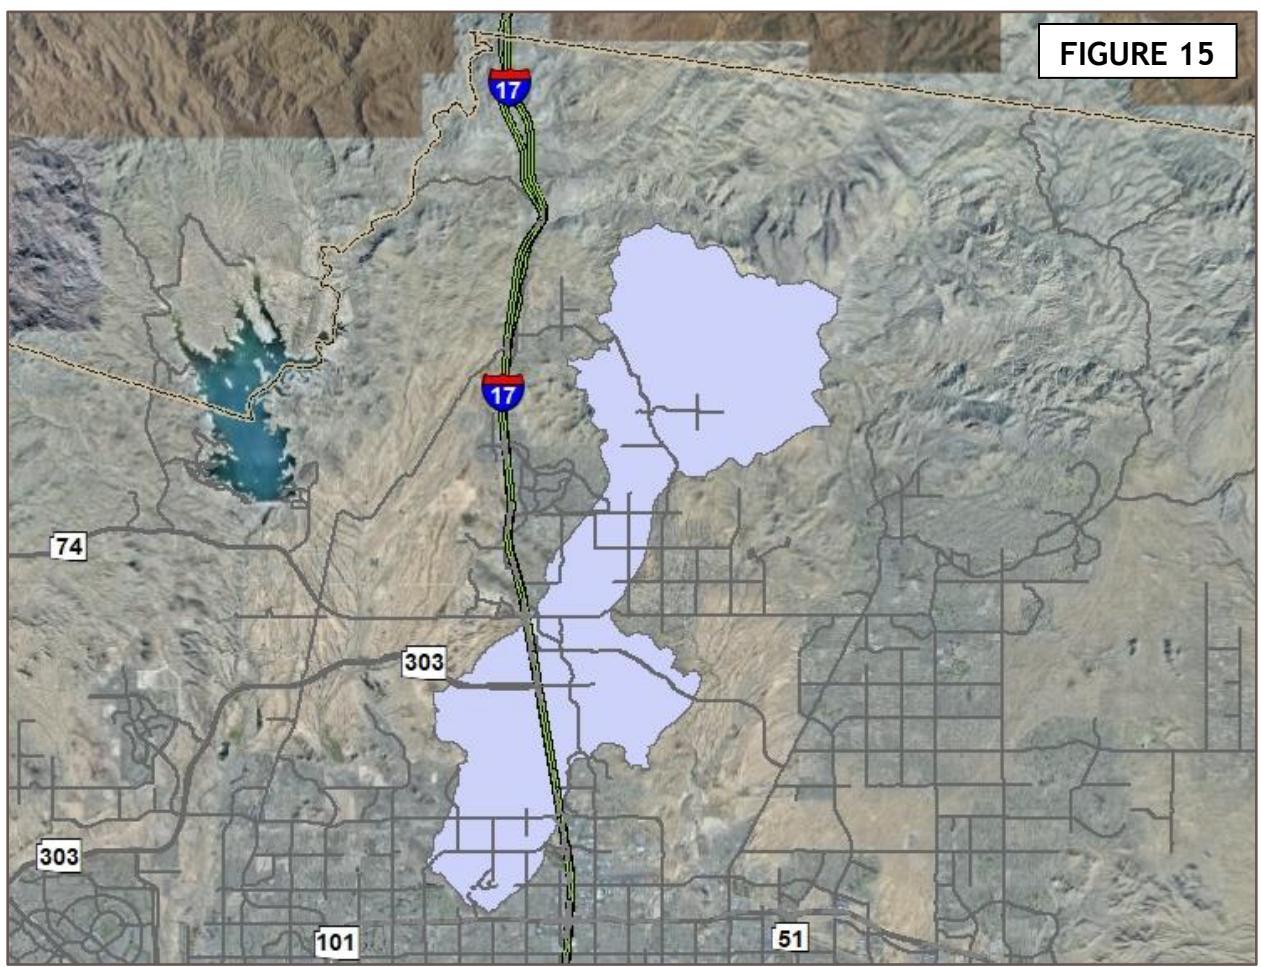
Figure 15 - Skunk Creek watershed above Adobe Dam

The Skunk Creek watershed is located in north-central Maricopa County and crosses I-17 near the Loop 303. It is surrounded by the New River watershed on the north and west and Cave Creek on the east. Rainfall amounts over 5 inches fell on the upper watershed that caused significant runoff and amd a minor impoundment at Adobe Dam.

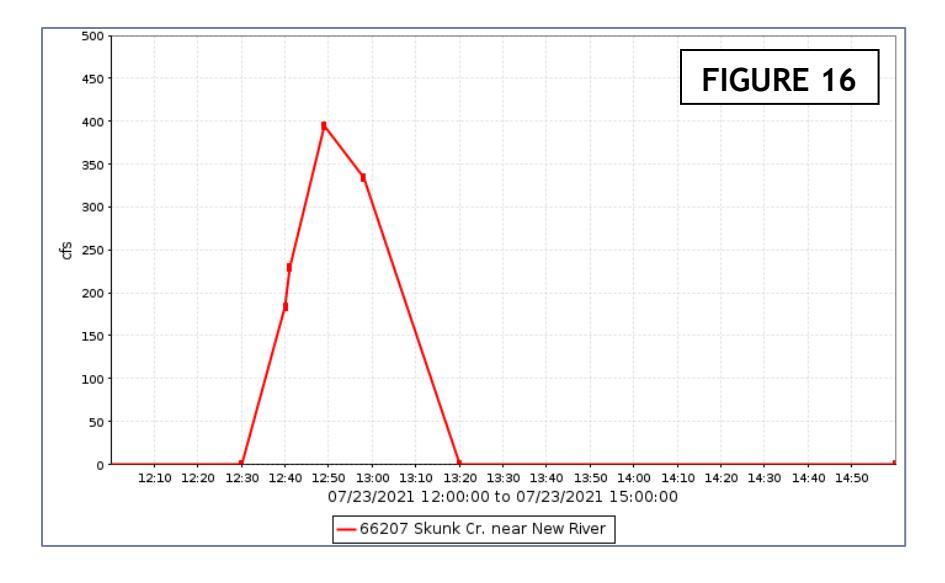
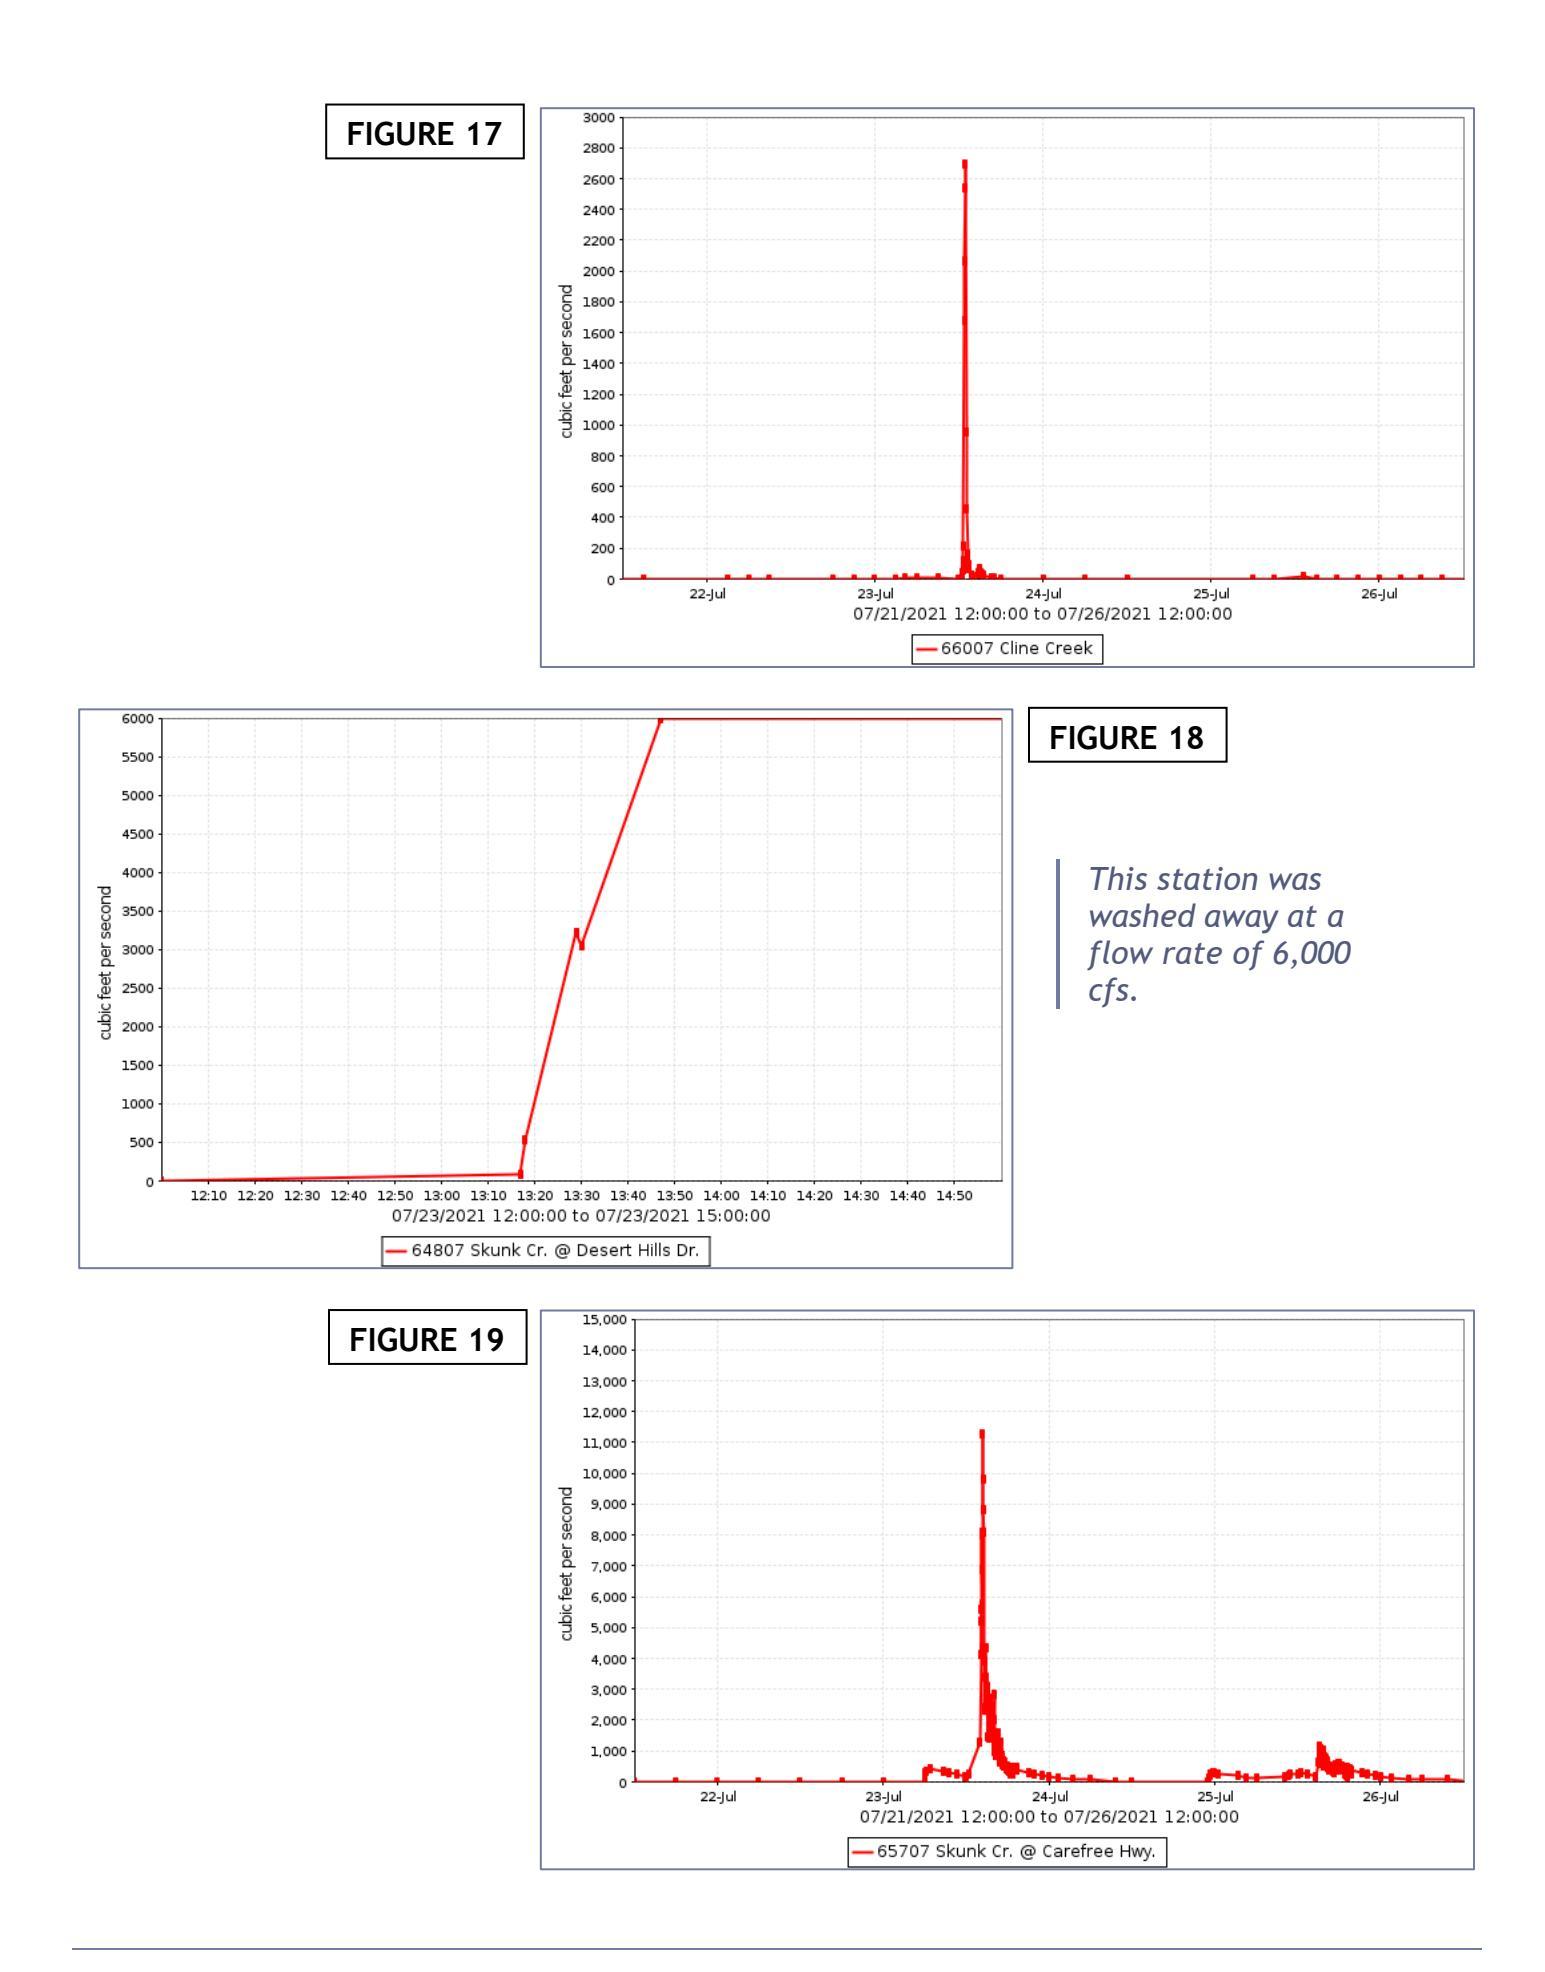
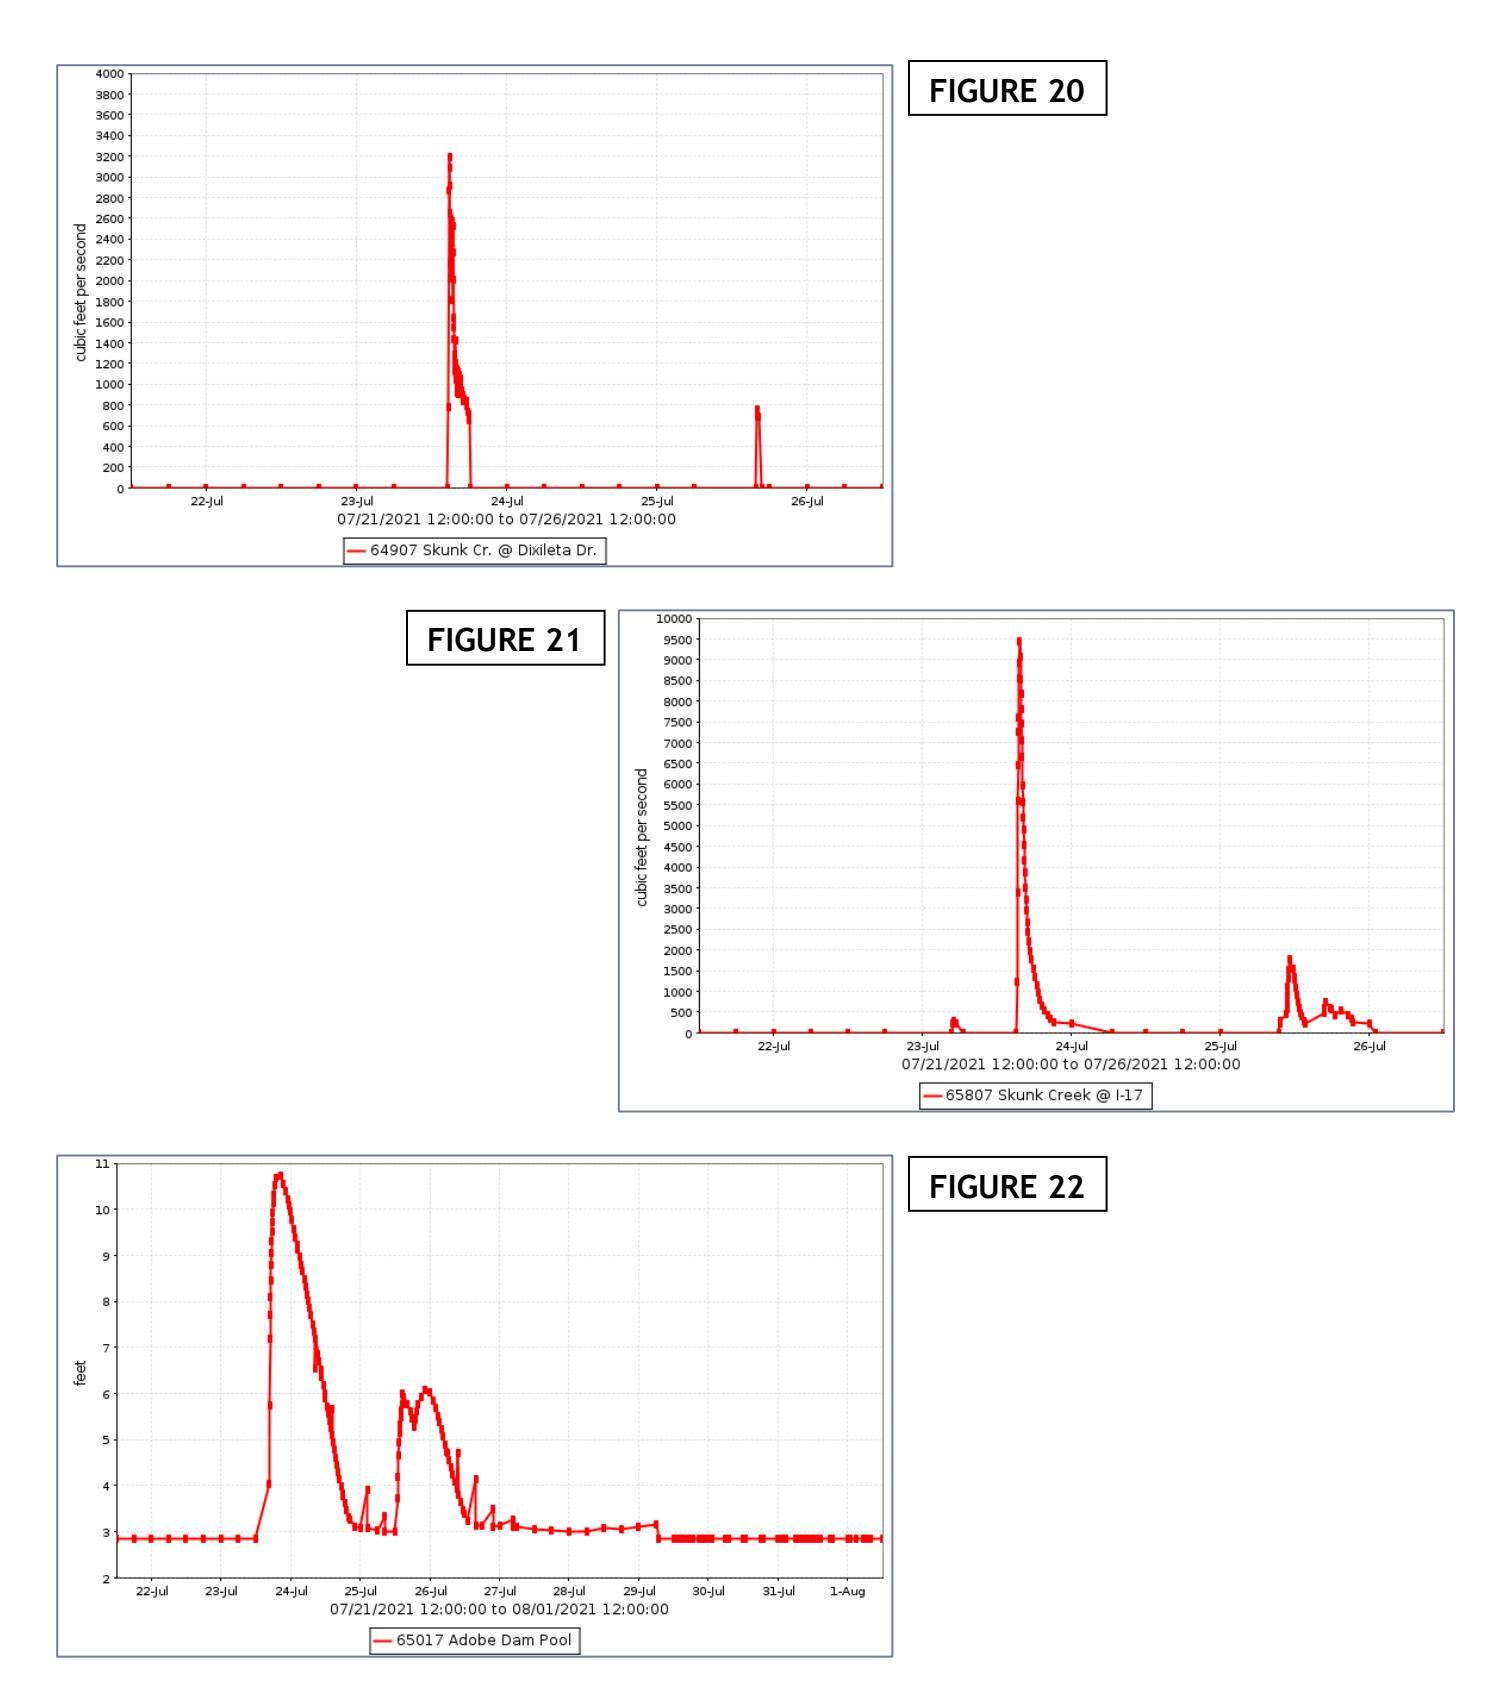
Select Hydrographs are shown on the following pages, highlighting the July 23 peak flow event.

Significant runoff occurred in the watershed among the gaged locations. One gage failure occurred at Skunk Creek at Desert Hills Drive (#64807, Fig. 17) The station had been relocated in May 2021, and unfortunately the gage was washed away in the high-water flows, right after the peak of about 6,000 cfs was recorded just before 2 pm on July 23, 2021.

A smaller magnitude runoff event occurred in the Skunk Creek watershed on July 25, 2021, and its data are included in the hydrographs above (Figs. 16-21) and summarized in the table below. Nevertheless, rainfall produced a record flow at Sonoran Wash.

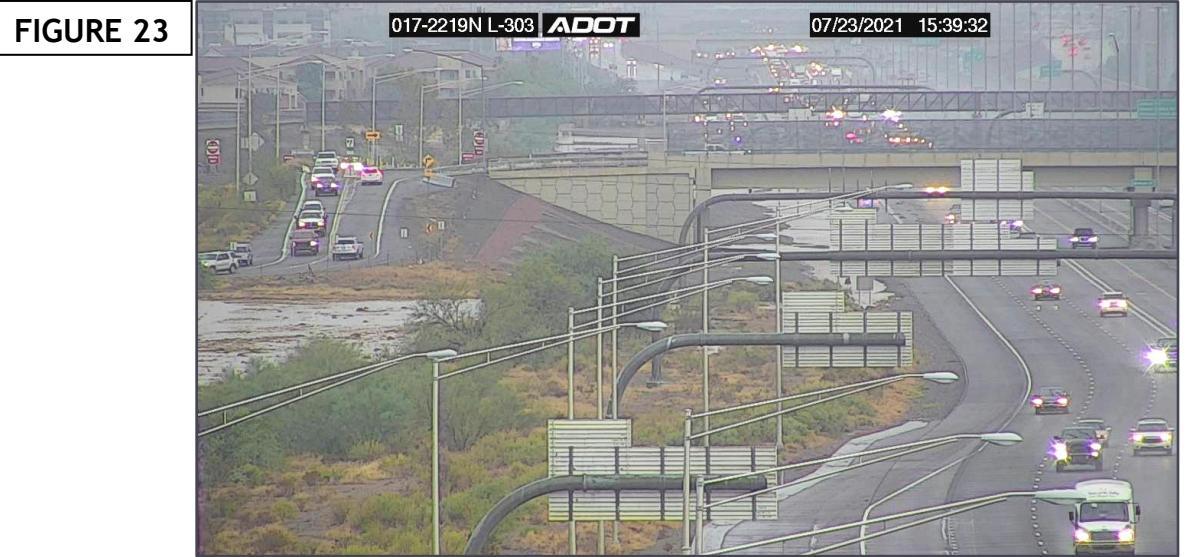
The flow on Skunk Creek was high enough at Dixileta Drive to overtop the roadway and spill west out onto I-17.

I-17 Freeway looking at the Dixileta Drive bridge. Source: ADOT camera.
