Flood Control District of Maricopa County

Engineering Division, Flood Warning Branch

Storm Report : July 22-25, 2021

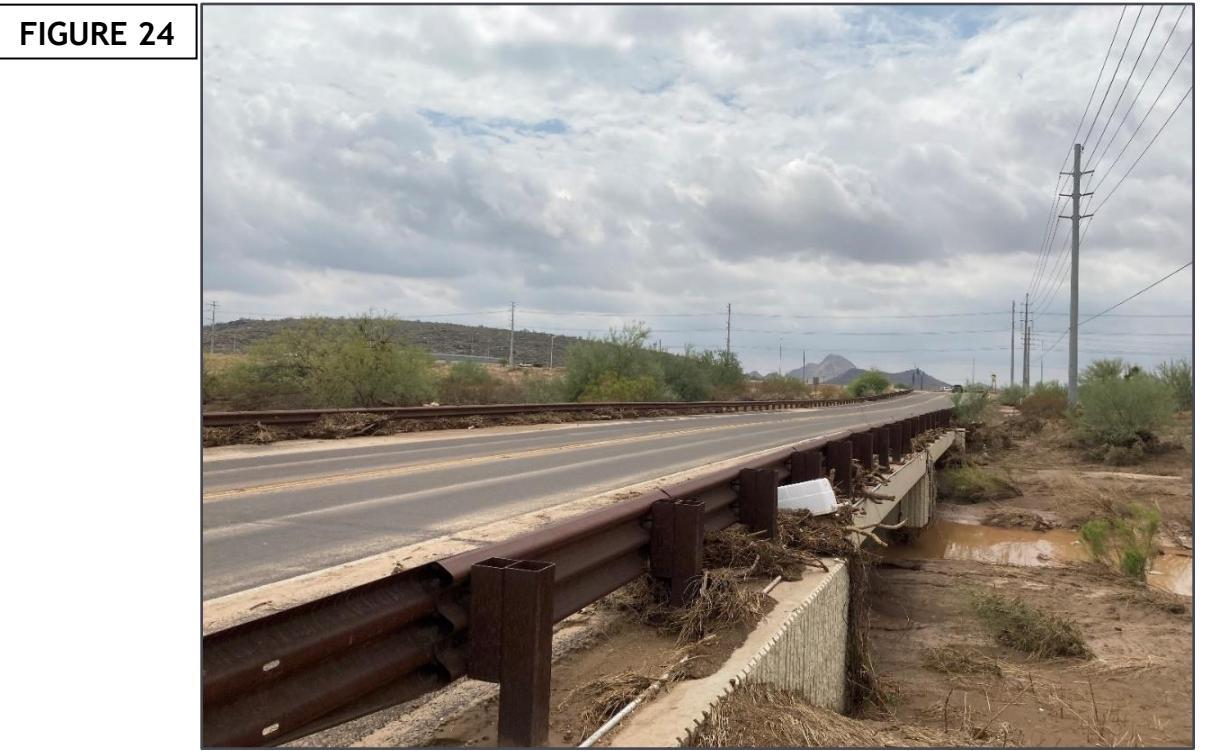
Skunk Creek at Dixileta Drive, July 24, 2021.

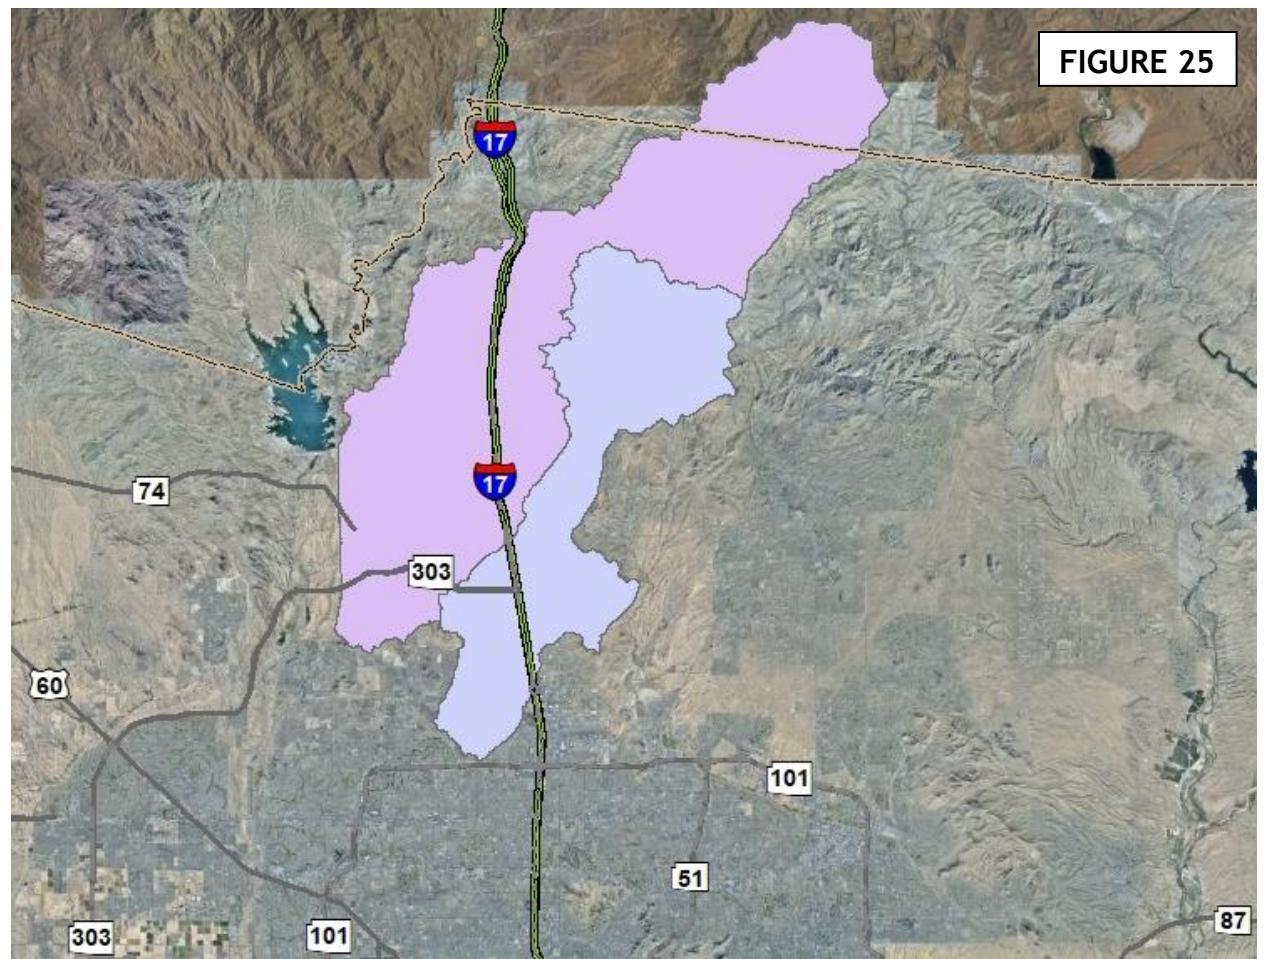
Figure 24 - New River Watershed (darker purple) above New River Dam

The New River watershed is located north and west of the Skunk Creek watershed. There are fewer gages on this watershed than Skunk Creek, but it too ends at an impoundment at New River Dam. A very large flow was recorded at the upstream gage, New River Fire.

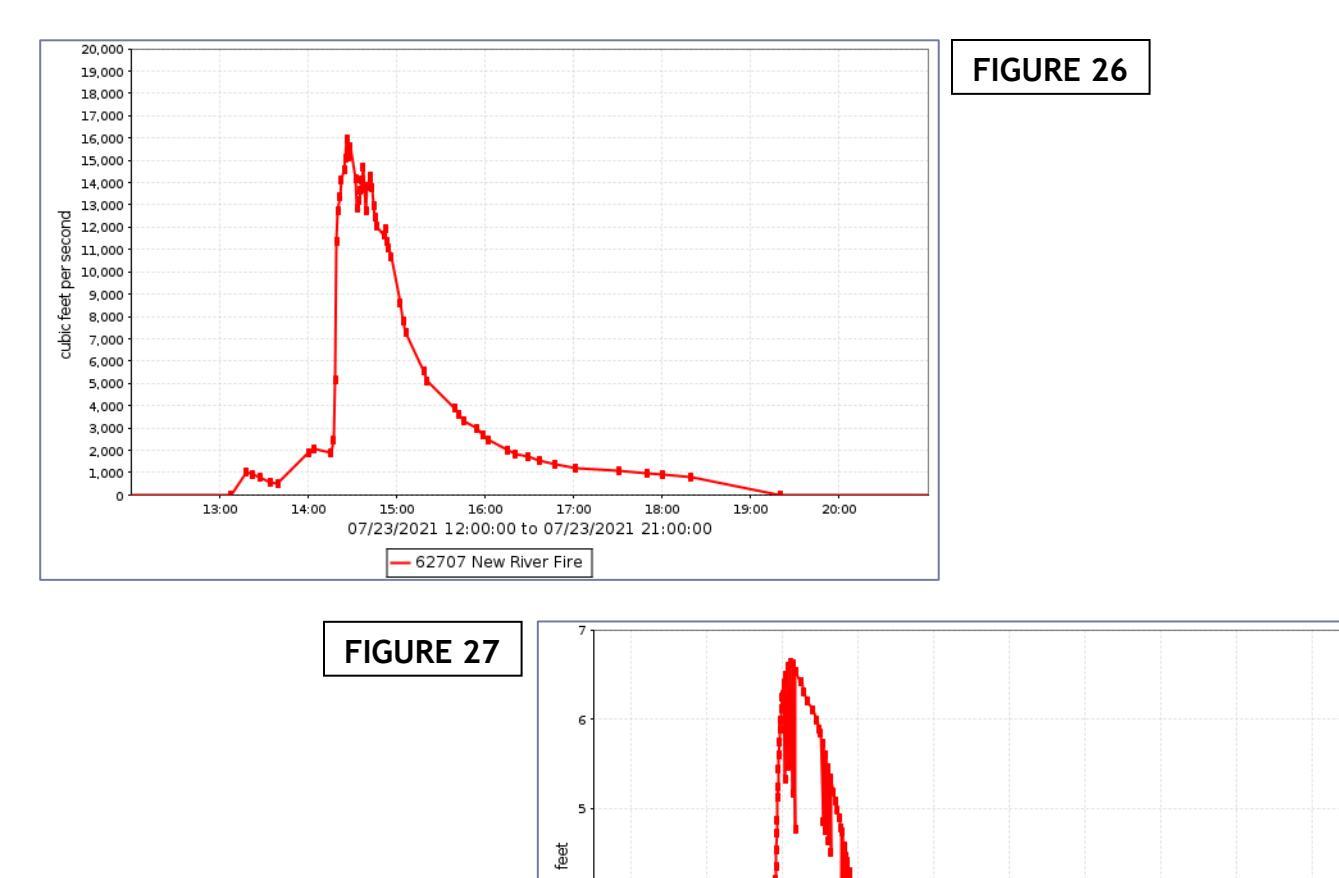
62017 New River Dam Pool

Fields visits indicated that these flows are reasonable. The gage at New River at SR303L failed to operate during the event. The peak stage was recovered from the crest-stage gage at the site. The date and time of peak at that location are estimated and unknown. There were no flows recorded for the July 25, 2021 event. Below are hydrographs for the event.

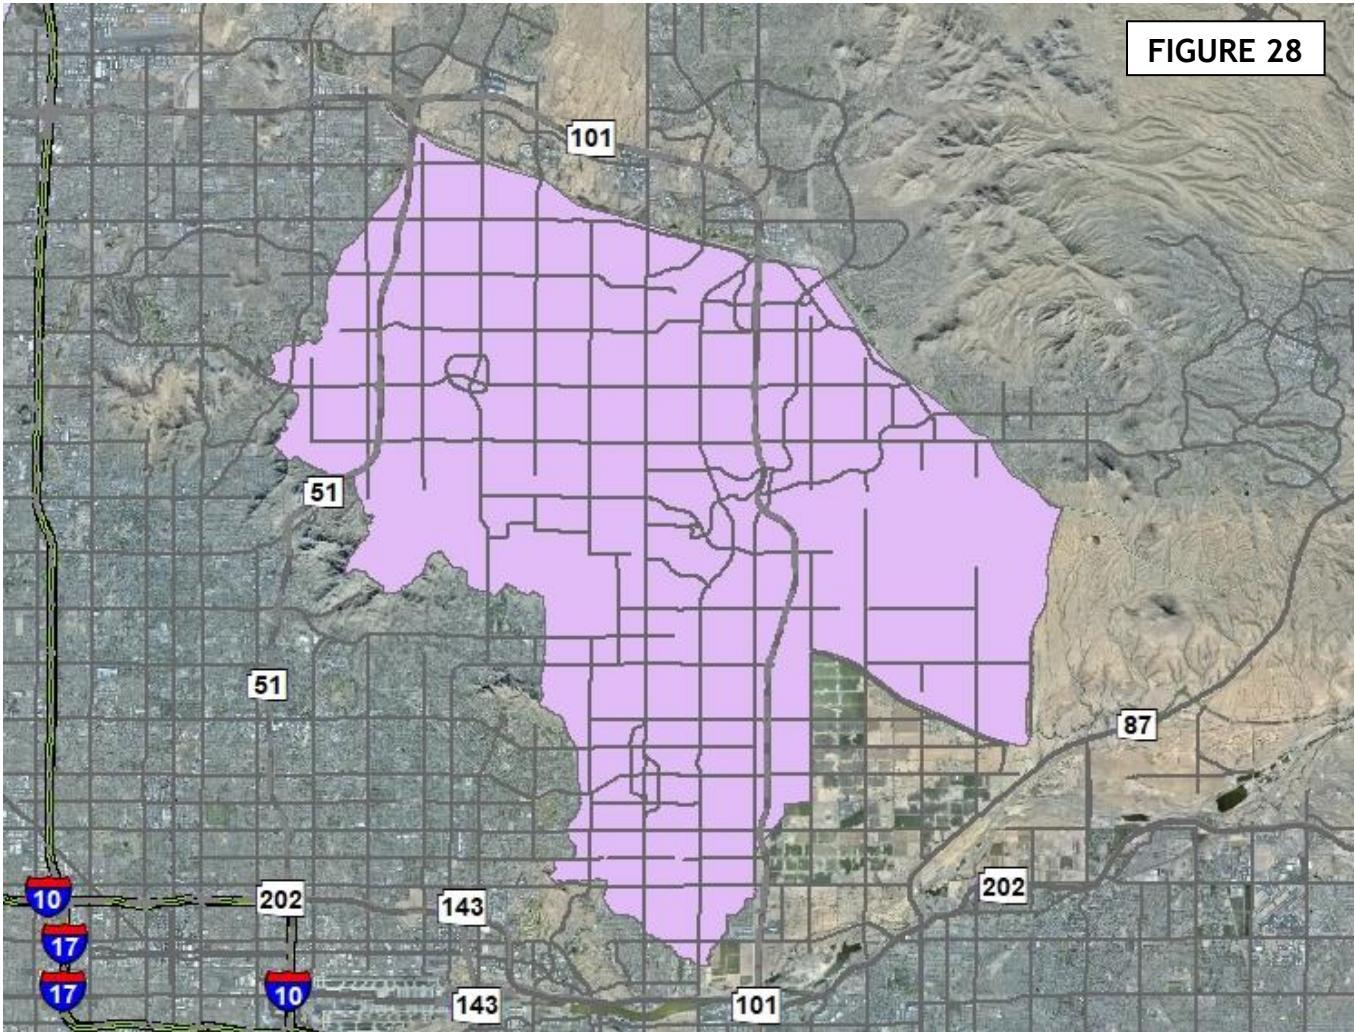
Figure 28 - Indian Bend Wash watershed above McKellips Rd. Gage

The Indian Bend Wash watershed has contributing area below the CAP canal and Reach 11 Dikes, which completely remove the upper watershed from contributing to flows.

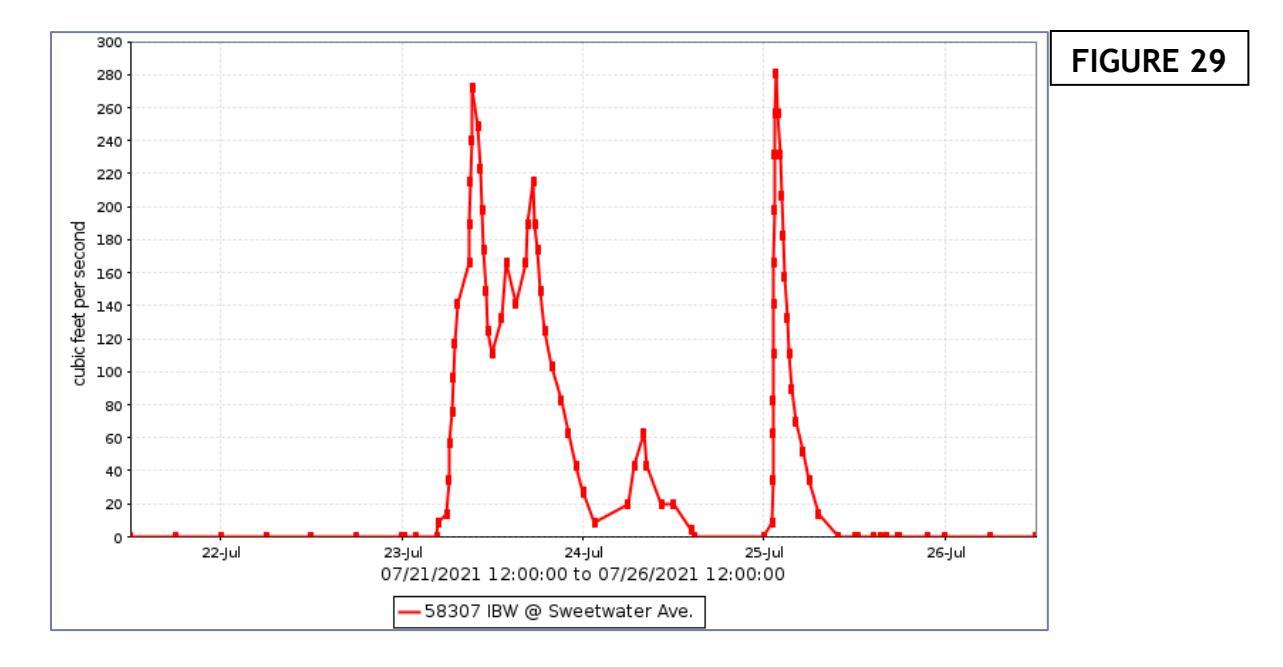
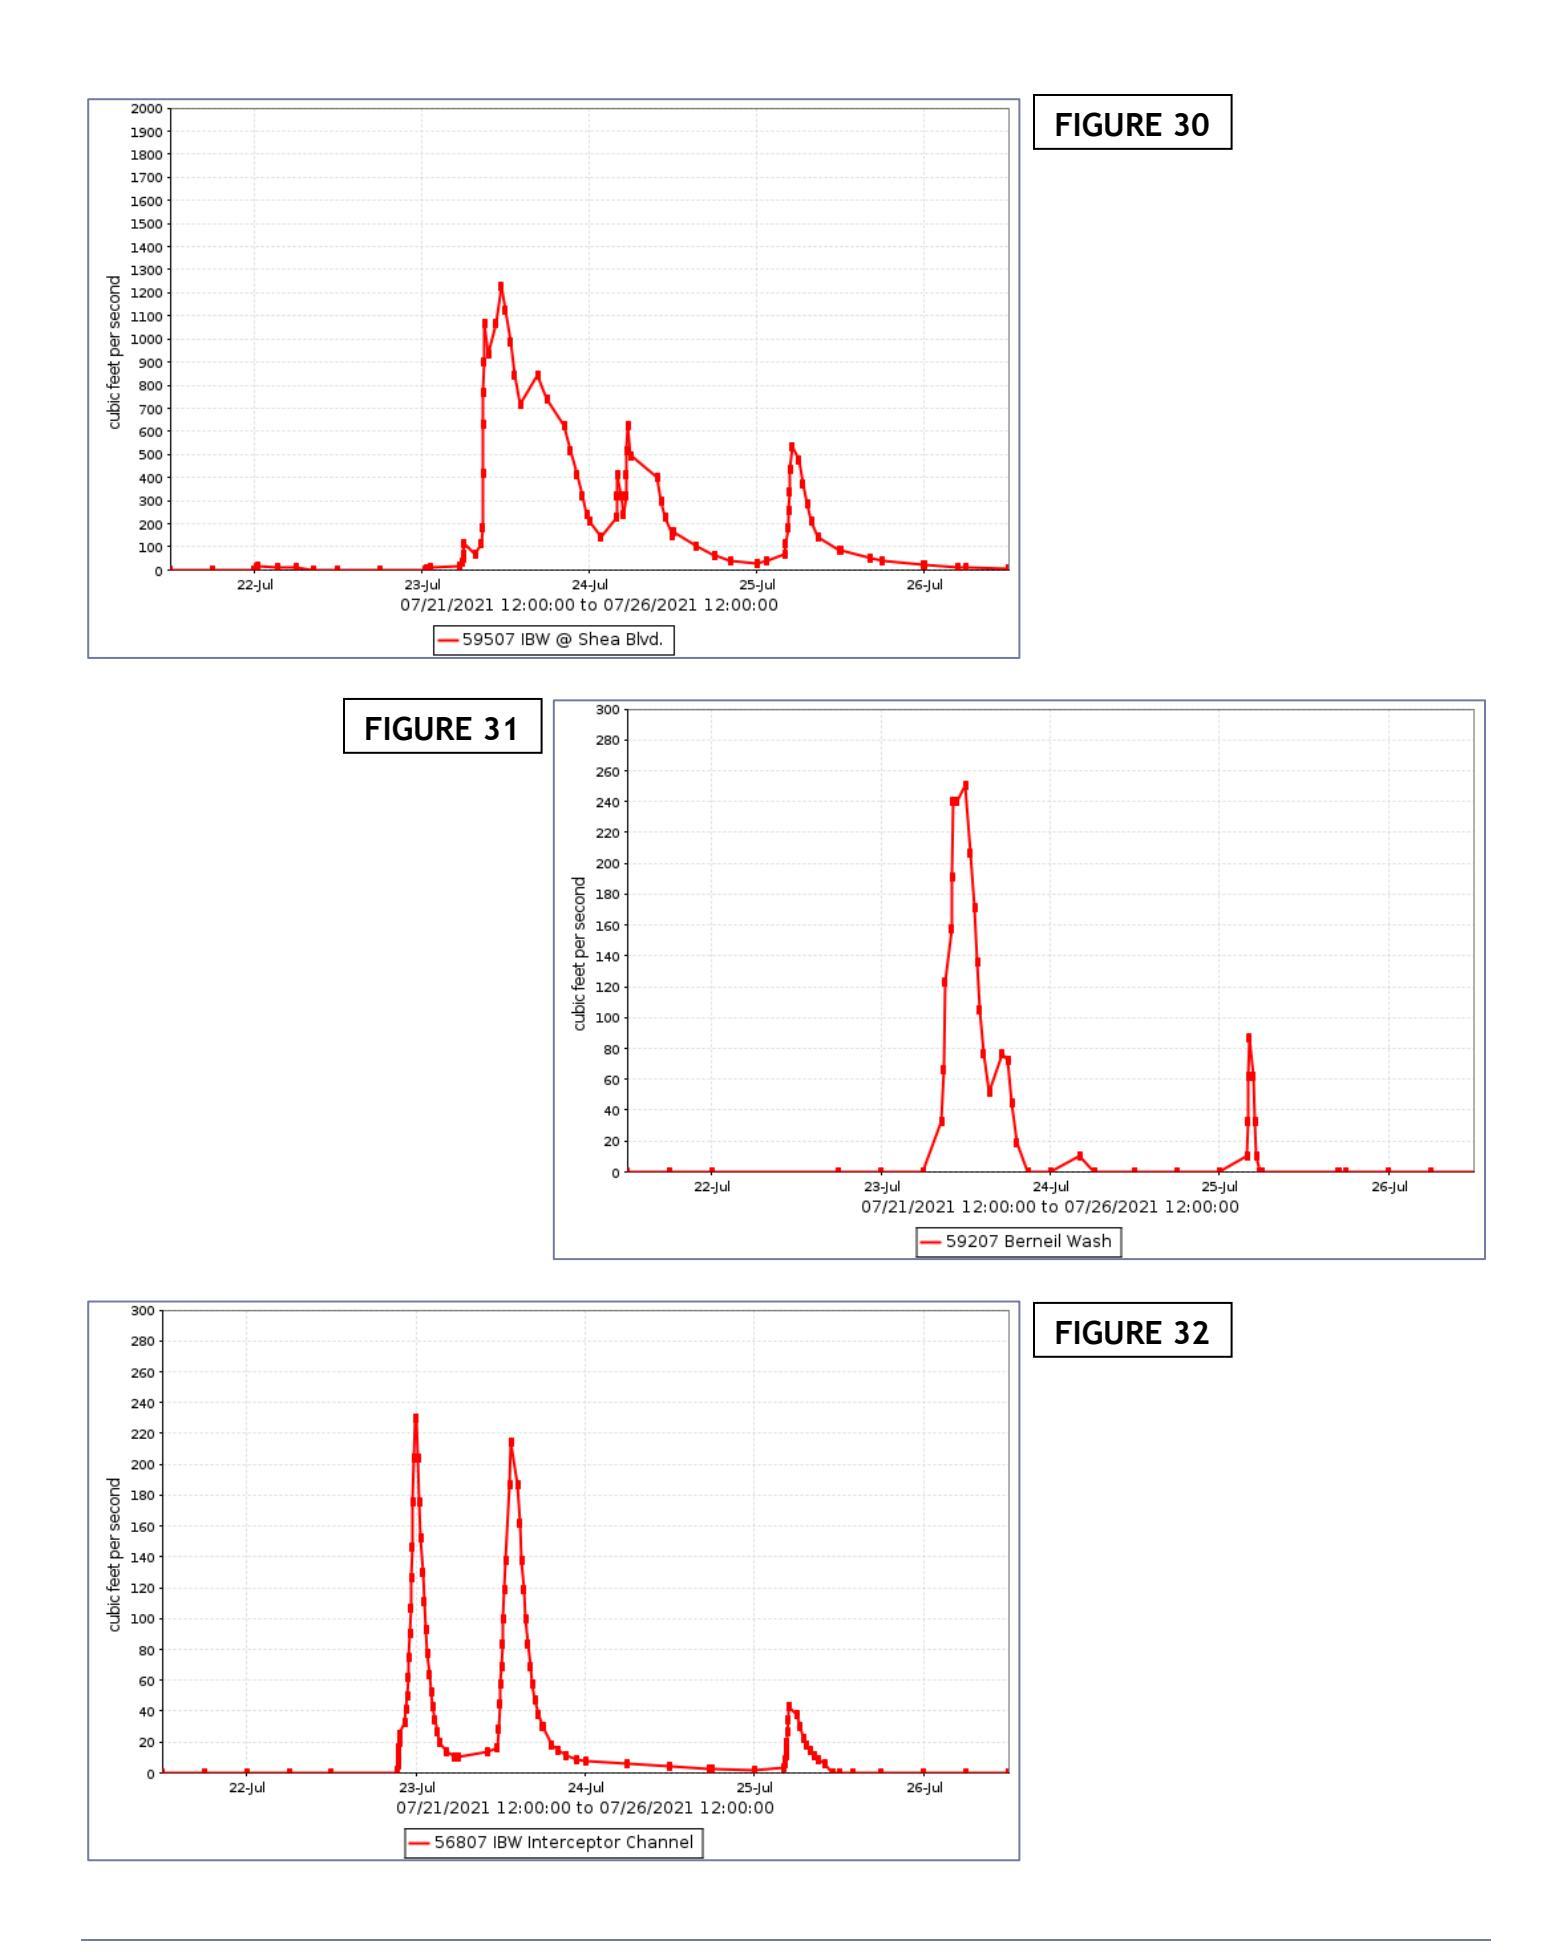
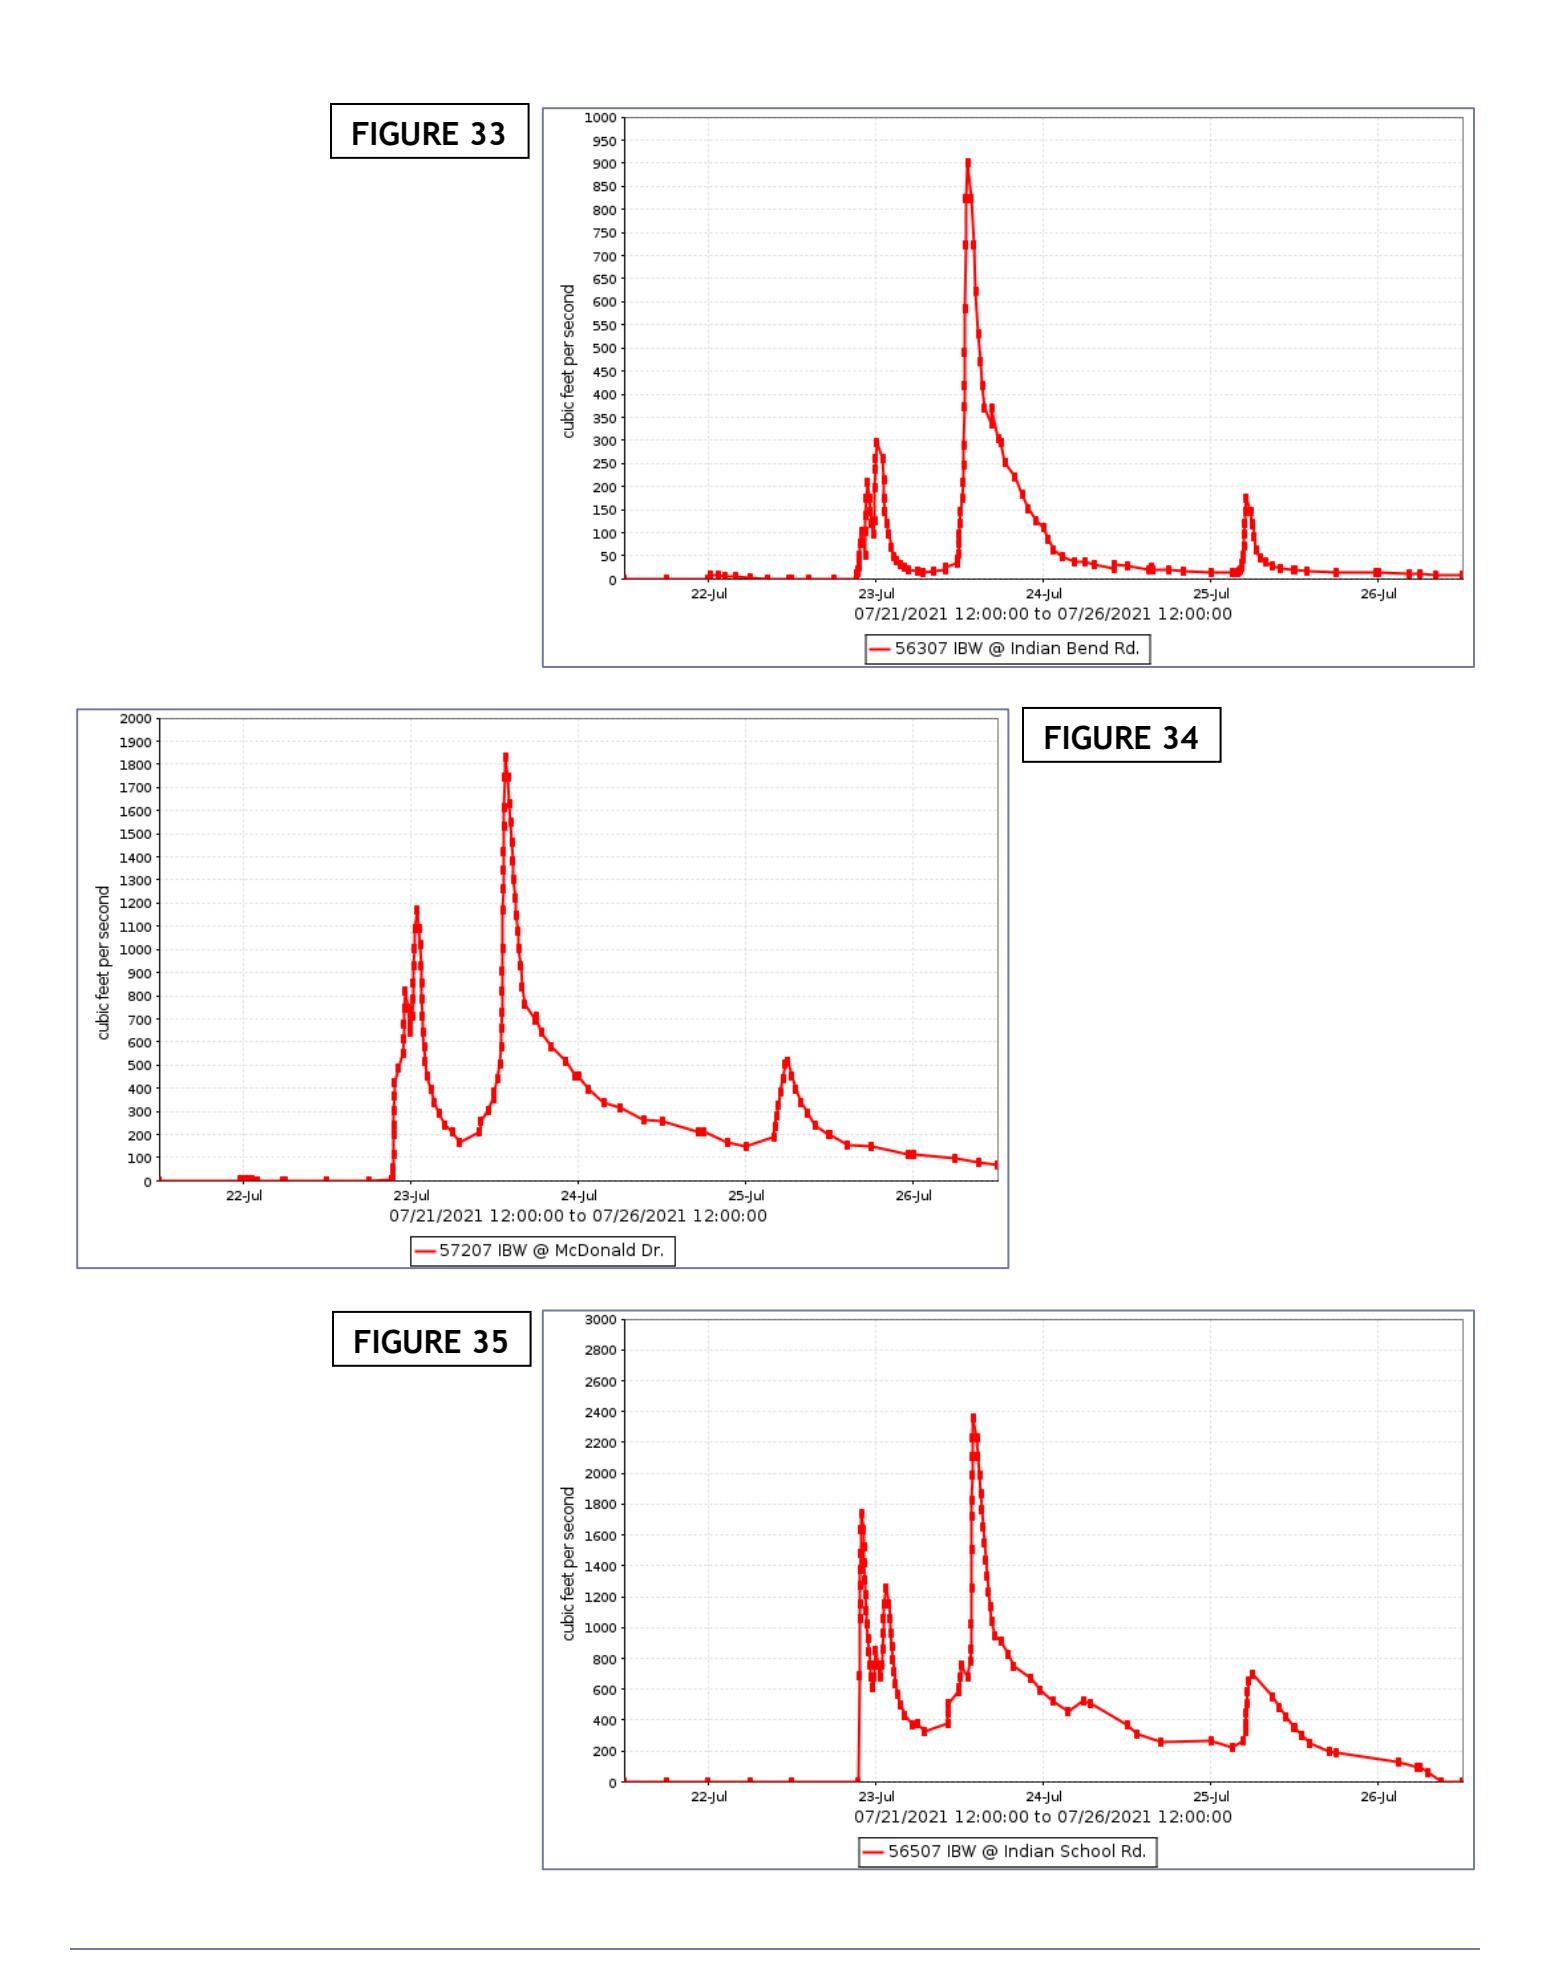
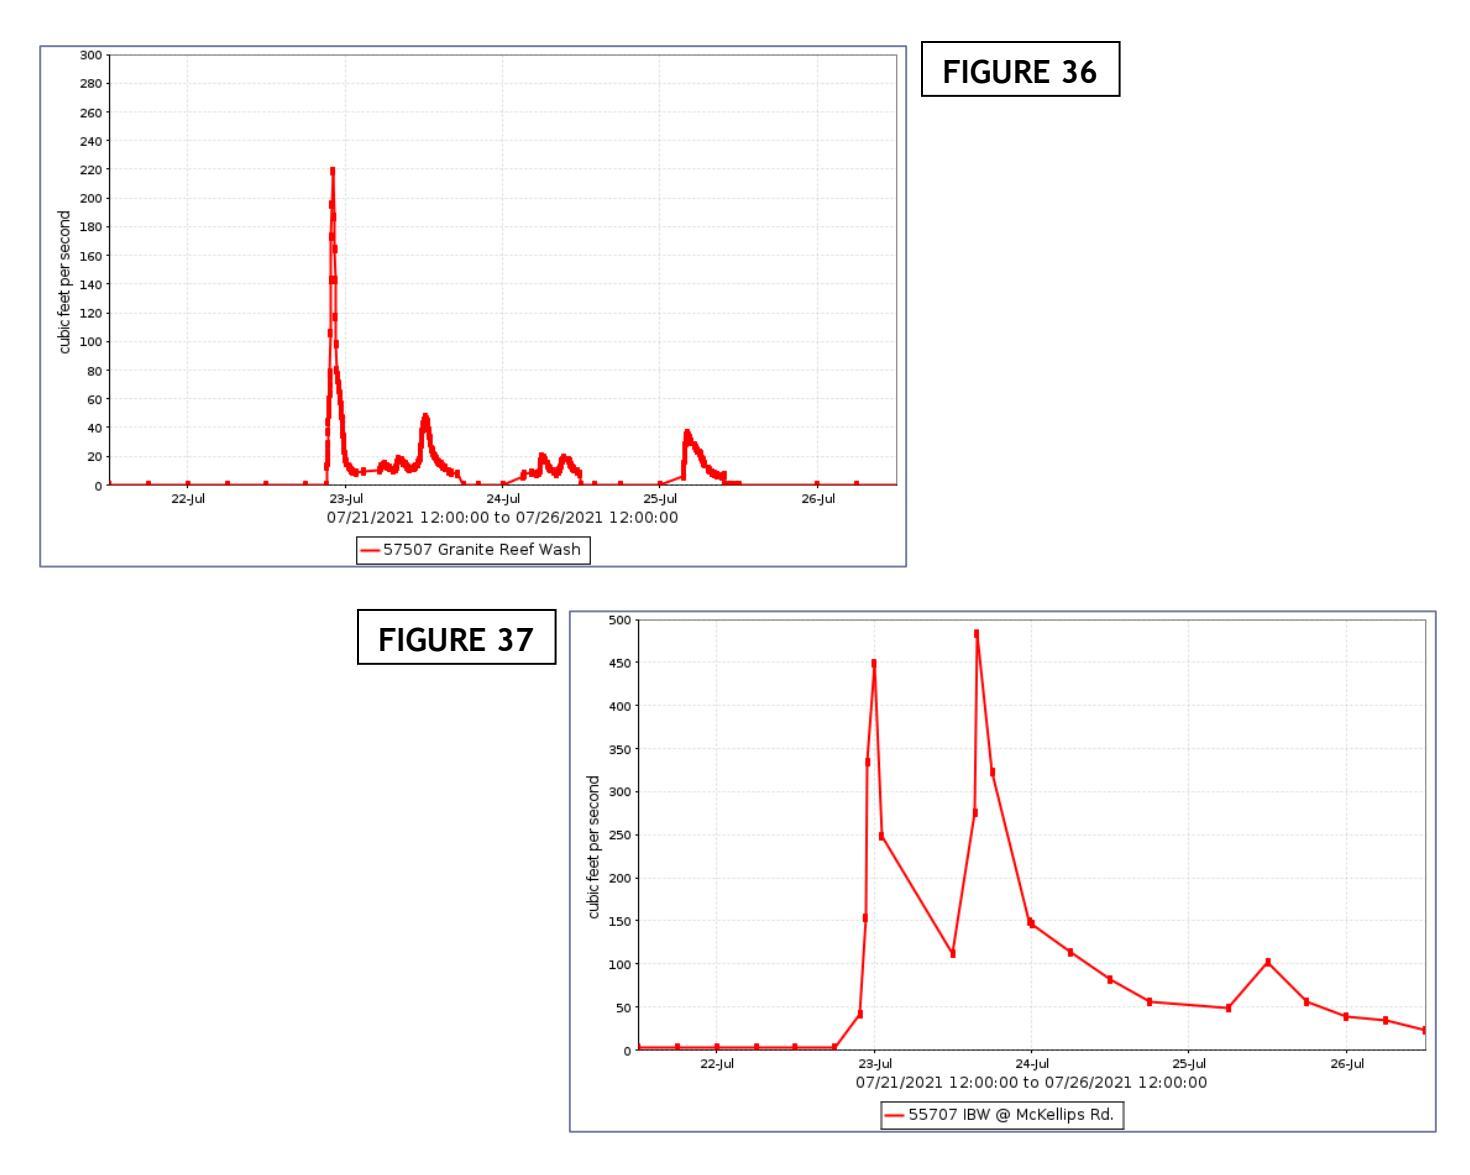
Flows were nowhere near records, but they did cause unbridged crossings within the City of Scottsdale to be closed for several days. Starting on the next page are hydrographs for each station for the period. The hydrographs are in stream order starting upstream.

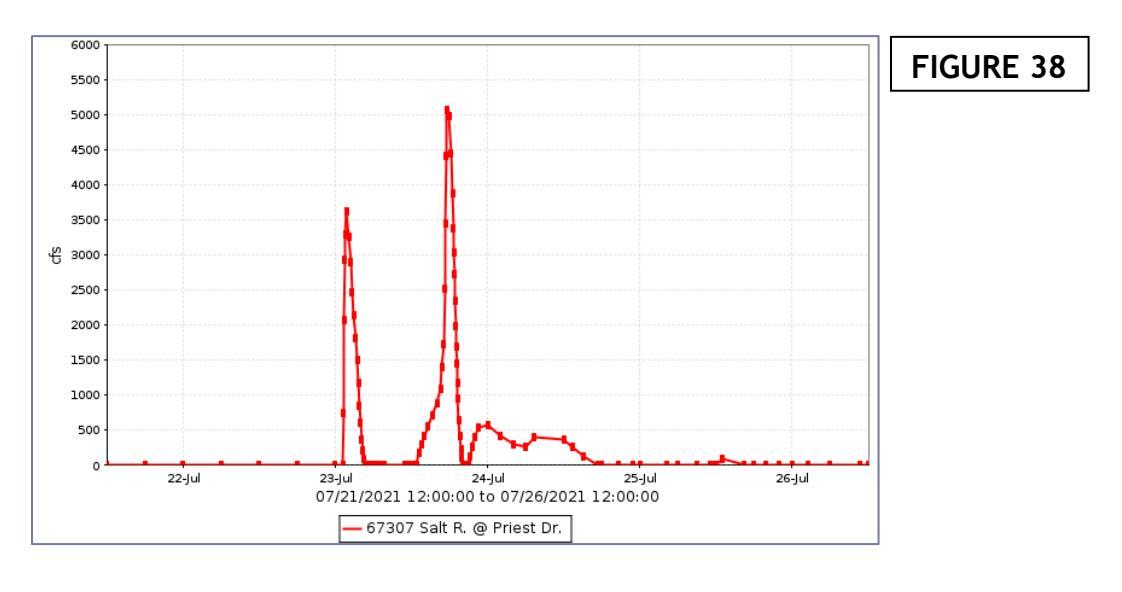
Flows from Indian Bend Wash discharge directly into the Salt River and Tempe Town Lake east of Scottsdale Road. These in turn affect the Salt River gage at Priest Drive, just below the Tempe Town Lake dam.
