# **Flood Control District of Maricopa County**

### **Engineering Division, Flood Warning Branch**

# Storm Report : August 12-14, 2021

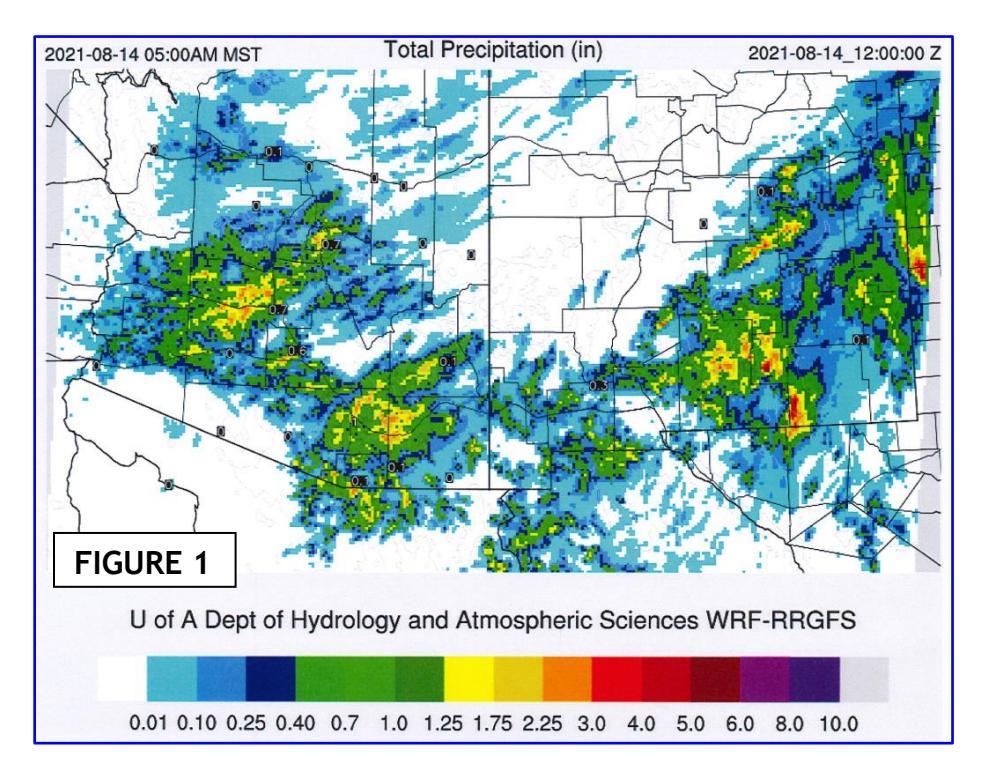
**Figure 1**: depicts a forecast of storm-total rainfall ending at 5:00 AM on 8/14/2021. The forecast model run was completed at 5 AM on August 13<sup>th</sup>. The model suggests a large area of rainfall greater than 1.25 inches through west-central Maricopa County, which was for the most part verified. It missed an area of heavy rainfall south of I-8.

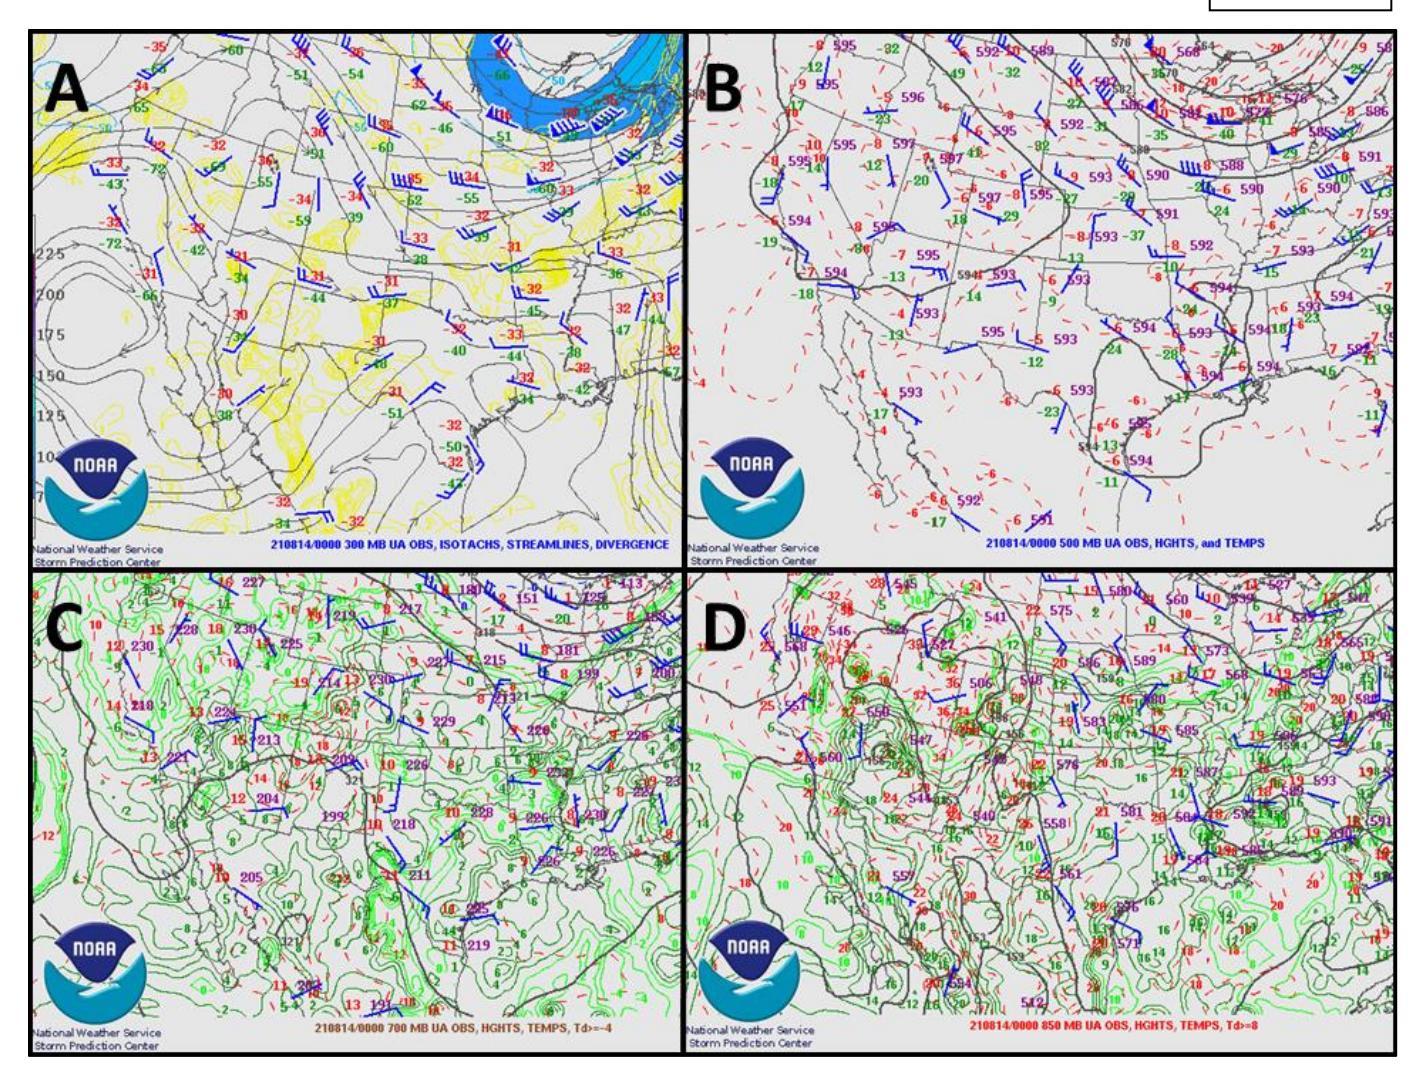
#### FIGURE 2

**Figure 2**: depicts the synoptic setup at 00Z (5:00 PM MST) on September 13<sup>th</sup>,2021. The images are from the Storm Prediction Center upper air maps archive. **A)** is the 300mb map: the black lines are stream lines, the yellow lines are divergence, and station obs. are plotted at each available location **B)** is the 500mb map: the red dashed lines are isotherms, the other variables are colored the same as in A. **C)** is the 700mb map: variables are colored the same as **D**. **D)** is the 850mb map: the black lines are heights, the red dashed lines are isotherms, the green lines are isodrosotherms, blue barbs are wind speed, and station observations are plotted at each available location.

The synoptic setup on the evening of August 13<sup>th</sup> is shown in Figure 1 (below). The upper-level images (A and B) depict a diffuse ridge of high pressure draped across NV/UT and a well-defined inverted trough across southwestern NM. The positioning of the ridge and trough during this period created a large area of upper-level divergence (rising motion, yellow lines in A) across eastern AZ, which likely enhanced initial t-storm development across the Mogollon Rim and White Mountains regions. Both the 700mb and 850mb maps (images C and D) depict the moisture rich environment across AZ.

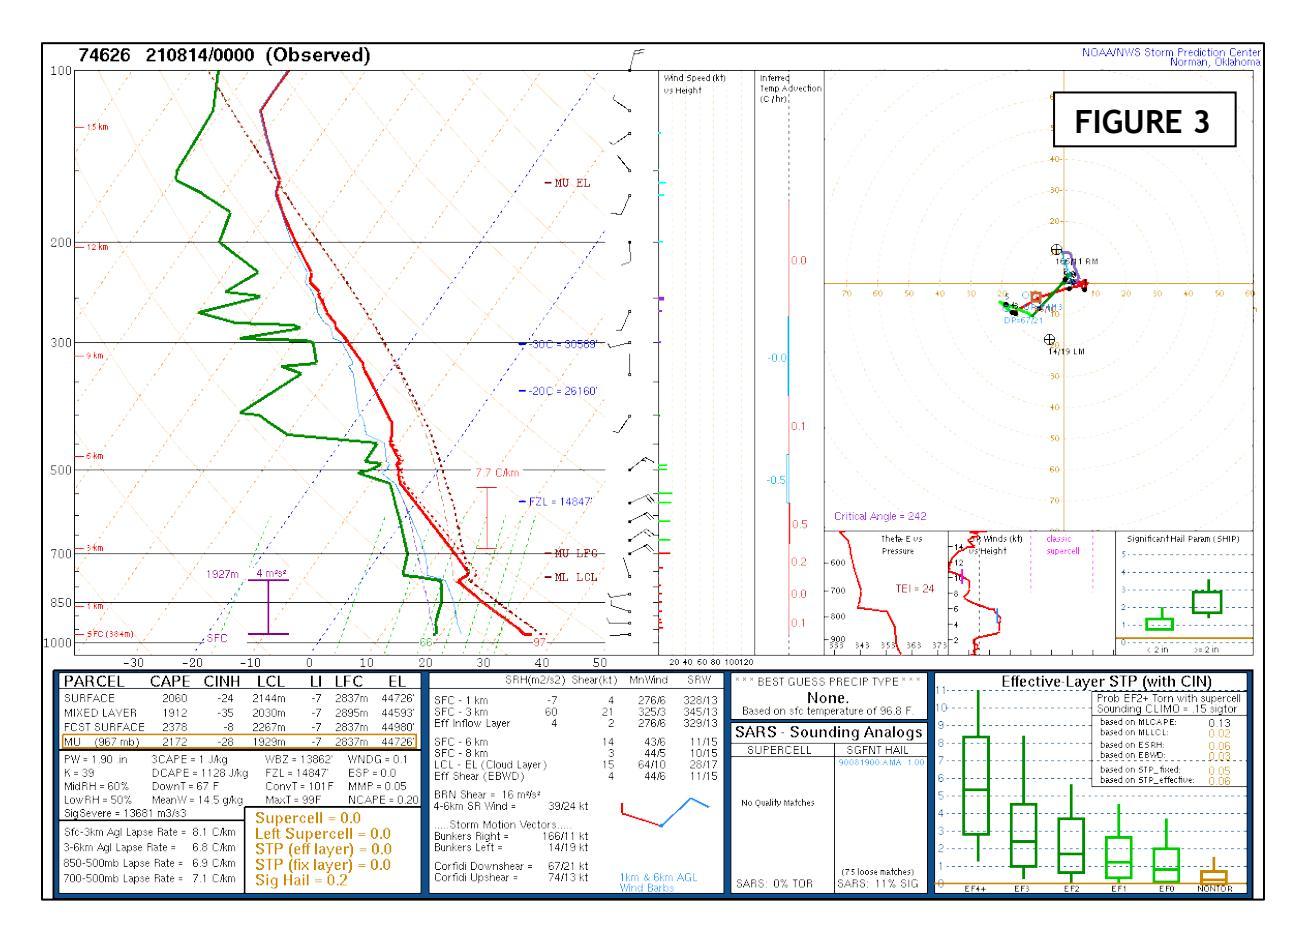
**Figure 3**: Observed Skew-T/log P (vertical profile of the atmosphere above Phoenix) diagram at 5:00pm MST on August 13<sup>th</sup>, 2021. Sounding generated from NOAA/SPC. The vertical axis is pressure in (hPa) and the horizontal axis is temperature in (°C). The thick solid red line is the temperature profile. The thick solid green line is the moisture profile. The dashed grey and orange lines are the atmospheric parcel profiles. The vertical axis on the right displays the wind speed and direction at each level in knots. Gray solid lines sloping from upper left to lower right are constant potential temperature (°K). Thin dashed blue and gray lines sloping from right to left are isotherms (°C). Thin dashed green lines sloping from right to left are mixing ratio (g/kg). The table in the bottom left displays various parcel attributes and thermodynamic indices. The image in the top right is a hodograph showing the change in speed and direction of the atmospheric winds with height.

Mesoanalysis data across southcentral AZ in the near storm environment on Friday evening revealed a favorable setup for organized t-storms capable of severe weather and heavy rainfall. Evidence of this was shown by the 00Z, 5:00pm MST, KPHX sounding in Figure 2 below. Precipitable water was sampled at 1.90", which is an incredibly high (wet) value for August. In fact, according to the Storm Prediction (SPC) sounding climatology page this sounding set the period of record value for the date. Thermodynamic variables of note included: high CAPE/low CIN profile (extremely unstable atmosphere), negative lifted indices, and high DCAPE values indicative of strong downdrafts capable of damaging wind gusts. The vertical wind profile showed strong 700mb-500mb 20kt steering-level winds out of the northeast and low level (below 850mb) westerlies. The District's hourly Convective Quantitative Precipitation Forecast (QPF) at 8:06pm MST here was generated just before the first line of storms developed across the eastern half of the County and showed an atmosphere primed for heavy rainfall (notable 60min and 30min rainfall values highlighted in yellow). Another QPF generated at 11:06pm MST here shows the rainfall environment across southwestern Maricopa County just before storms dropped torrential rains over the area (discussed in detail in following sections). It's also worth noting an additional description of the setup for severe weather can be viewed on the Storm Prediction Center's weather event archive here. A full description of the heavy rain and flash flooding potential was conveyed by the Weather Prediction Center through its mesoscale precipitation discussions here and here.

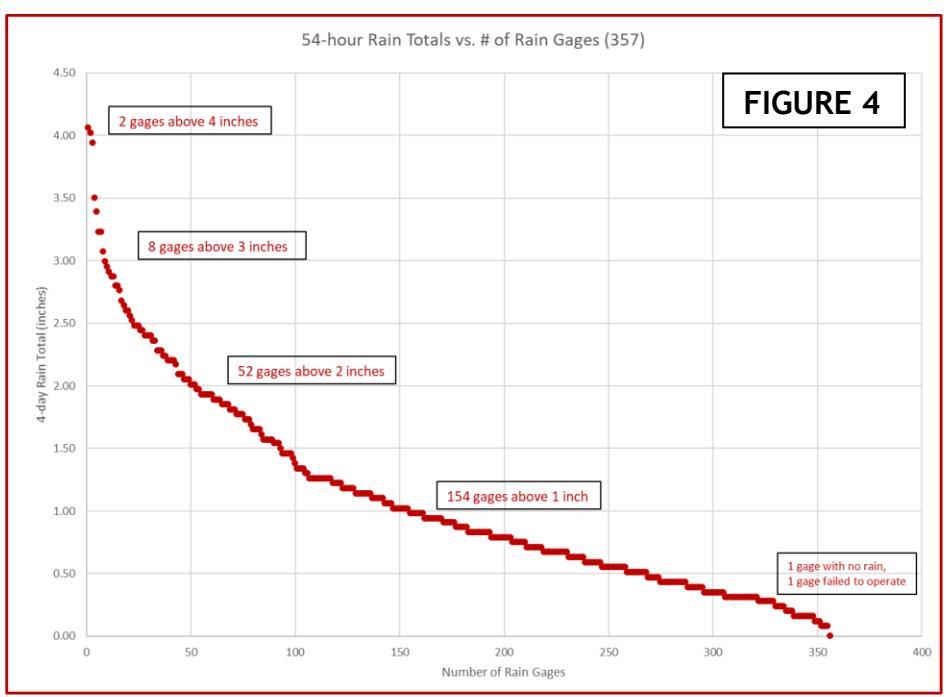
**Figure 4** above presents a plot of rainfall amounts for all FCDMC ALERT rain gages for the period 8/12/2021 0:00 through 8/14/2021 06:00. One gage recorded no rain (Narrows Damsite) and one gage failed to operate (Buckeye FRS #1). Tabular hourly data for all gages for the 54-hour period is available <u>here</u>.

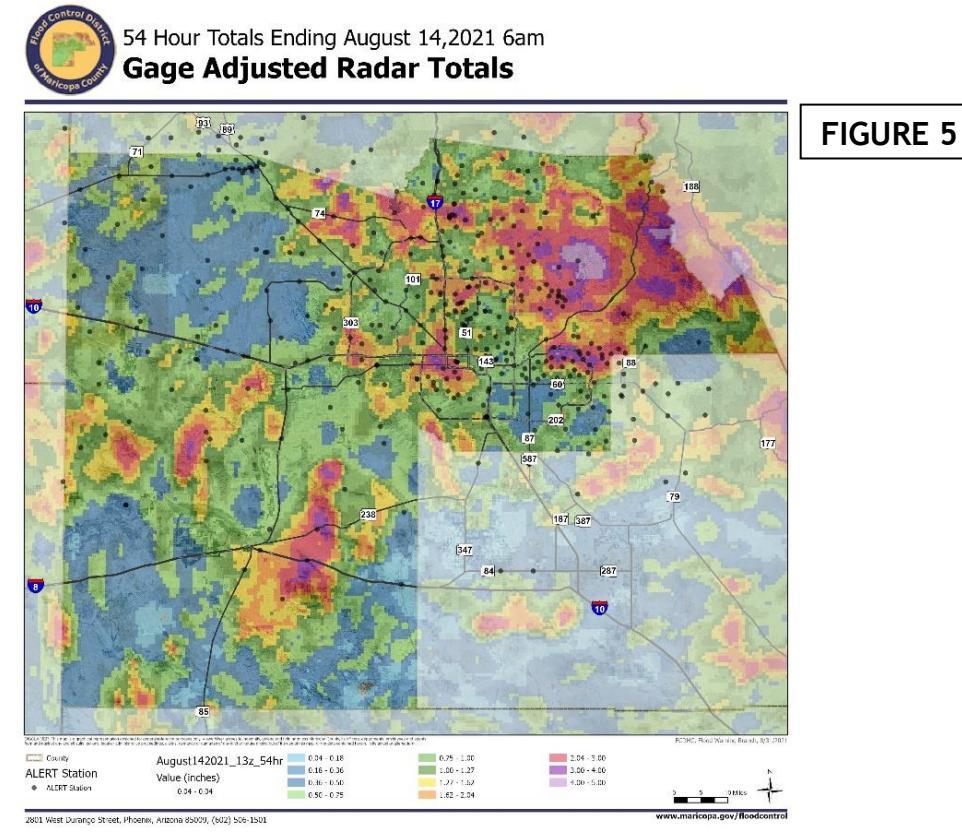
**Figure 5** above presents an image of rainfall amounts for all FCDMC ALERT rain gages for the period 8/12/2021 0:00 through 8/14/2021 06:00. Click the image for a full-size view in your browser. Use CTRL +/- to zoom in/out.

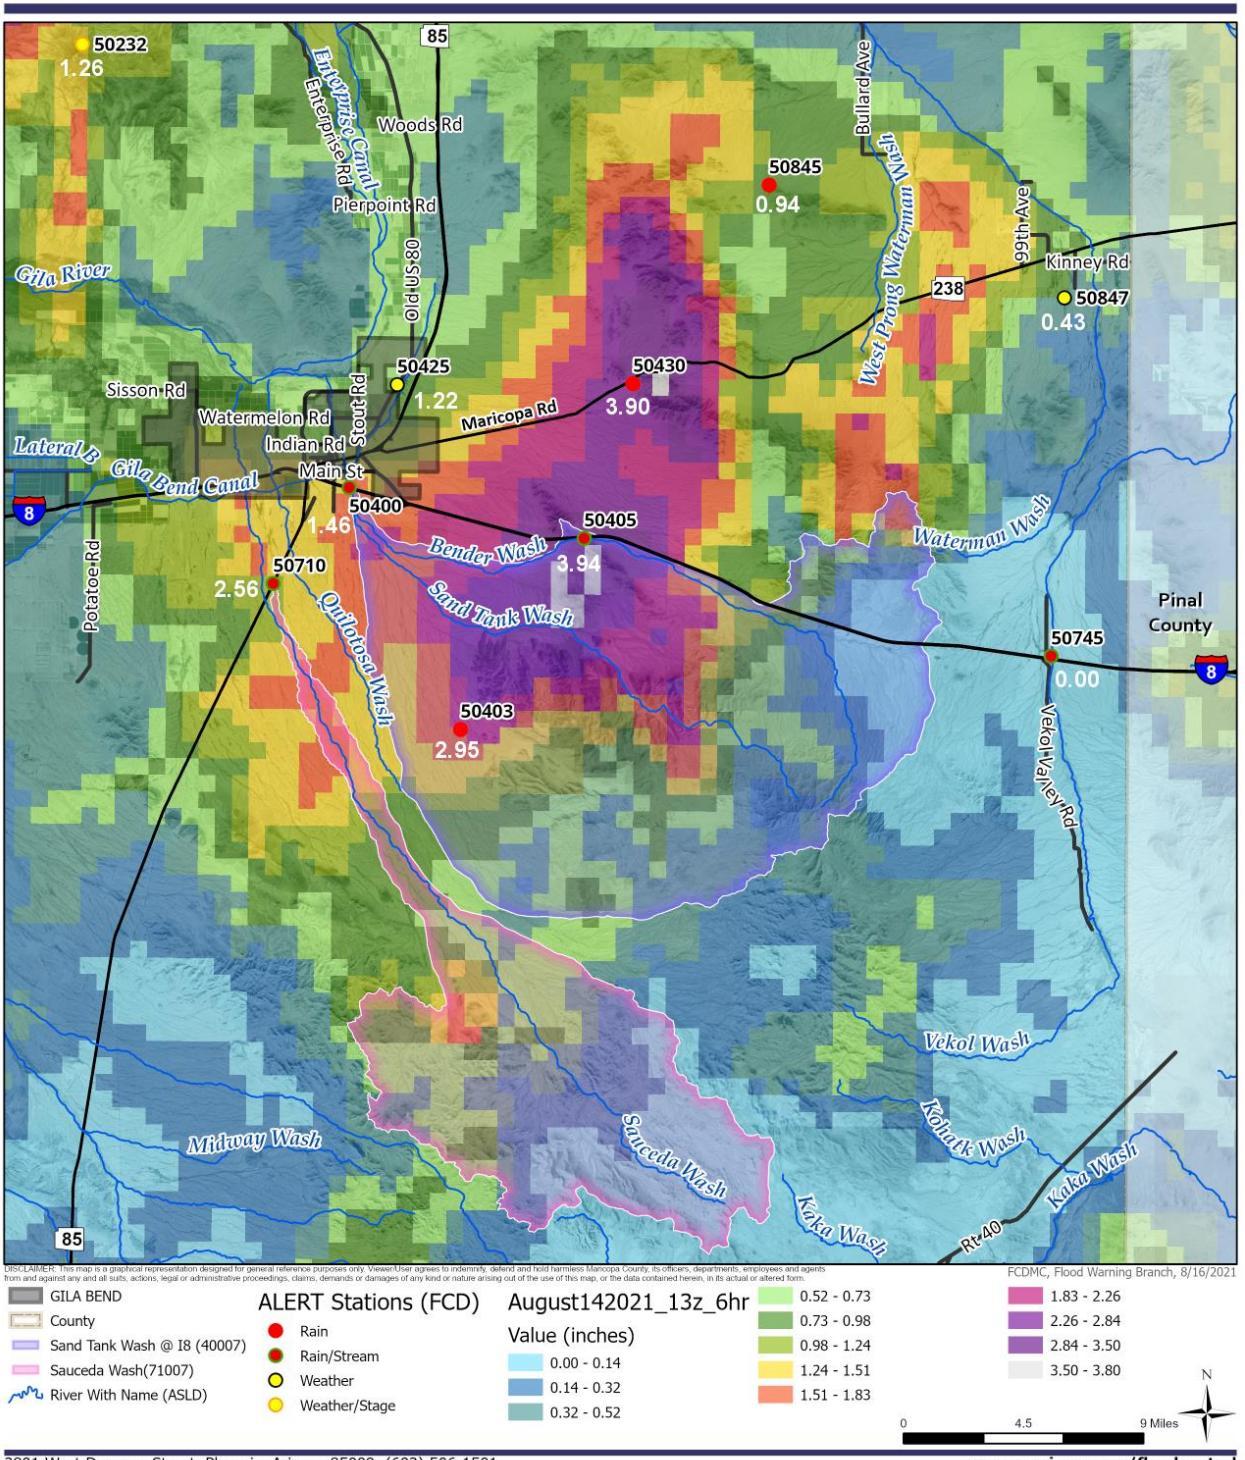
FIGURE 6

**Figure 6** above presents an image of rainfall amounts from gage-adjusted radar rainfall estimates for the period 8/14/2021 0:00 through 06:00. Recorded rainfall amounts at FCD automated rain gages are show in white numbers. The image gives a visual representation of where heavy rain fell in relation to Sand Tank and Bender Washes. The average rainfall over the entire Sand Tank Wash watershed was 1.20 inches.

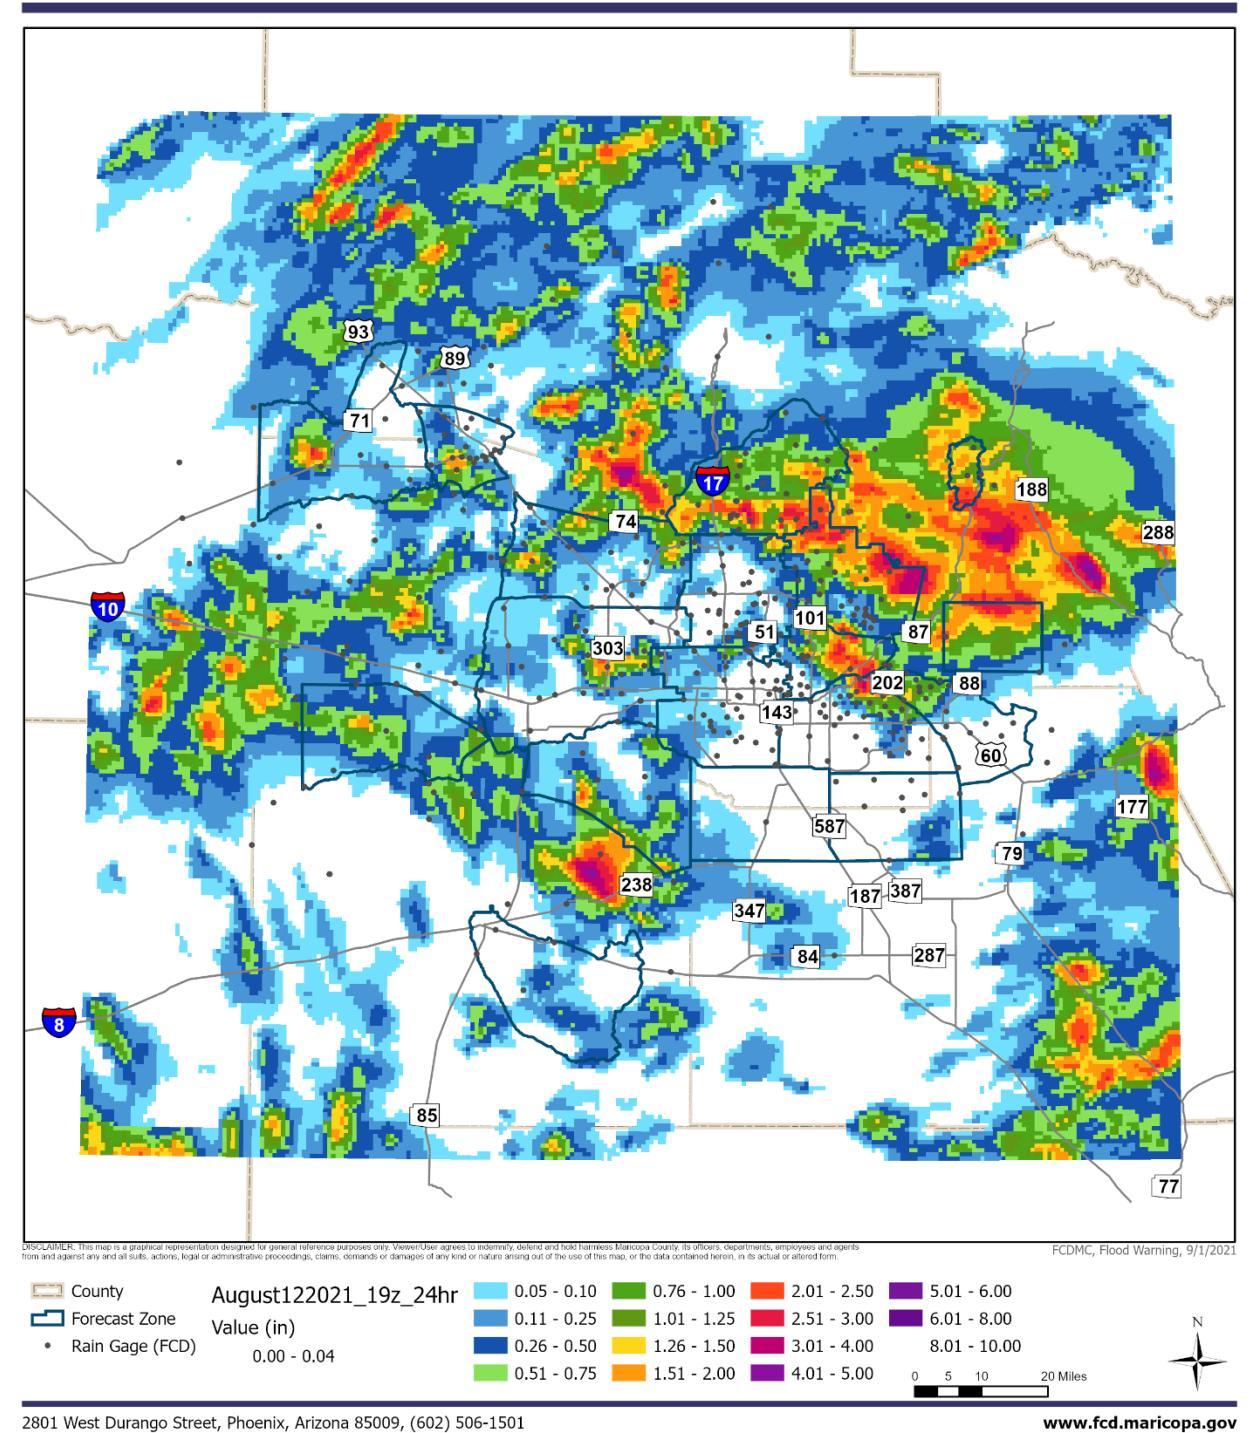
**Figure 7** above presents an image of rainfall amounts from gage-adjusted radar rainfall estimates for the period 8/11/2021 12:00 through 8/12/2021 12:00.

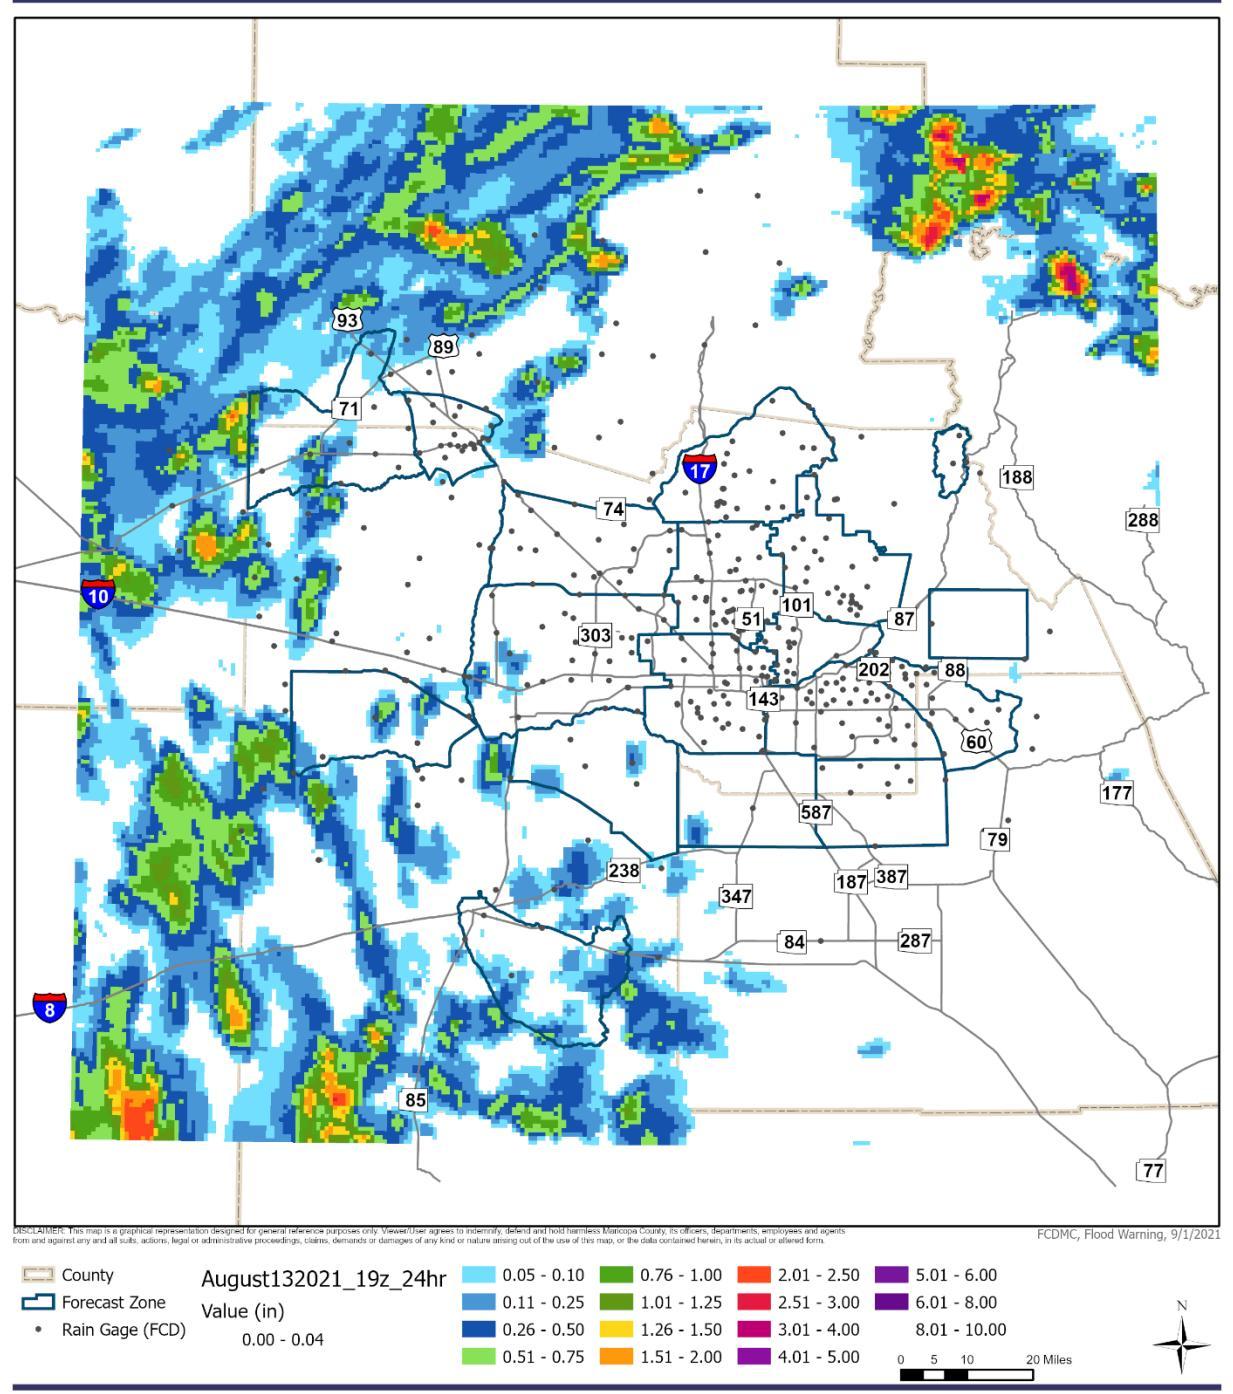
**Figure 8** above presents an image of rainfall amounts from gage-adjusted radar rainfall estimates for the period 8/12/2021 12:00 through 8/13/2021 12:00.

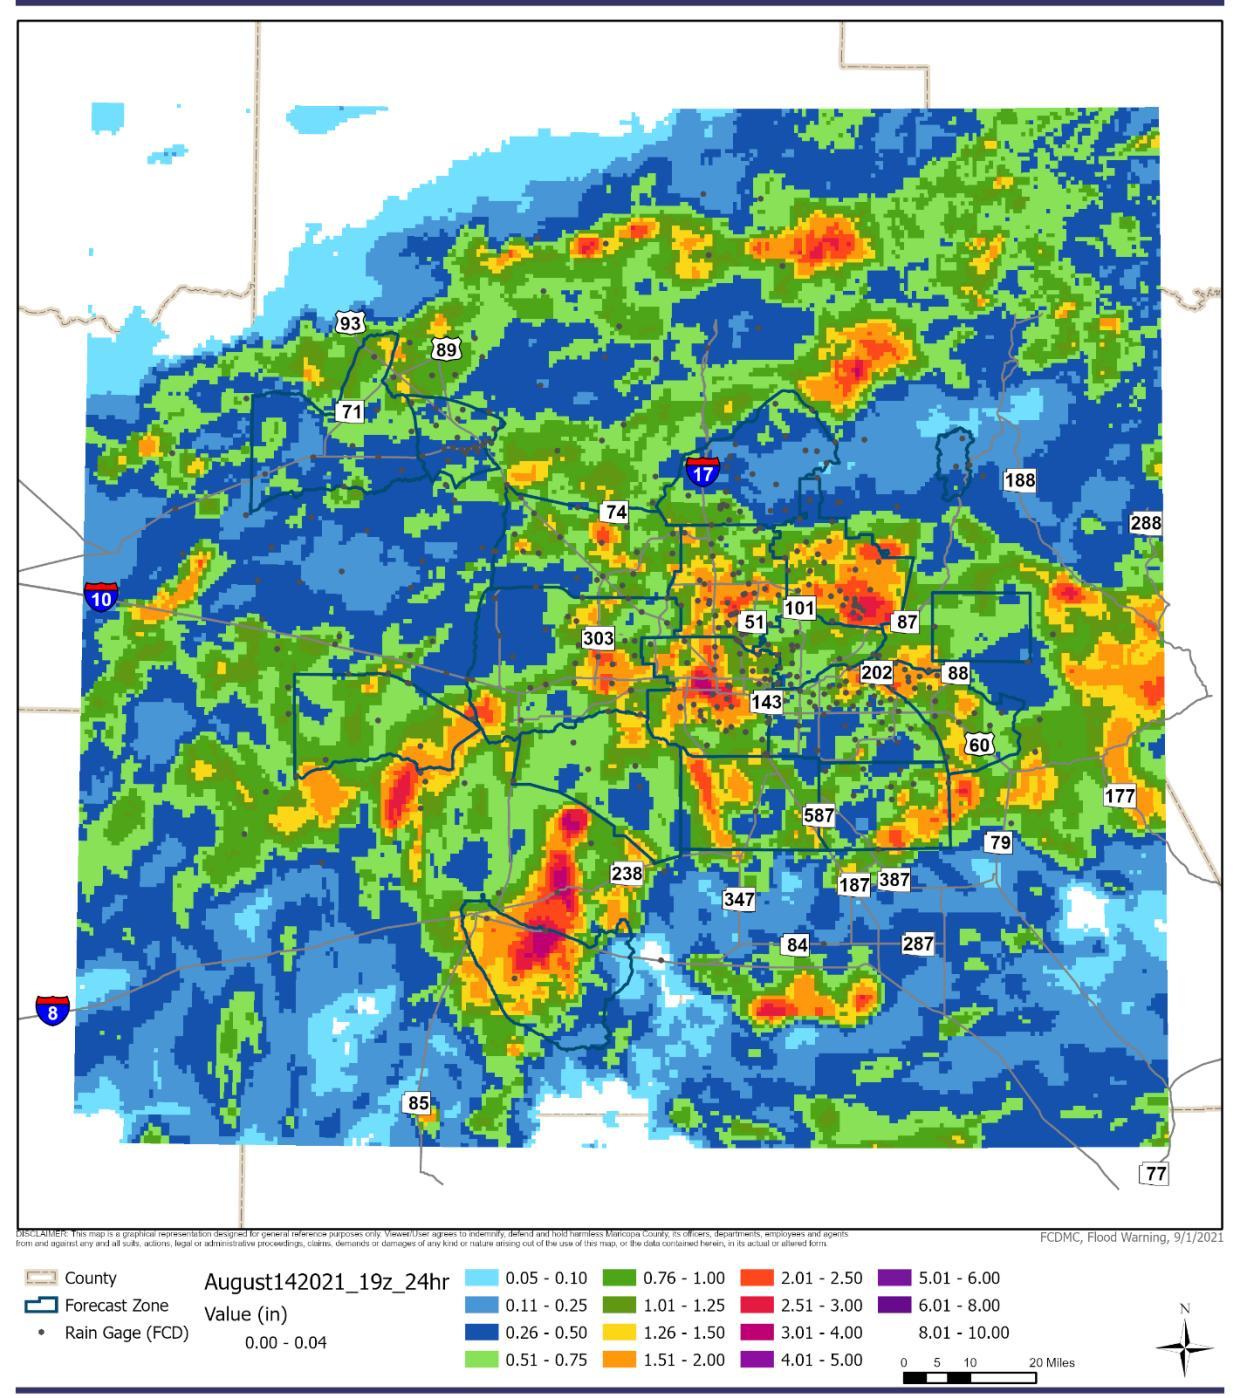
FIGURE 9

**Figure 9** above presents an image of rainfall amounts from gage-adjusted radar rainfall estimates for the period 8/13/2021 12:00 through 8/14/2021 12:00.

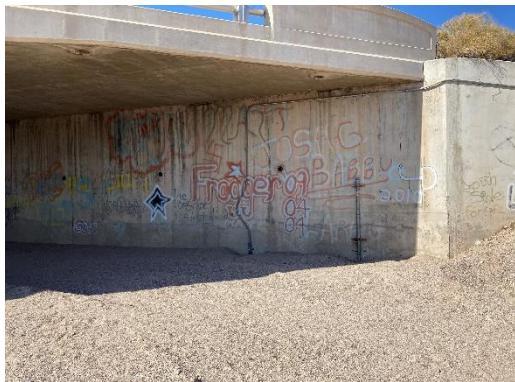
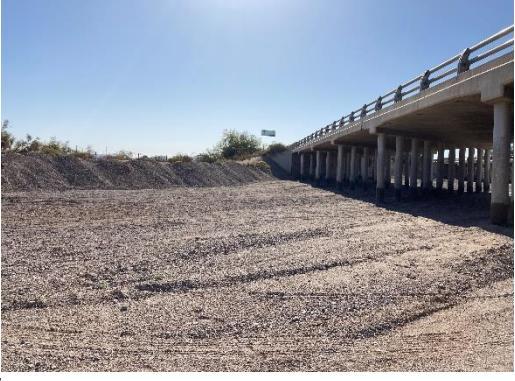
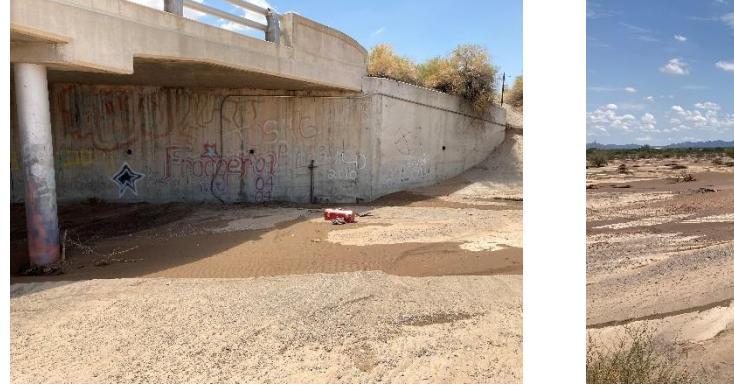
FIGURES 16 a-d

Sand Tank Wash at I-8, August 16, 2021

The photos above are intended to depict the magnitude of the channel changes that occurred due to the runoff event on August 14, 2021.

From a post-event inspection on August 16, 2021, it was evident that the runoff at Sand Tank Wash was of a greater magnitude than that recorded by the ALERT gage, which showed a peak of 7.69 feet and 5,000 cfs, which was the highest rated value.

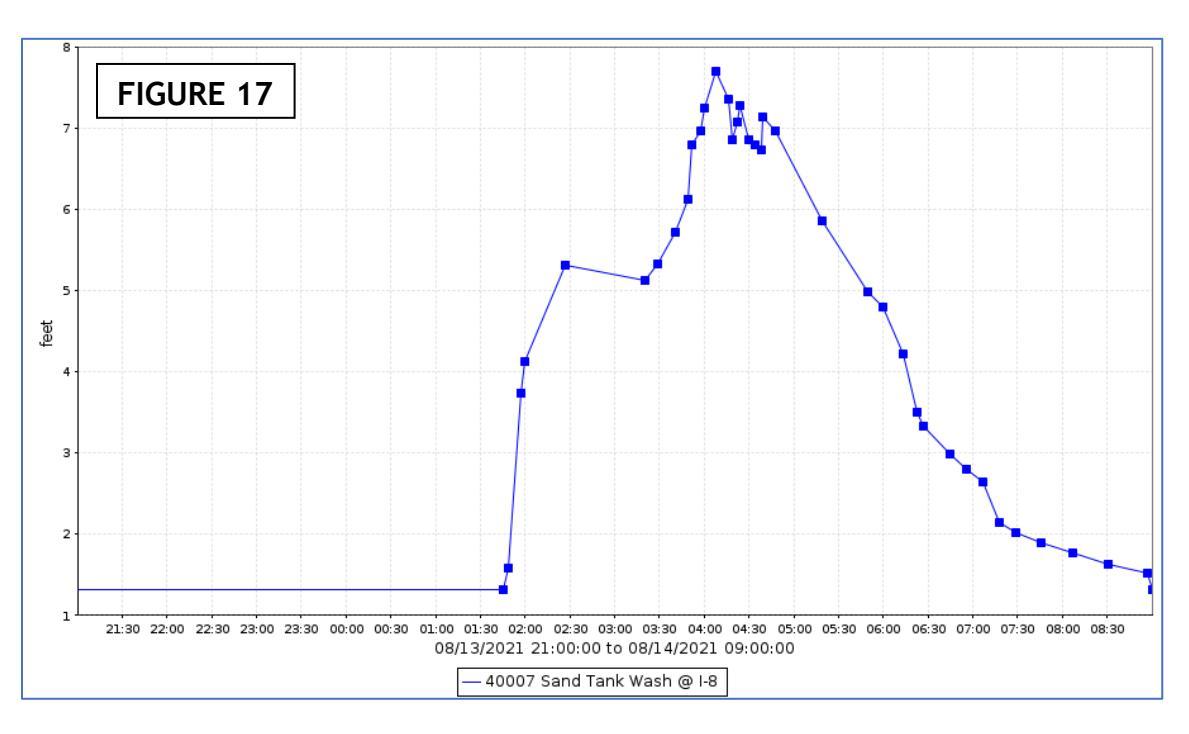
In addition to the evidence at the gage, inspection of the high watermarks downstream of the I-8 bridge indicated that the flow was very wide and may have consumed much of the floodway as defined by the current floodplain map. Inspection of the I-8 bridge showed water marks approximately 3 feet below the low chord.

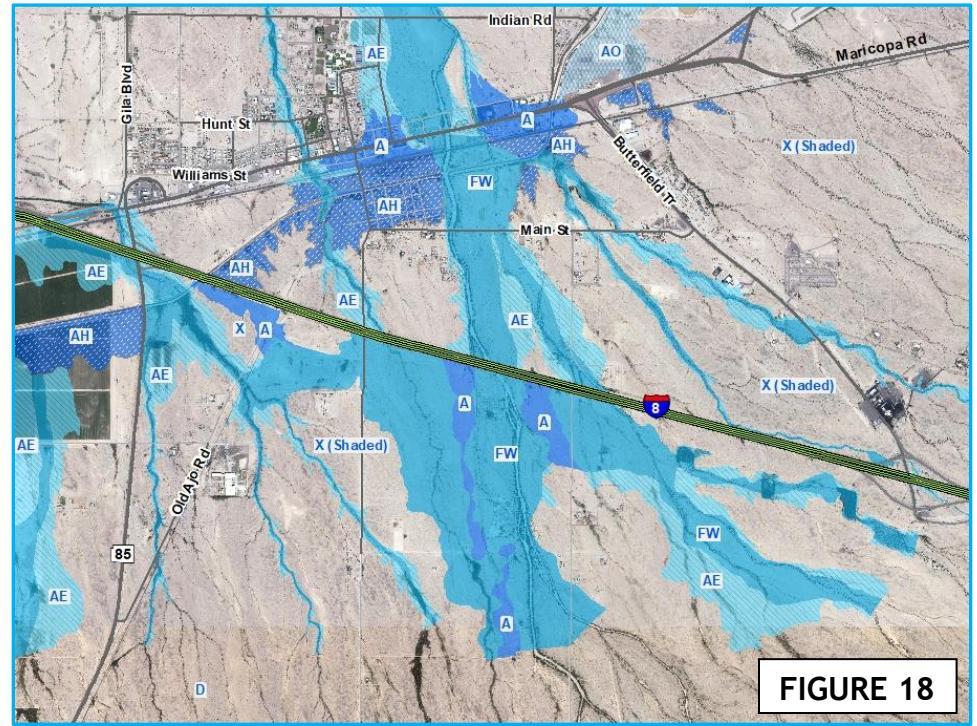
Figure 18: Current Floodplain Map for the area around Sand Tank Wash

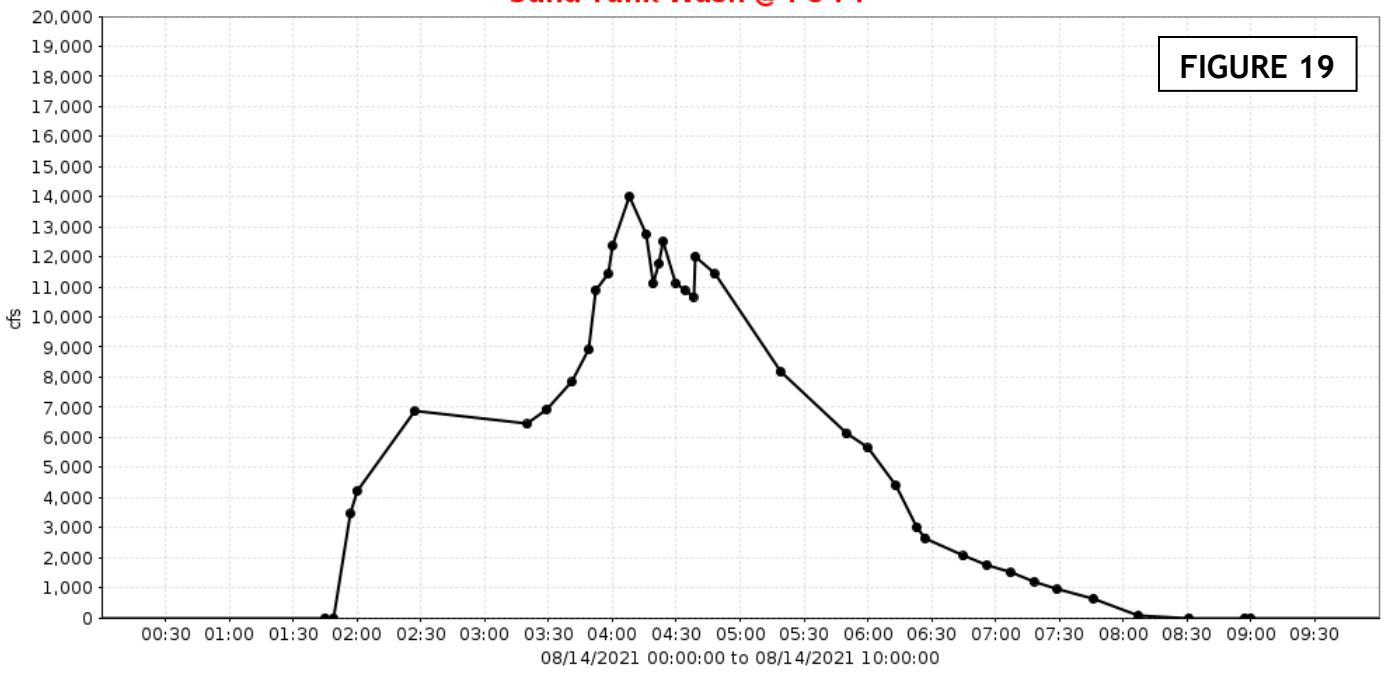
Figure 19 - Sand Tank Wash @ I-8 hydrograph adjusted to the estimated peak of 14,000 cfs

A peak discharge estimate was conducted from previous cross sections extended to the floodplain limits. That analysis indicated a peak discharge of about 14,000 cfs at 8.7 feet gage height. Using the USGS StreamStats program to estimate return periods for this event, 14,000 cfs is approximately a 60-year event. According to the current Flood Insurance Study, the 100-year event has a peak discharge of 23,700 cfs.

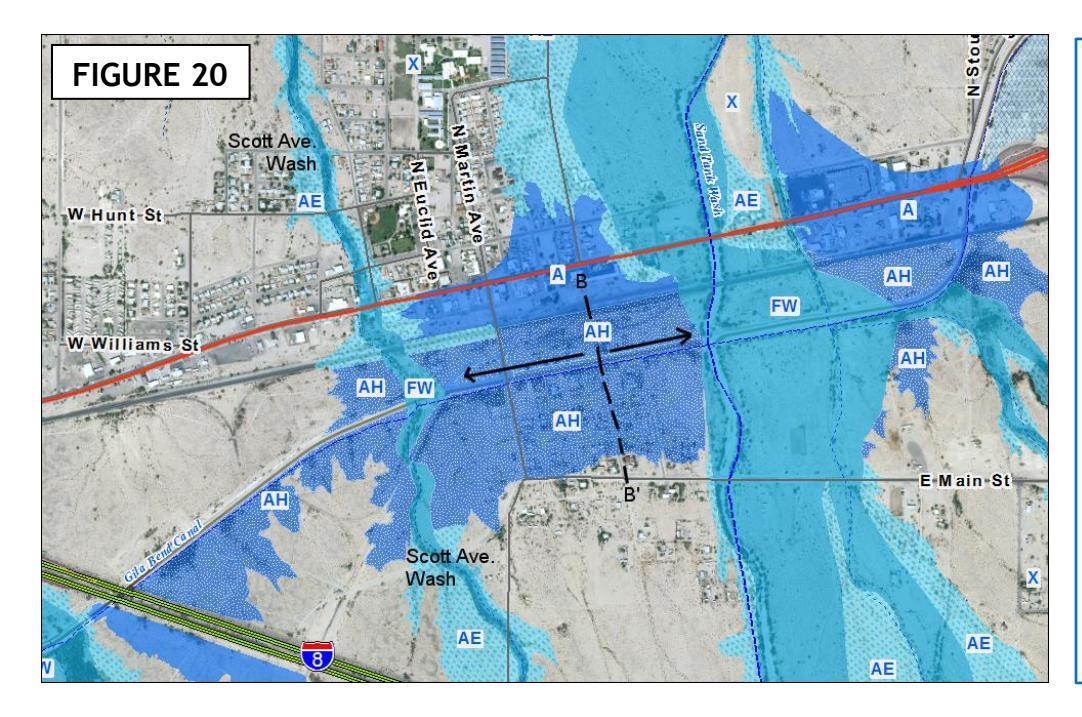
Another area where occupied structures suffered flood damage was along Scott Ave. Wash (left side of Figure 20). Line B to B' is a raised area or ridge line between Scott Ave. and Sand Tank Washes. It is likely that water from Sand Tank Wash overtopped this ridge line and was intercepted by Scott Ave. Wash, aggravating the flood condition for structures north of the railroad underpass.
