# **Flood Control District of Maricopa County**

### **Engineering Division, Flood Warning Branch**

# Storm Report : August 12-14, 2021

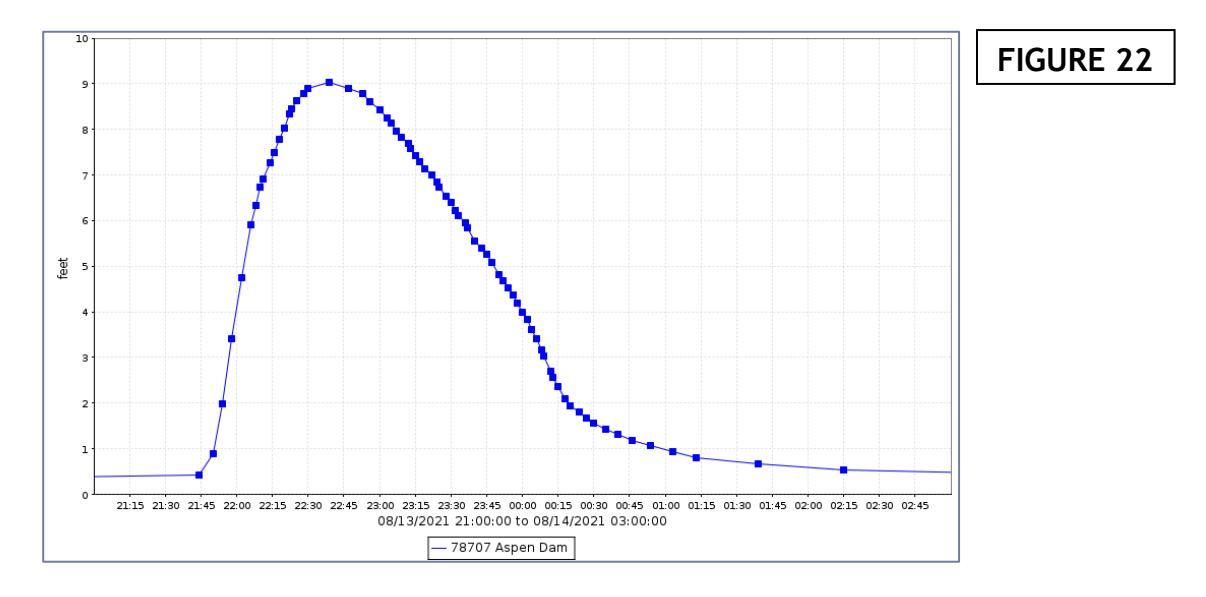
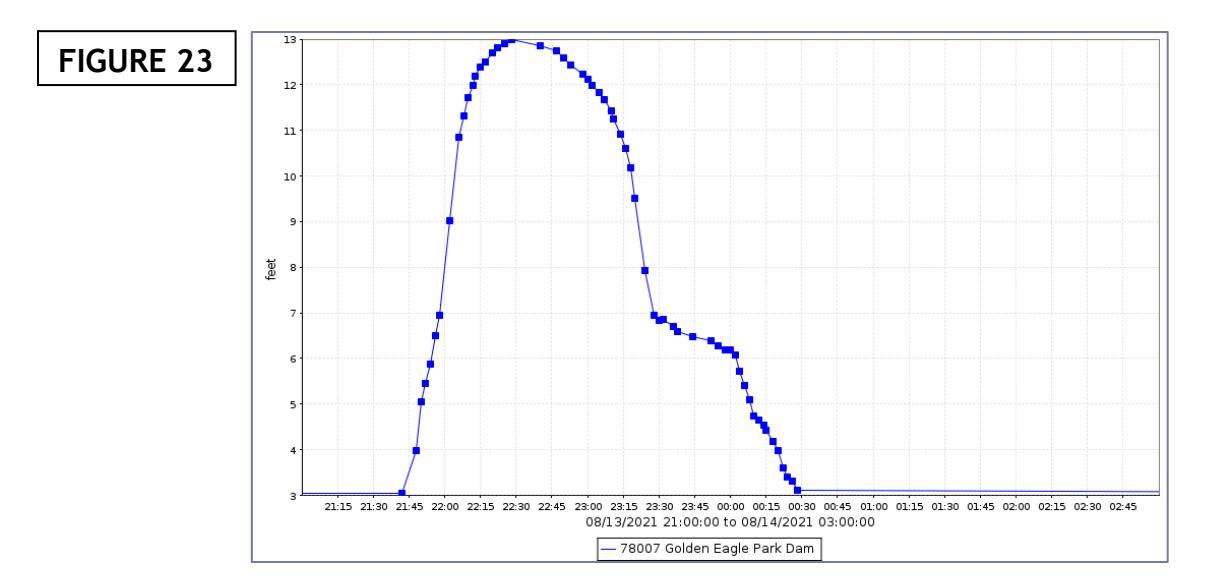
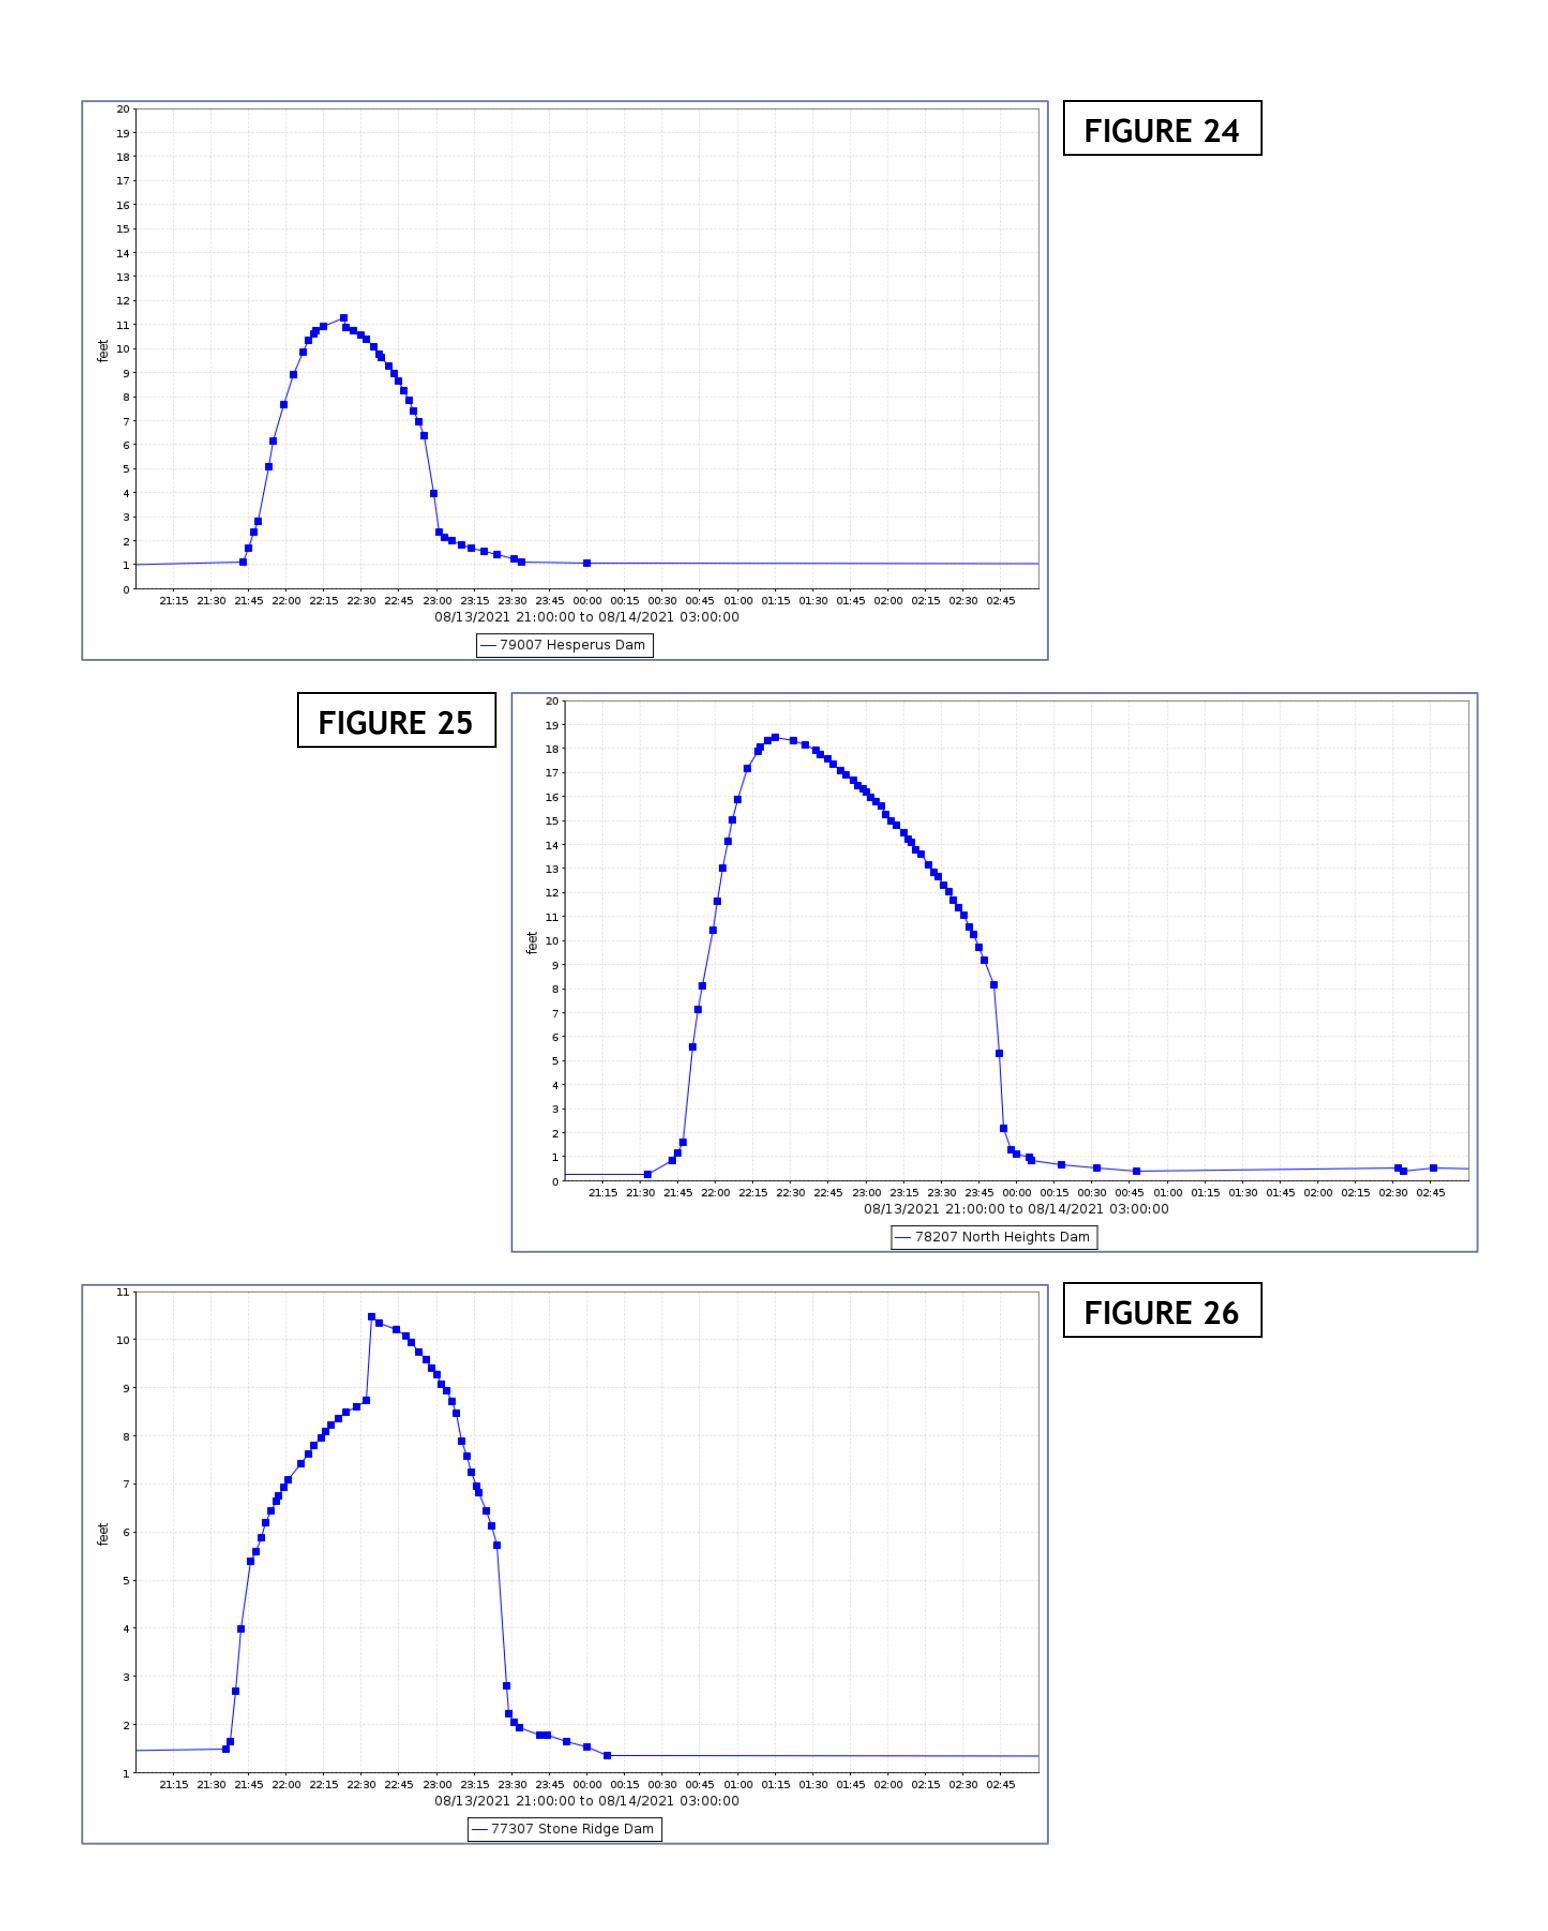
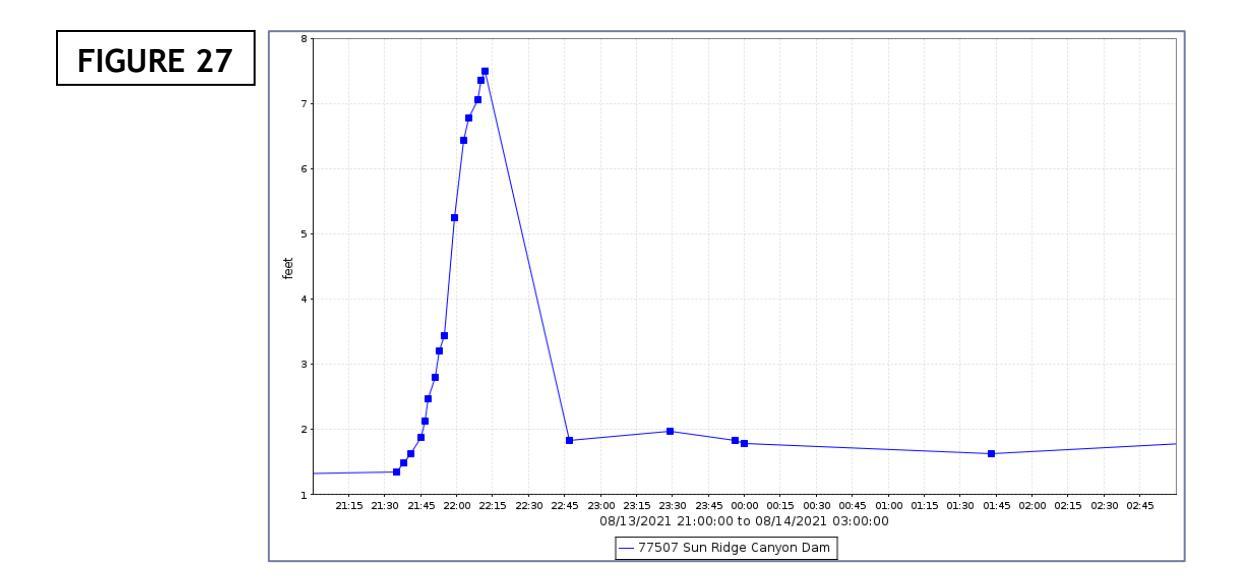
Hydrographs for each dam are provided below.

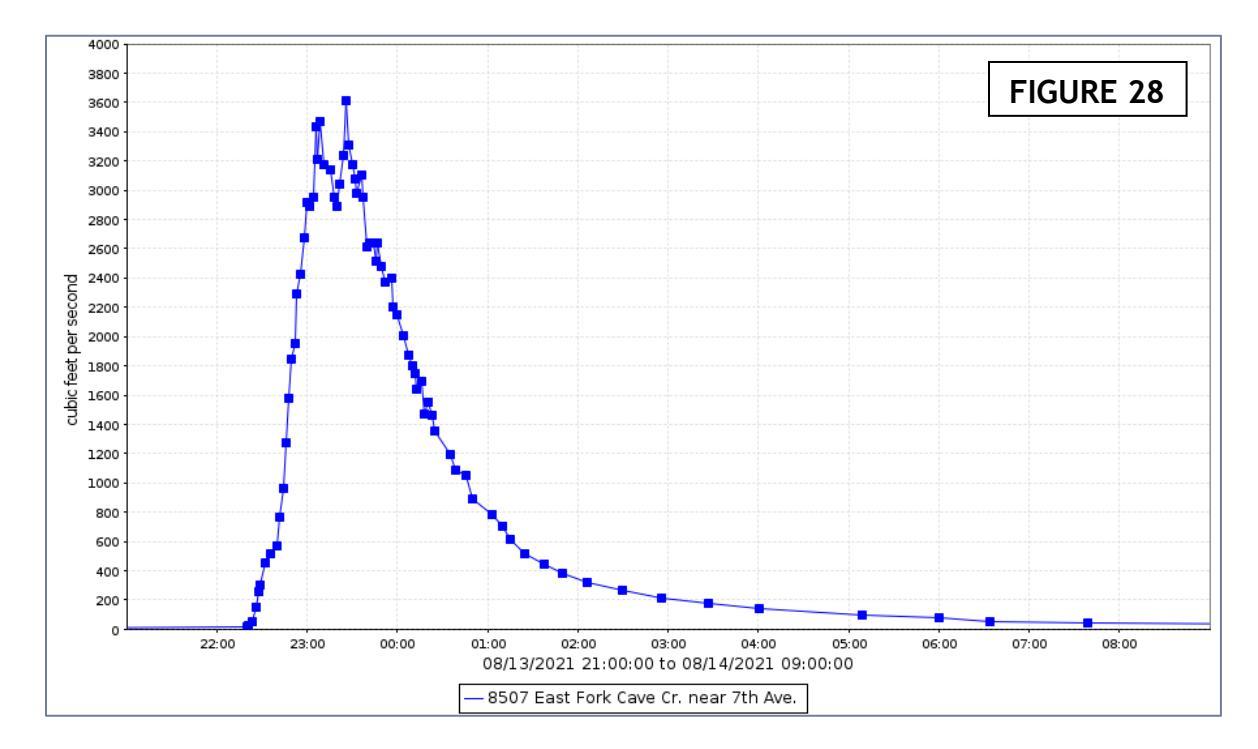
It had a peak discharge of 3,610 cfs at 7.08 feet gage height on 08/13/2021 23:26:00. Though not a record, this flow was near the record from 2005. A hydrograph is provided below.
